**PHASE I
ENVIRONMENTAL SITE ASSESSMENT**

**Nicola Mameet IR # 1,
Lower Nicola Indian Band
Merritt, British Columbia**

Project No: 10-0374
April, 2011

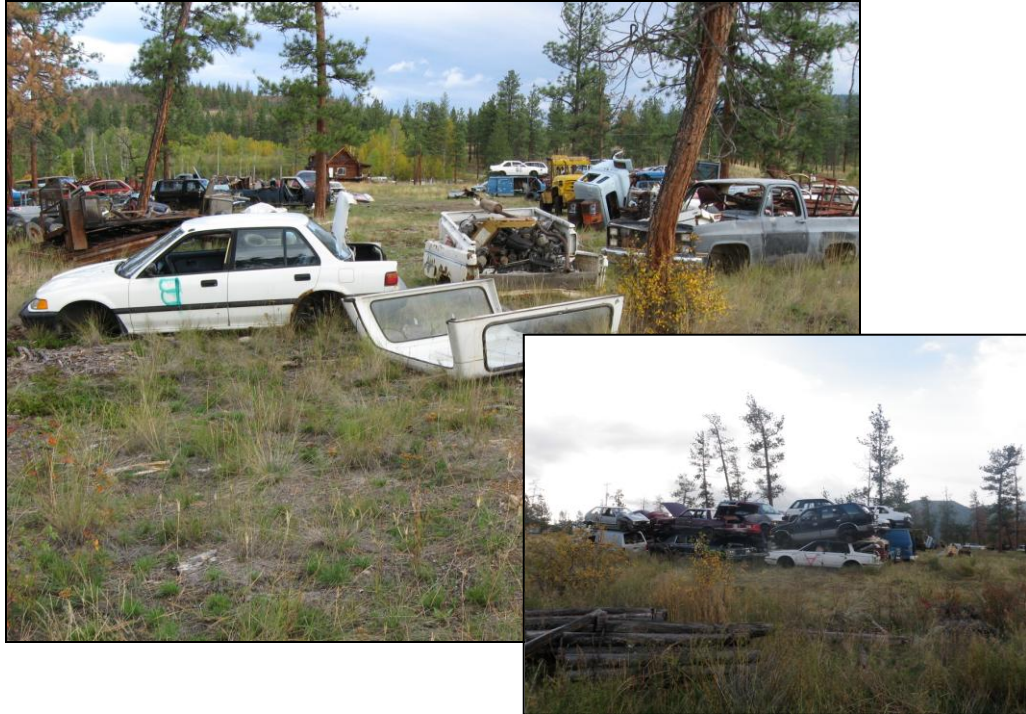
Photo 1. View Rocky Pines Car Crushing facing north. Note abandoned vehicles and stack of crushed cars on the right (facing south).

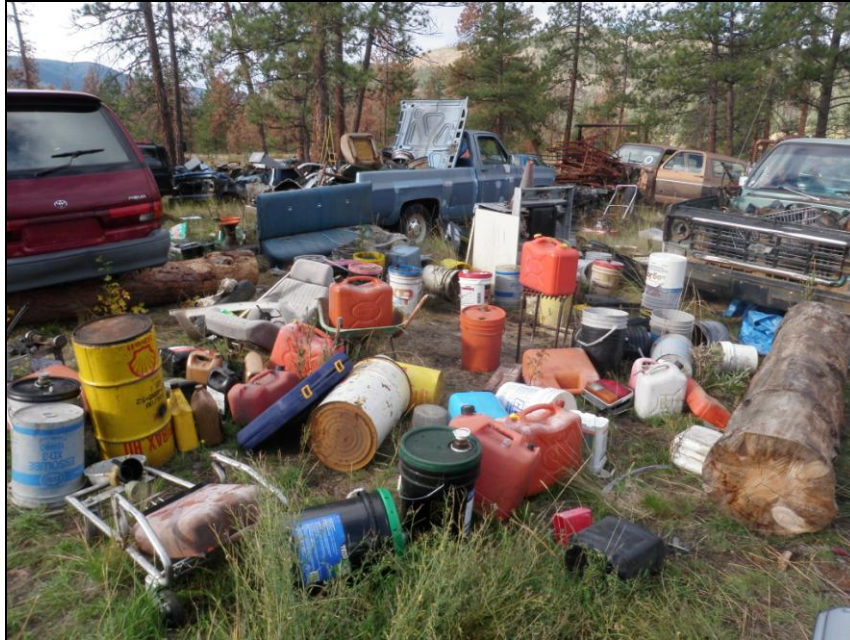
Photo 2. View of open oil containers and soil staining at the Rocky Pines Car Crushing facing southwest.

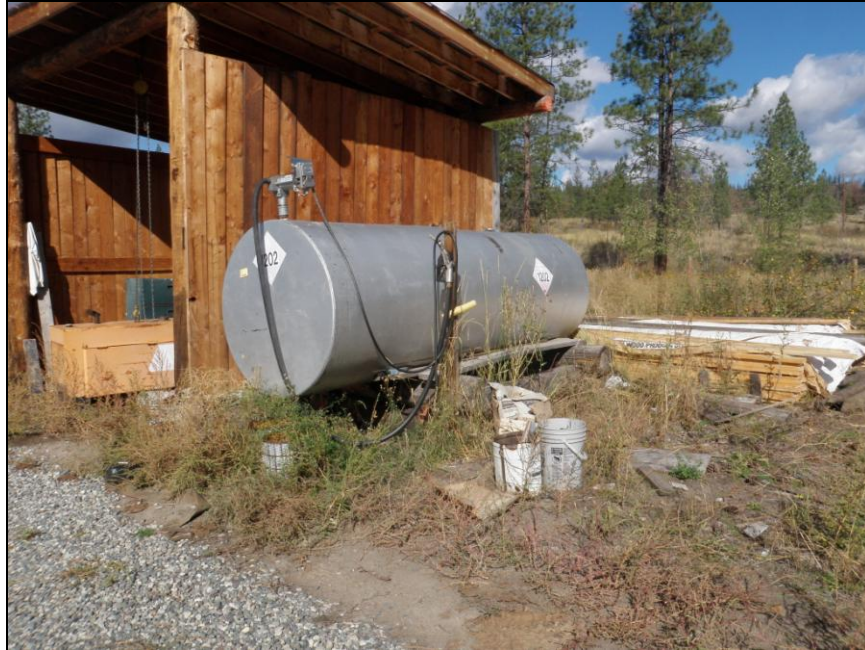
Photo 3. View of the Lot 219 AST facing northwest.

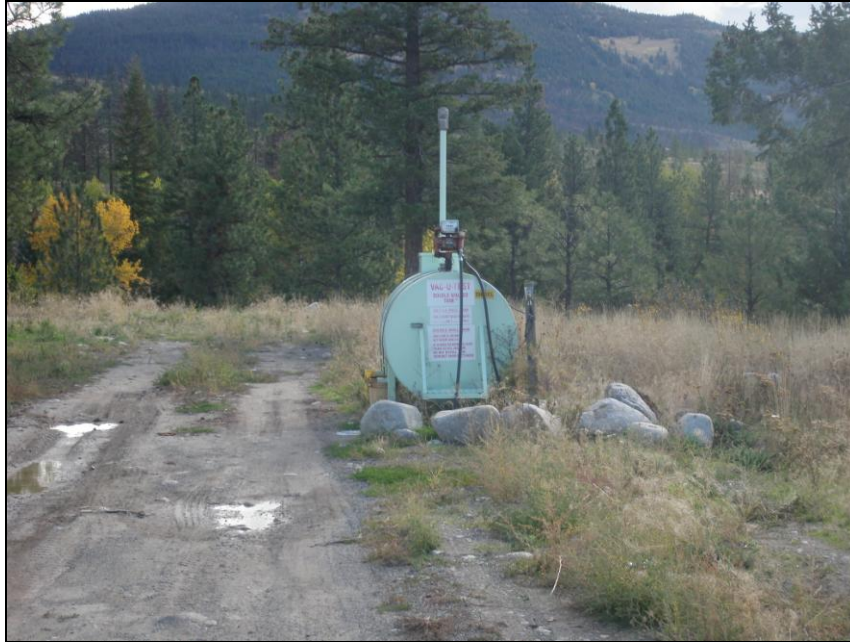
Photo 5. View of the Lot 254 AST facing east. Note the lack of secondary containment, and good tank condition.

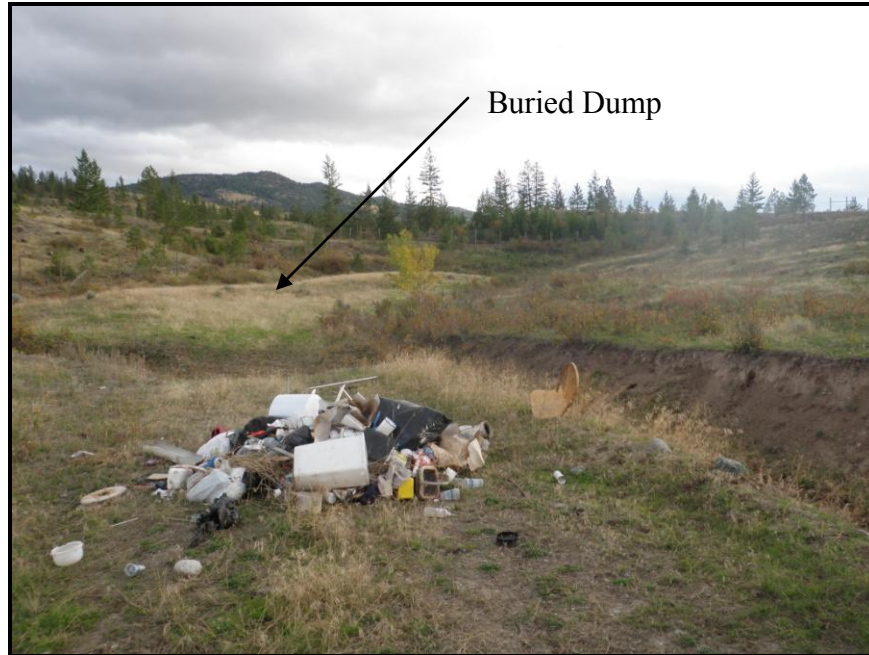
Photo 7. View of the buried Mamit Lake Road Four Mile Dump facing southwest. Note the recently dumped debris.

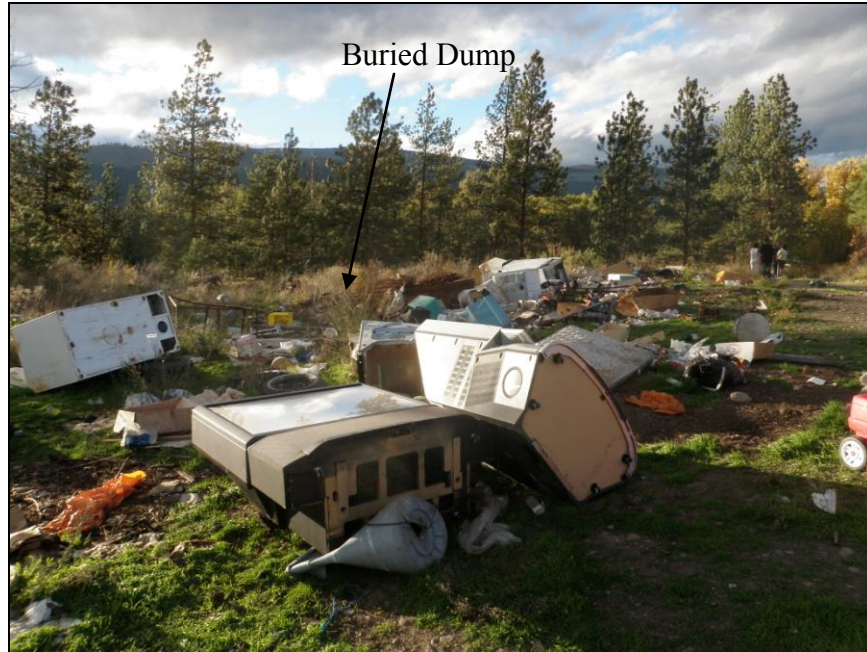
Photo 9. View of the Buried Dump #1 Mamit Lake Ranch Road South facing west. Note the recent surface debris dumped on the buried wastes.

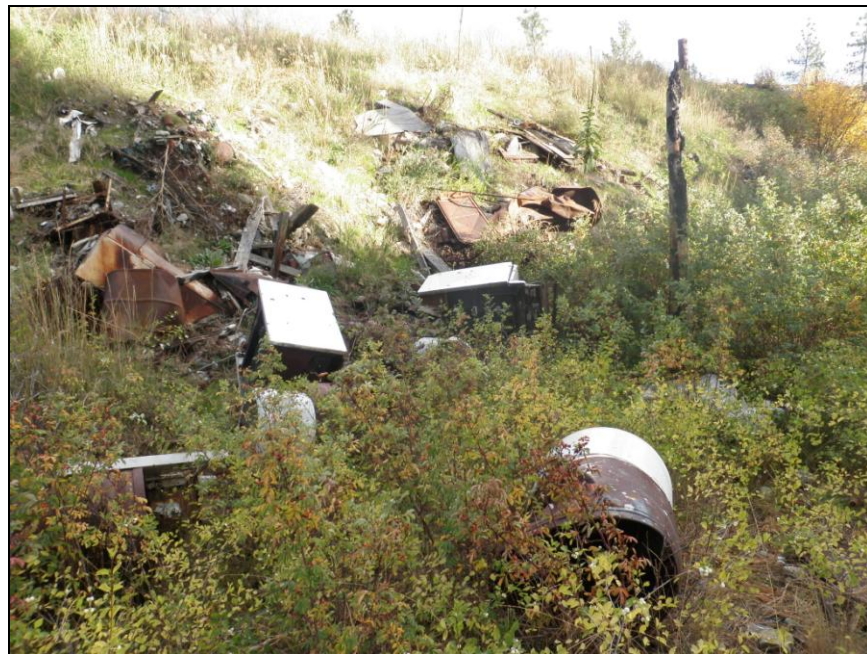
Photo 10. View of Buried Dump #1 facing east. Note the bank covers the buried debris, and limited scattered surface waste has rolled down the bank.

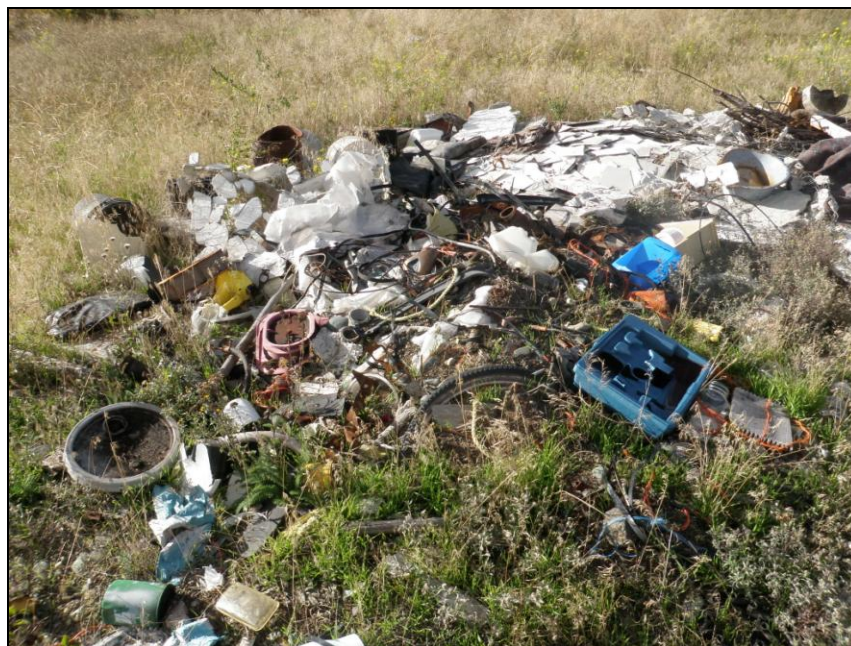
Photo 12. View of building material pile at Buried Dump #2.

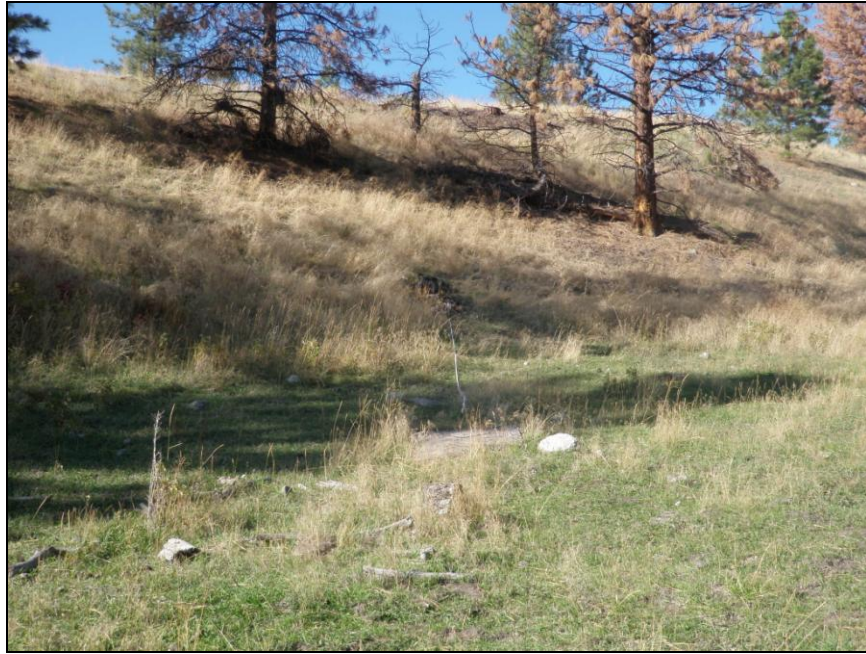
Photo 13. View of the North Firing Range backstop area located east of Mamit Lake Road facing northwest.

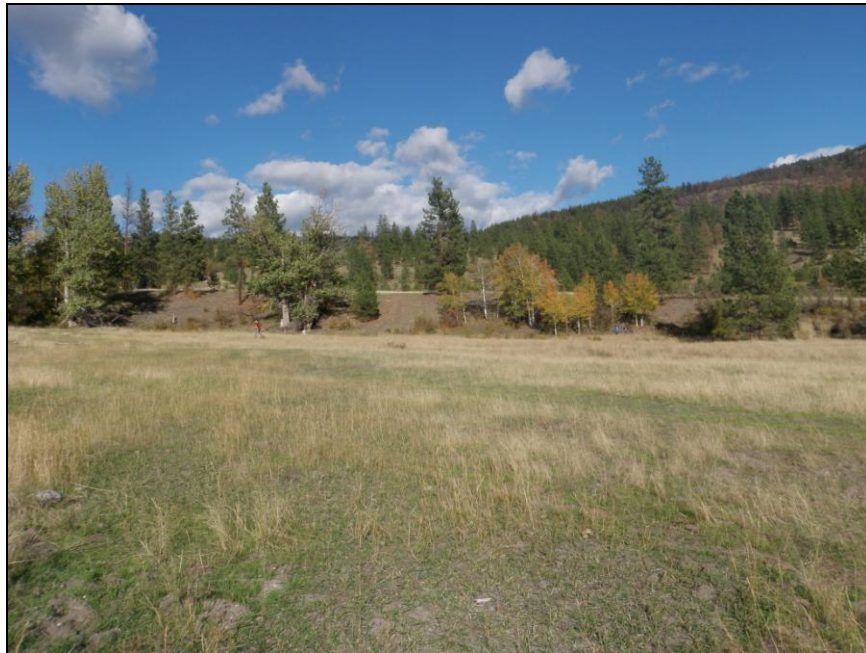
Photo 14. View of the South Firing Range backstop area located east of Mamit Lake Road facing north.

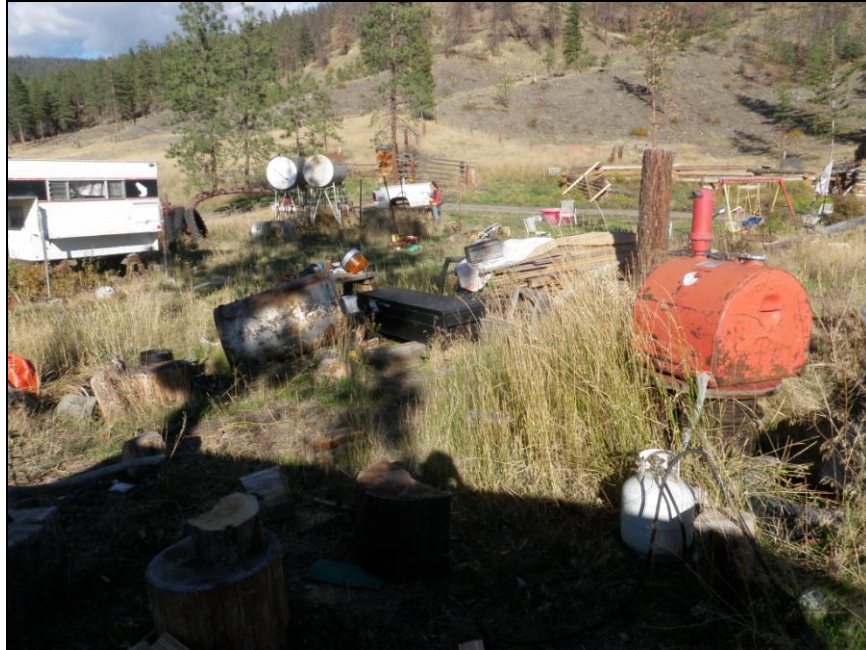
Photo 15. View of the Lot 297 ASTs facing northeast. Note the two 1800L ASTs (Diesel and Gas) on the left, the rusted 800L tank (unknown), and the red empty tidy tank.

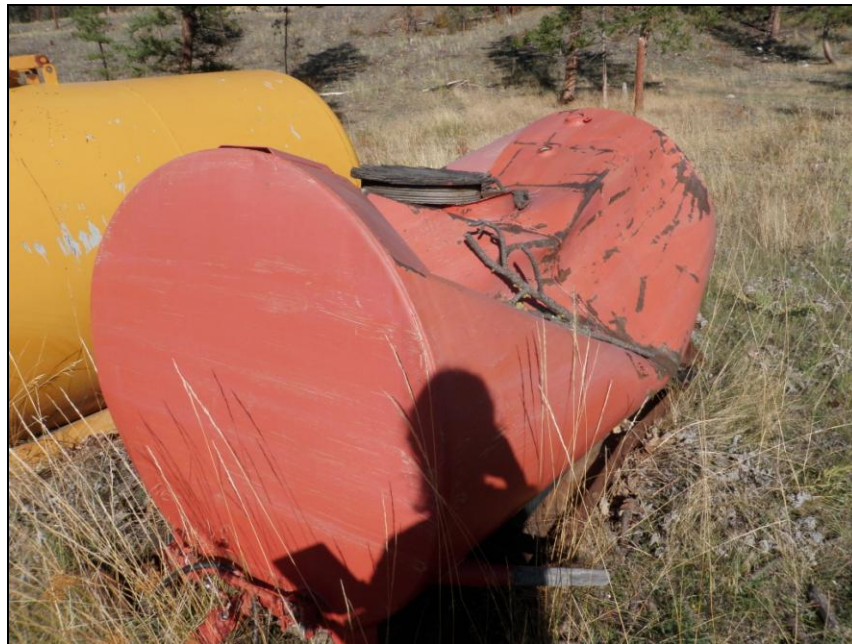
Photo 16. View of the empty 2000L red AST at Lot 297, and the adjacent septic tank facing north.

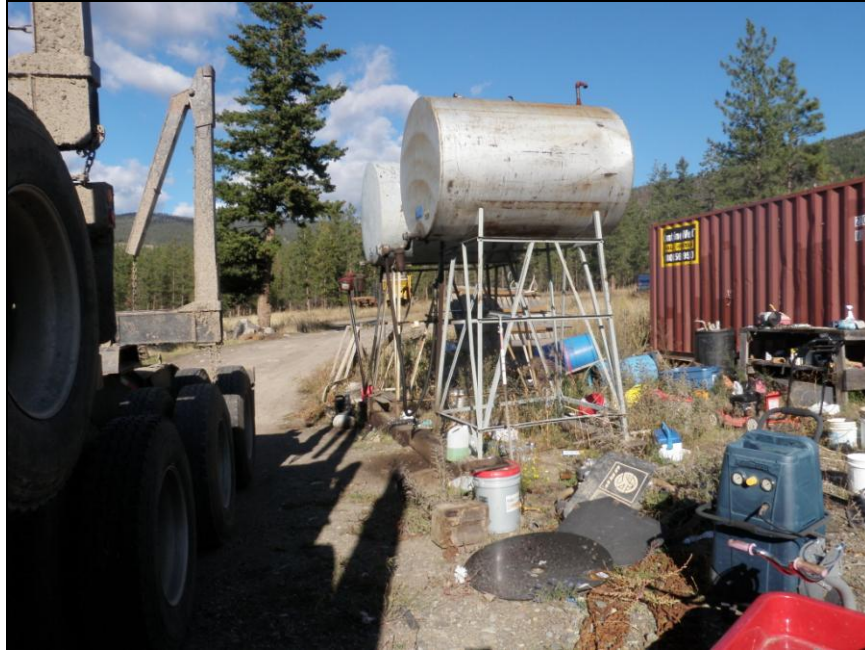
Photo 17. View of the two diesel ASTs located on Lot 294 facing northeast. Tanks appear in good working condition with some weeping at the bungs and fill pipes. Note the adjacent hydrocarbon product storage, and staining below tanks.

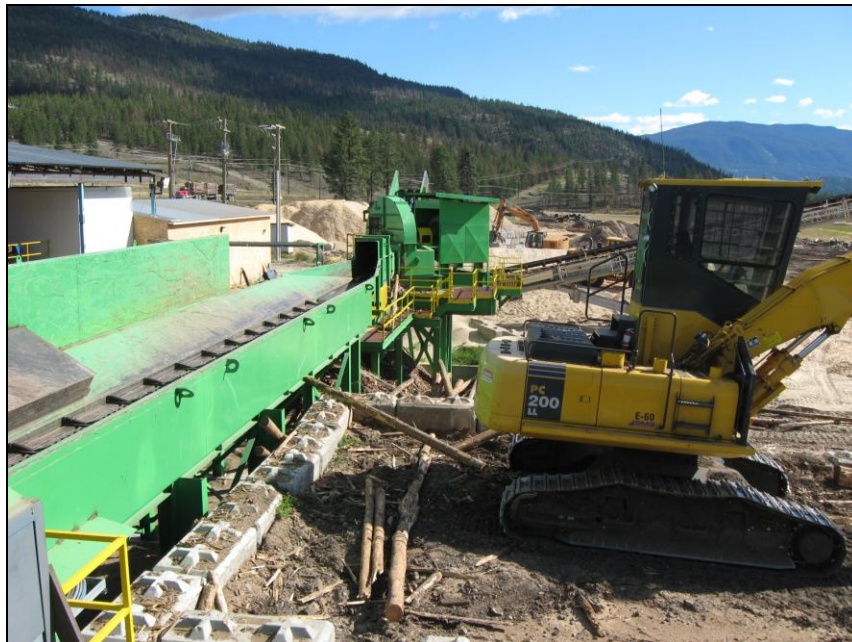
Photo 18. Overview of the Lot 146 Sawmill facing southeast. Note the chipper, conveyor belts, heavy duty equipment, and sawdust piles. Mill building is located on the left.

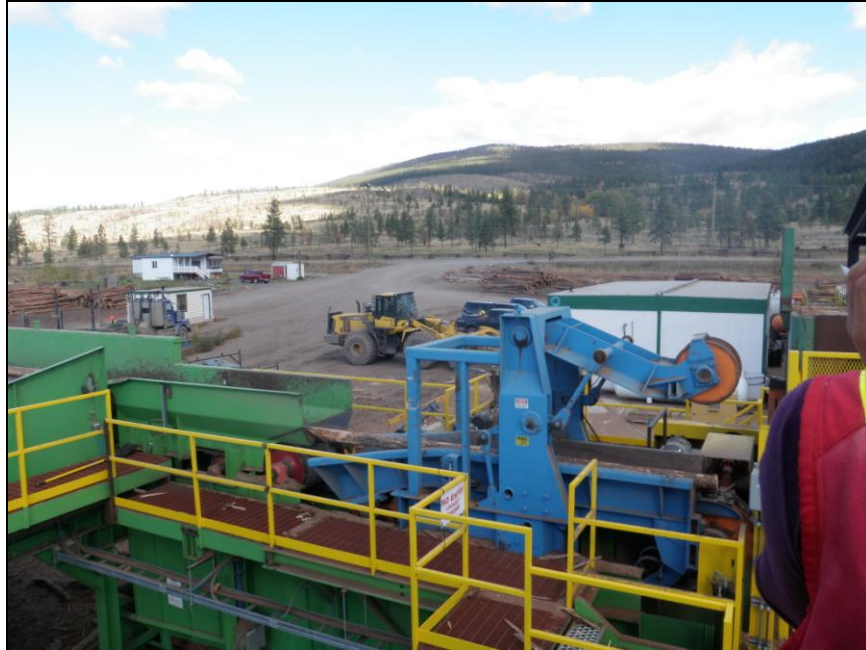
Photo 19. Overview of the sawmill de-barker (left) and conveyor to chipper facing northeast. Note the weigh scales and night watchman residence on the left, and the lunchroom on the right.

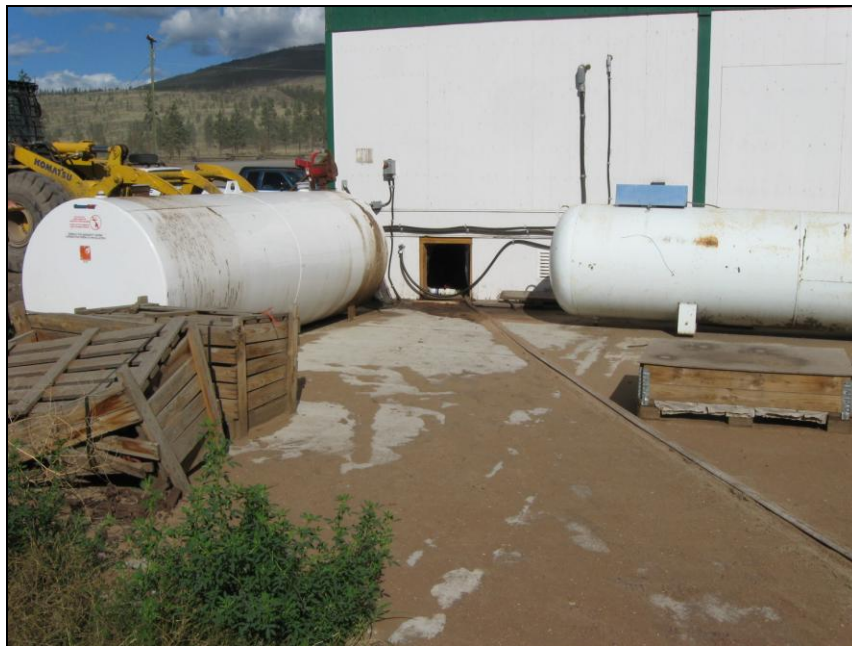
Photo 20. View of Lot 146 Sawmill ASTs (Diesel on left, propane on right) facing northeast. Note the concrete pad, and position next to lunchroom.

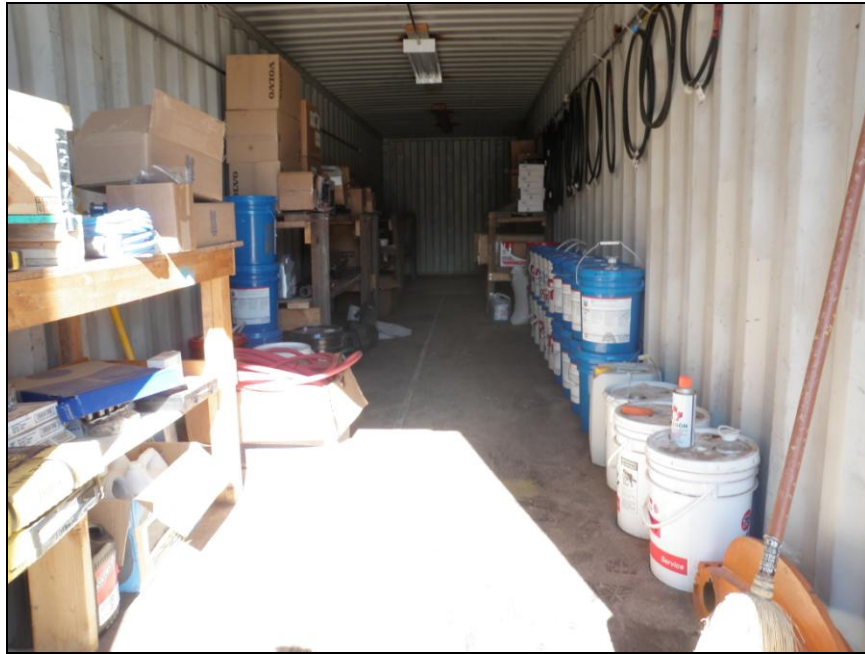
Photo 21. View of chemical storage in steel storage containers at the Sawmill. Note that all chemicals are in sealed in well organized labeled containers.

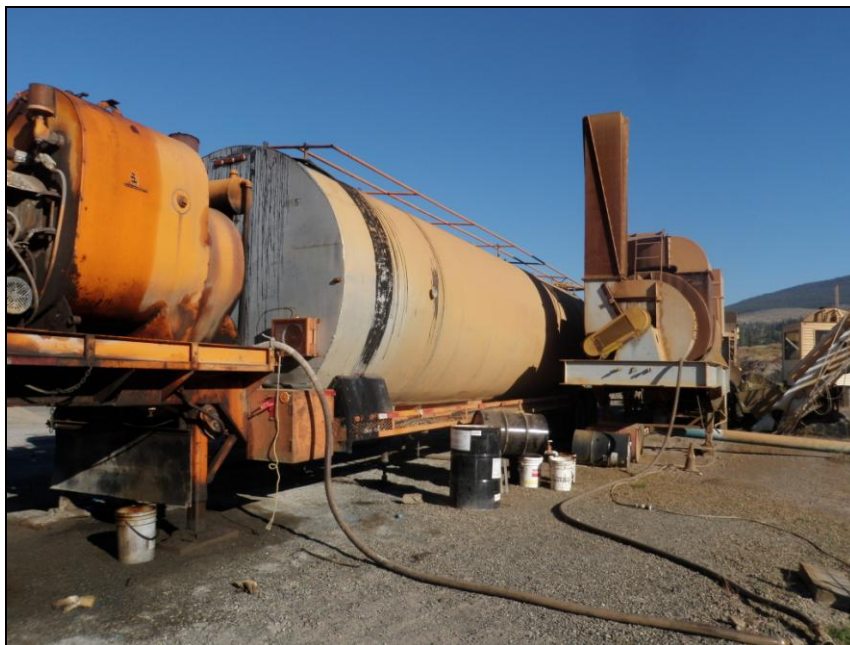
Photo 24. View of the portable asphalt plant at Mojo's Gravel Pit facing north. Note the 205L drums and 20L plastic pails and staining of soil beneath the machine. Stained area is lined with poly 30cm below the surface.

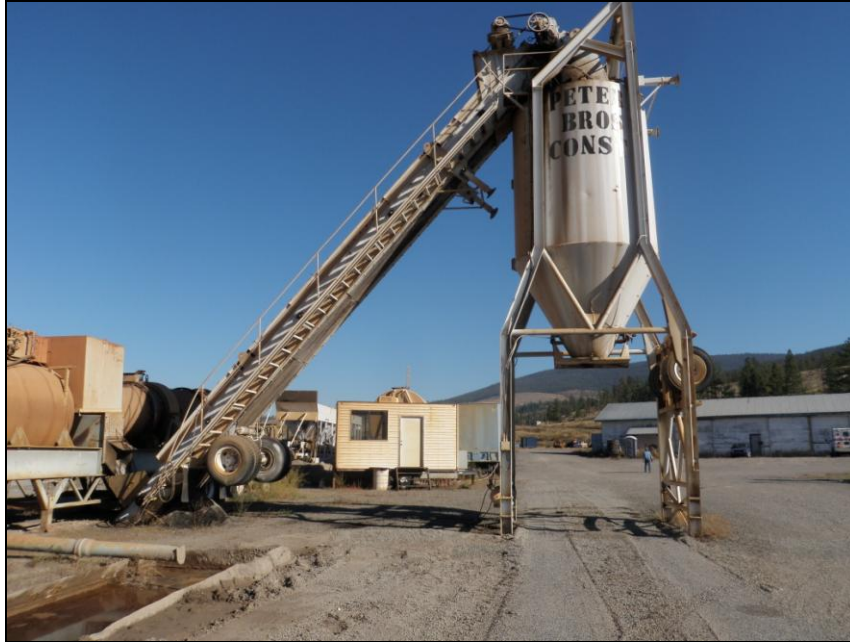
Photo 25. View of the asphalt silo, holding tanks, and office within the portable asphalt plant at Mojo's Gravel Pit facing north.

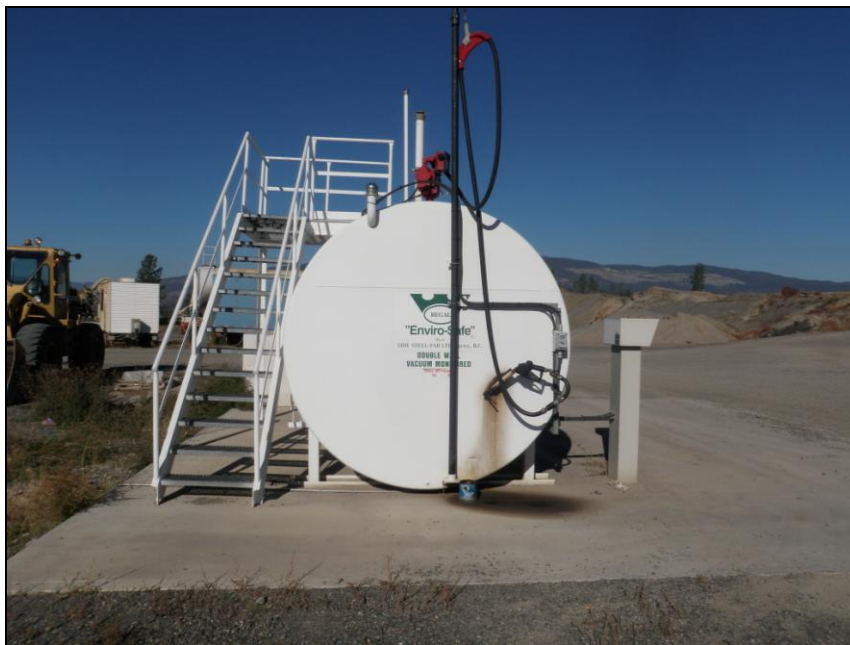
Photo 26. View of Lot 265 Mojos Gravel Pit Diesel AST facing west. Note the staining on the concrete pad.

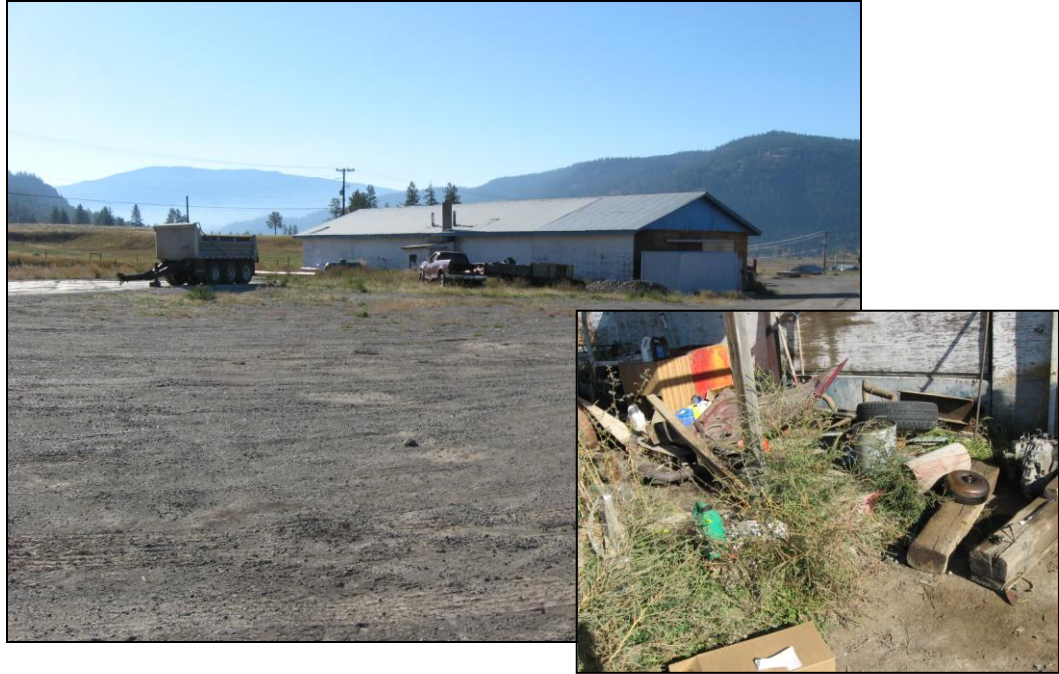
Photo 27. View of the warehouse within the gravel pit facing south. Debris and the storage of automotive lubricants and oil are found outside the warehouse.

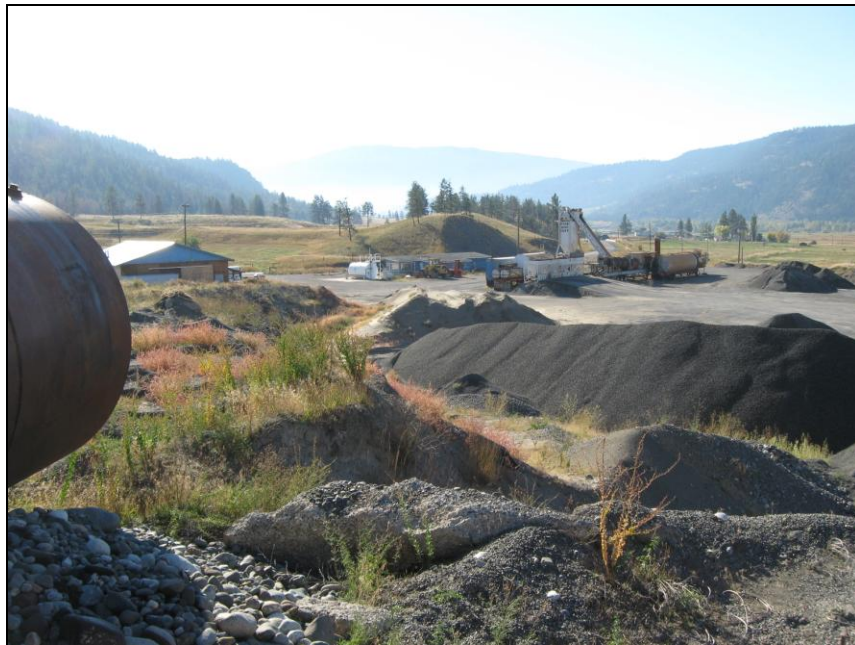
Photo 28. Overview of the Lot 265 Mojo's Gravel Pit property facing southeast. Note the abandoned AST on the left.

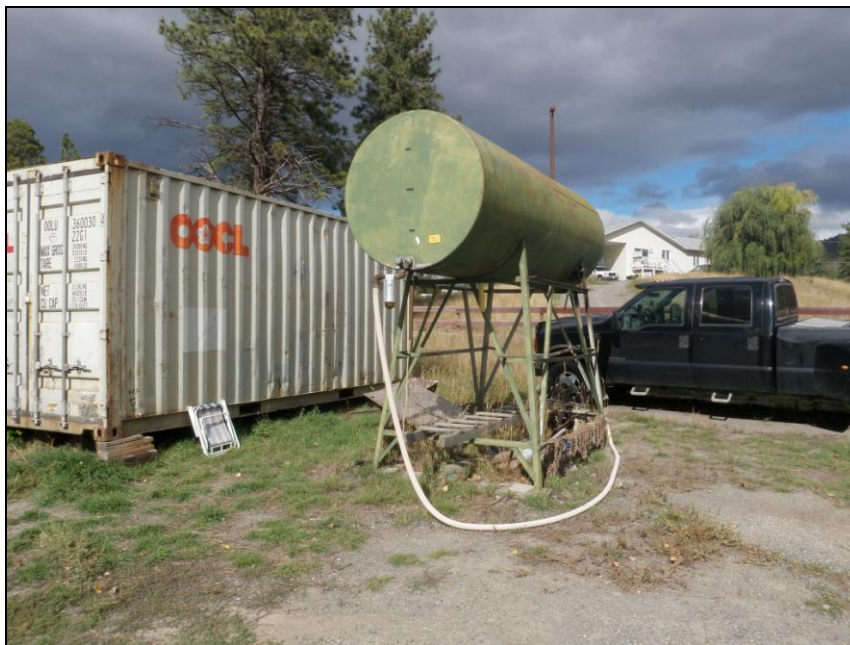
Photo 32. View Lot 87-4 AST facing north. Note small stain in soil below tank, and open 20L pail containing radiator fluid below tank supports.

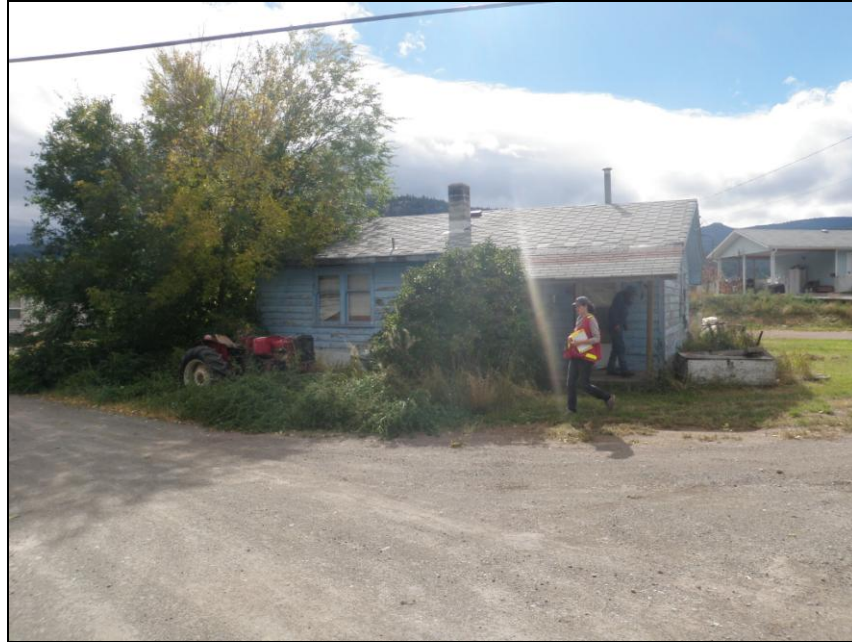
Photo 33. View the Lot 72-1 Abandoned House facing south. House reportedly contains xenolite (asbestos) insulation.

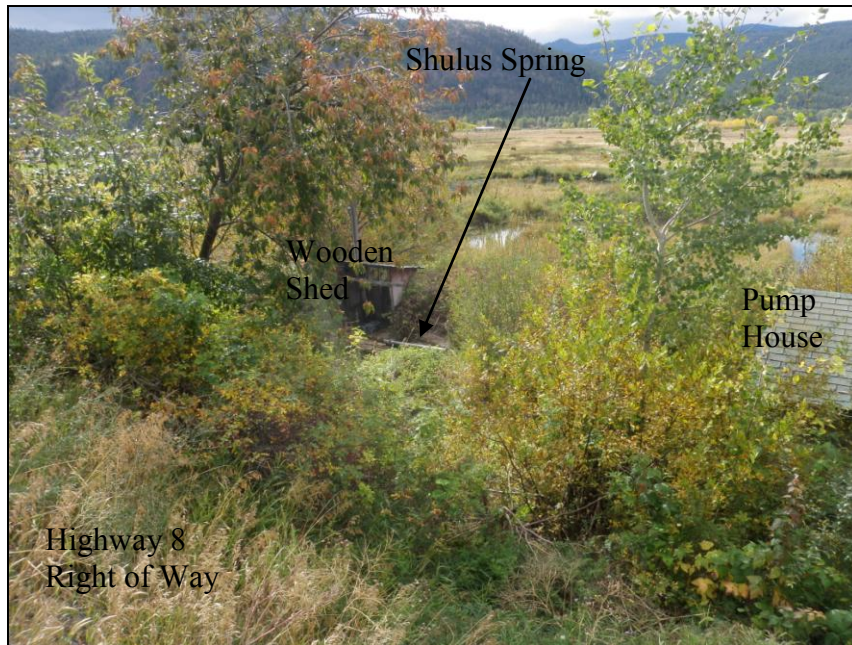
Photo 34. View of Lot 67 Shulus Spring and pump house facing southwest. Note the proximity to the highway right of way.

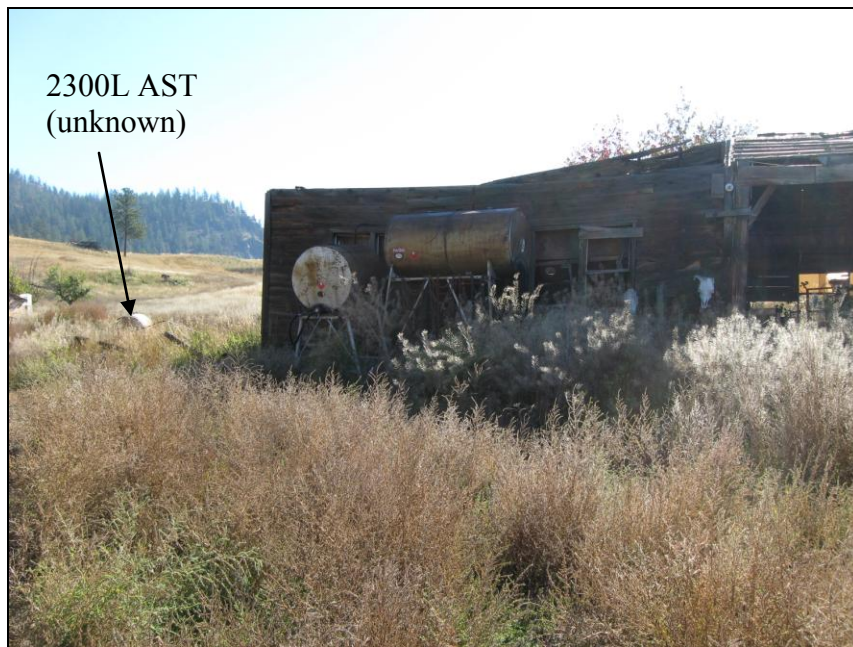
Photo 36. View of Lot 208 ASTs (225E) located on Highway 8, facing east. Note the Diesel and Gas AST against the collapsing building, and the unknown AST on a wood pallet in the field.

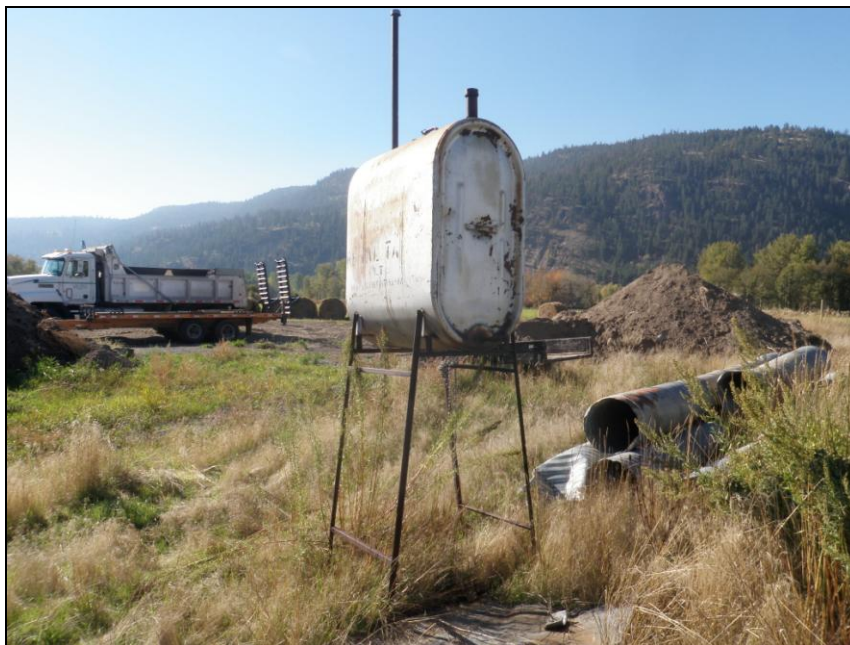
APEC 19 Lot 58 AST (280E) 654900E 5555102N	Privately owned empty heating oil AST (300L) appears in moderate condition. Tank is rusting, and does not appear to be in use. No staining or odors were noted below the tank.	<ul style="list-style-type: none"> • PAH • PHC

Photo 38. View of Lot 58 AST (280E) on Highway 8 at facing southeast. Note the lack of secondary containment, and no staining or odors.

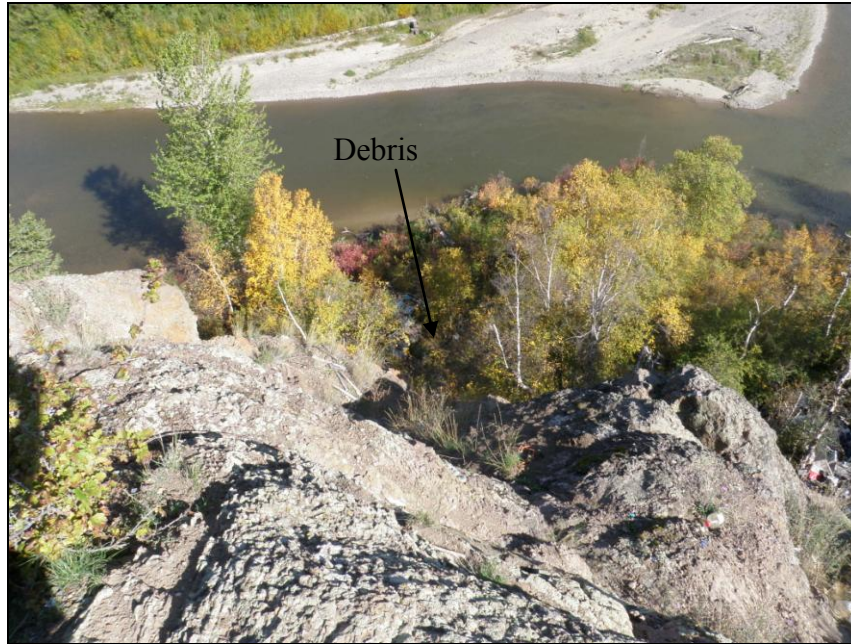
APEC	Description of Contamination or Risk	COPC
APEC 20 BC Plan 215 Nicola River Dump 654202E 5554569N	A 50x80 m area of debris was observed strewn down a bedrock slope between Lindley Creek Road and Nicola River. The area is densely vegetated riparian area at the toe of slope, and is within the floodplain of the Nicola River. Debris includes numerous abandoned vehicles, appliances, domestic waste, scrap metals, furniture, building materials, and rubber tires.	<ul style="list-style-type: none"> • Metals • PAH • PHC
APEC 21 BC Plan 215 Shulus Road ASTs 654194E 5554572N	Three (3) privately owned ASTs (1350L gasoline, 2400L unknown, 1600L diesel) are in moderate condition and do not appear in use. No soil staining was observed below the tanks in the current location, but a 1m diameter soil stain was noted at the front of the storage shed.	<ul style="list-style-type: none"> • PAH • PHC
APEC 22 Lot 78-2 Johnny's Gas Station 653625E 5556100N	The gas station contains a diesel (9000L), gasoline (46,000L), and a propane ASTs with underground lines running to four pumps within one pump island. No spills were reported, and no concerns with current practices were noted. Former USTs were located in same location as current USTs. The gas station is up gradient and approximately 1km from the Nicola River. Former diesel and gasoline ASTs from this site are abandoned on Lot 183.	<ul style="list-style-type: none"> • PAH • PHC

Photo 39. Overview of BC Plan 215 Nicola River Dump facing north. Note the debris scattered down the steep talus slope and close proximity to the Nicola River.

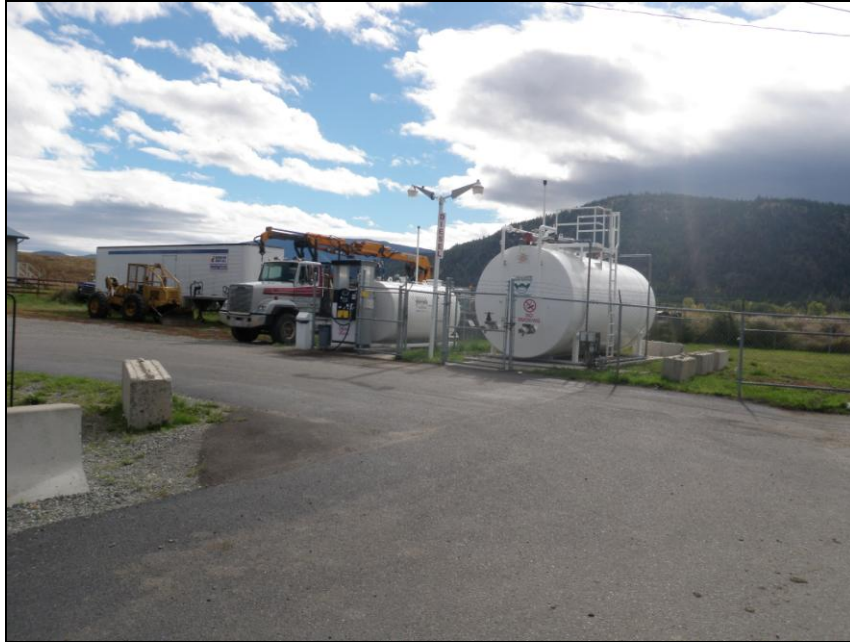
Photo 45. View Lot 78-2 “Johnnys on the Rez” gas station ASTs facing south. Note the two ASTs (Diesel at left, Gas at right) are on concrete pad within fenced compound. Note minor diesel staining on concrete below nozzle.

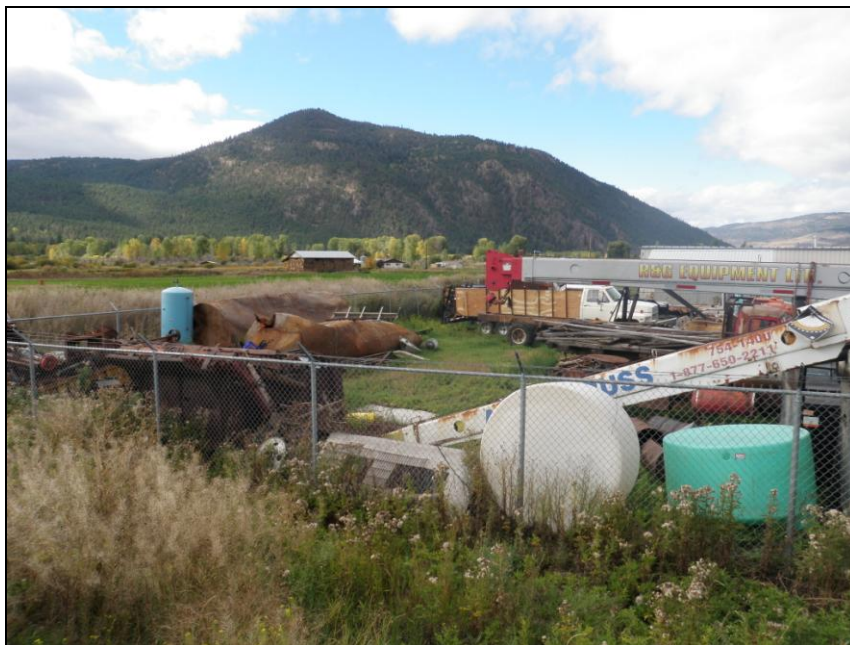
Photo 46. View of Lot 78-2 heavy equipment storage area adjacent to “Jonny’s on the Rez” Gas Station facing southwest.

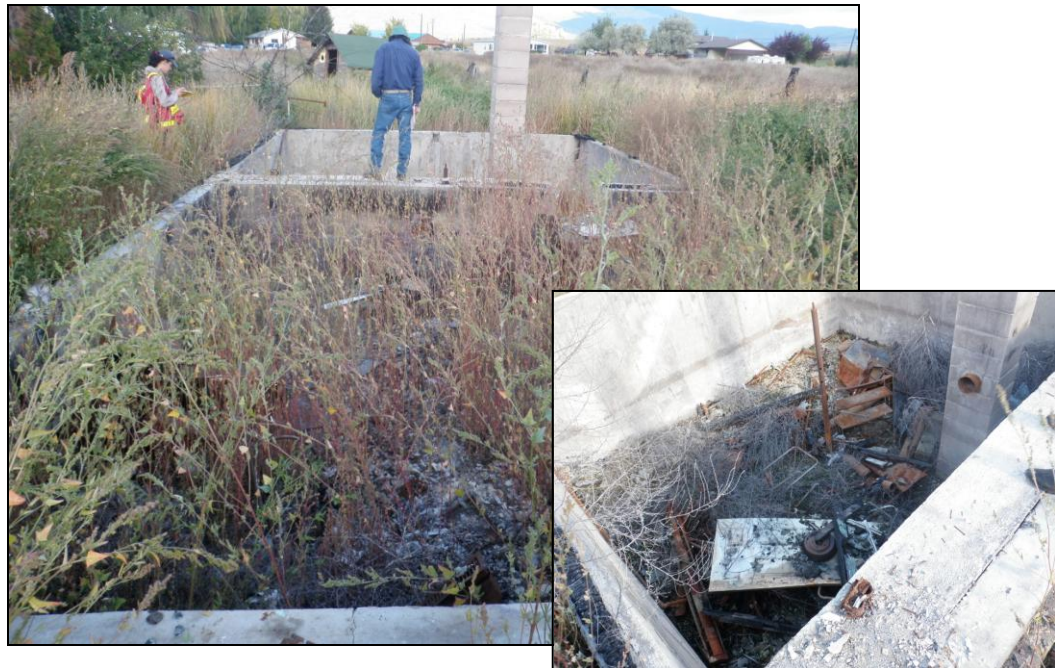
APEC 23 Lot 81 Burnt House 653278E 5556032N	Foundation and surrounding area is littered with scattered burnt debris. Basement portion is open to 2.2m below surface grade, and contains standing water. Area is overgrown and the open basement presents a safety hazard. Adjacent shed contains debris.	<ul style="list-style-type: none"> • Metals • PAH • PHC
APEC 24 Lot 17 & 18 Residential Dump 653223E 5555894N	Buried residential dump (20m x 8m) contains metals and domestic waste, and potential unknown substances. Buried debris is on bank above seasonally wetted area within a residential development.	<ul style="list-style-type: none"> • Metals • PAH • PHC • VOC
APEC 25 Lot 86 Residential Dump 652973E 5556056N	Buried residential dump contains metals and domestic waste, and potential unknown substances. Buried debris is on bank and within seasonally wetted area and within a residential development.	<ul style="list-style-type: none"> • Metals • PAH • PHC • VOC

Photo 48. View of the Lot 81 Burnt House concrete foundation facing west. Note the burnt debris and standing water within the basement (shown on right), and the wooden shed to the west.

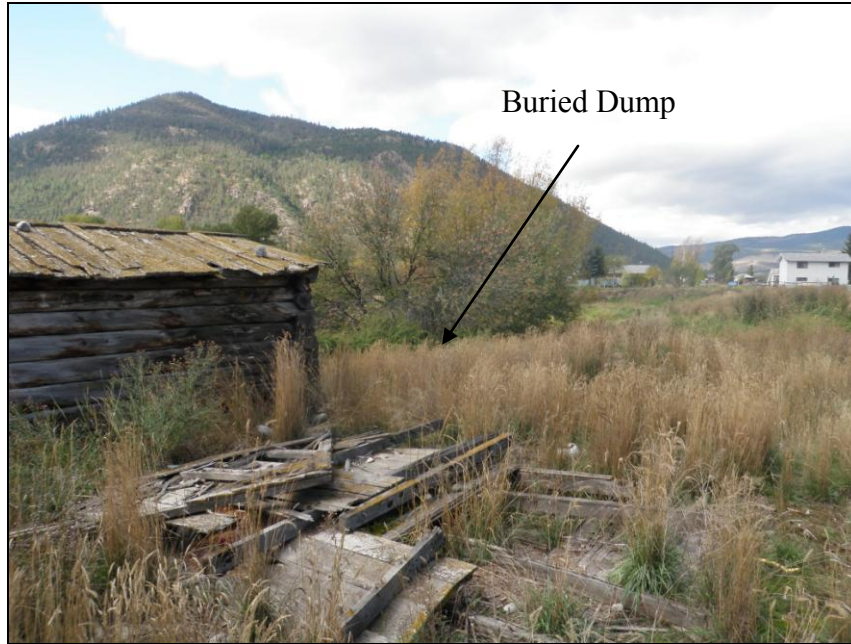
Photo 49. View of Lot 17 & 18 Residential Dump facing west. Note the log cabin and wood waste, and buried dump location west of the cabin.

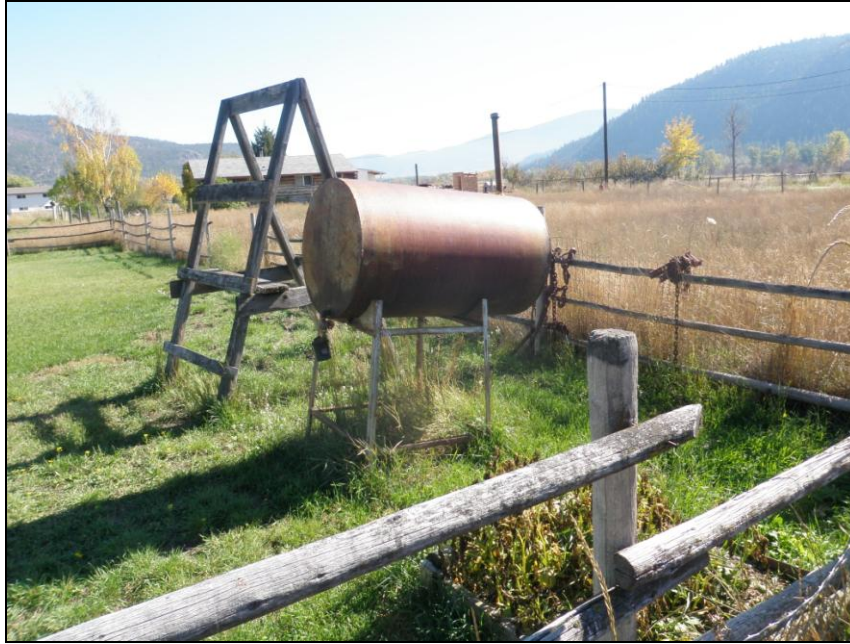
Photo 51. View of the Lot 12 AST facing east. The rusted tank and appears empty and without secondary containment.

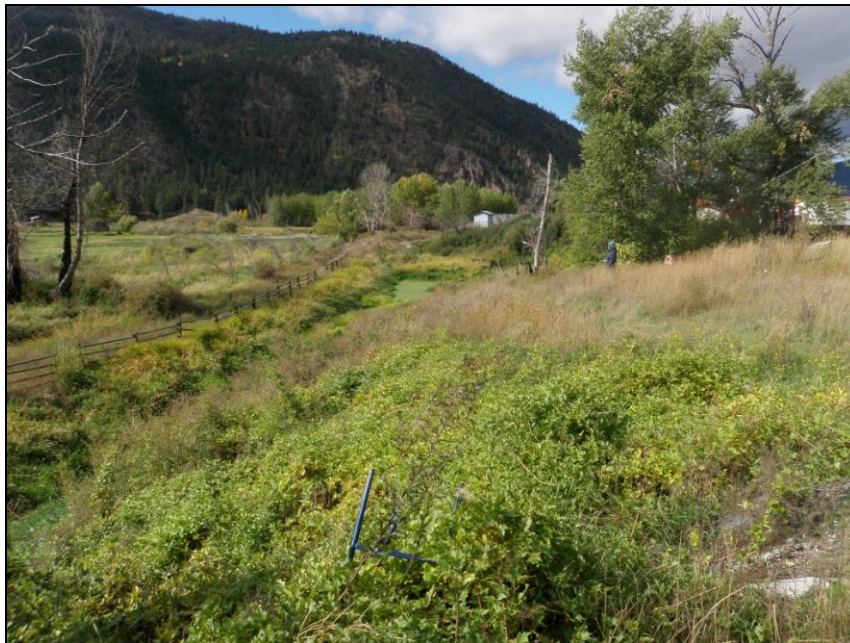
APEC 26 Residential Dump South of Lots 3,4, and 5 652742E 5556145N	Buried residential dump contains metals and domestic waste, and potential unknown substances. Buried debris is on bank above seasonally wetted area and Nicola River, and within a residential development.	<ul style="list-style-type: none"> • Metals • PAH • PHC • VOC
APEC 27 Lot 12 AST 652924E 5556138N	Privately owned empty AST (900L unknown contents) appears in moderate condition. Tank is rusting, and does not appear to be in use. No staining or odors were noted below the tank.	<ul style="list-style-type: none"> • PAH • PHC

Photo 52. View of Residential Dump South of Lot 3, 4 and 5 facing west. Note that the dump is buried along the bank, a seasonally wetted area is below, and connected to the adjacent Nicola River.

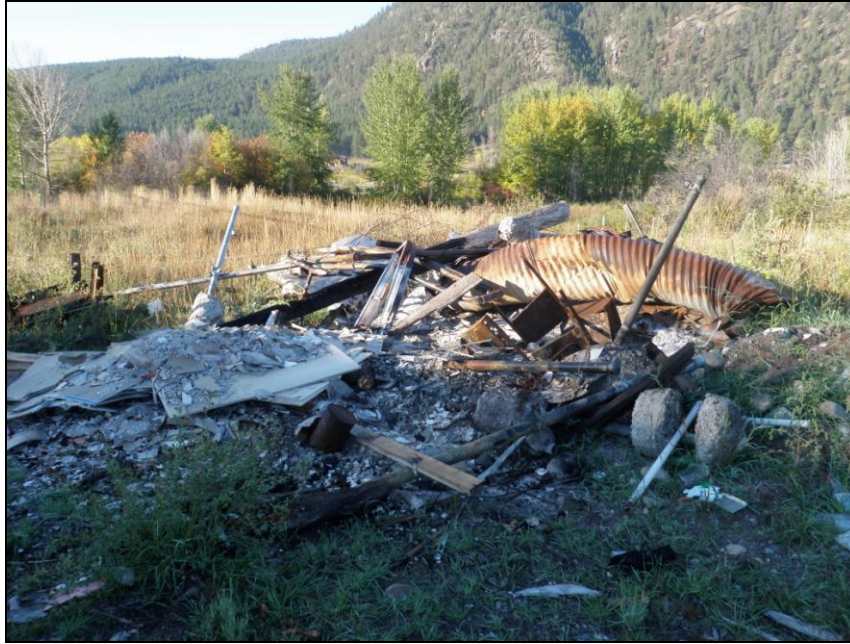
APEC	Description of Contamination or Risk	COPC
APEC 28 Band Firehall Burn Pile 652535E 5556181N	Burn pile includes electronics, light ballasts, dimensional wood waste, vinyl siding, drywall, corrugated metal, car hood, paint cans, metal window frames, and fencing materials. All debris is burnt.	<ul style="list-style-type: none"> • Metals • PAH • PHC • PCB
APEC 29 Lot 197 AST 652604E 5556610N	Privately owned empty AST (900L unknown contents) appears in moderate condition. Tank appears to be in use. The property was not accessible at the time of the site visit, and as such no observations regarding soil conditions beneath the tank were made.	<ul style="list-style-type: none"> • PAH • PHC
APEC 30 LNIB School AST 652675E 5556806N	Empty AST (24000L unknown contents) appears in new condition. Tank appears to be in use. The tank is double walled, on a concrete foundation, within a fenced perimeter. No concerns with current fuel use were identified at the school.	<ul style="list-style-type: none"> • PAH • PHC

Photo 53. View of the LNIB Fire hall Burn Pile facing south. Note the burnt electronics, corrugated pipe, paint cans and light ballasts.

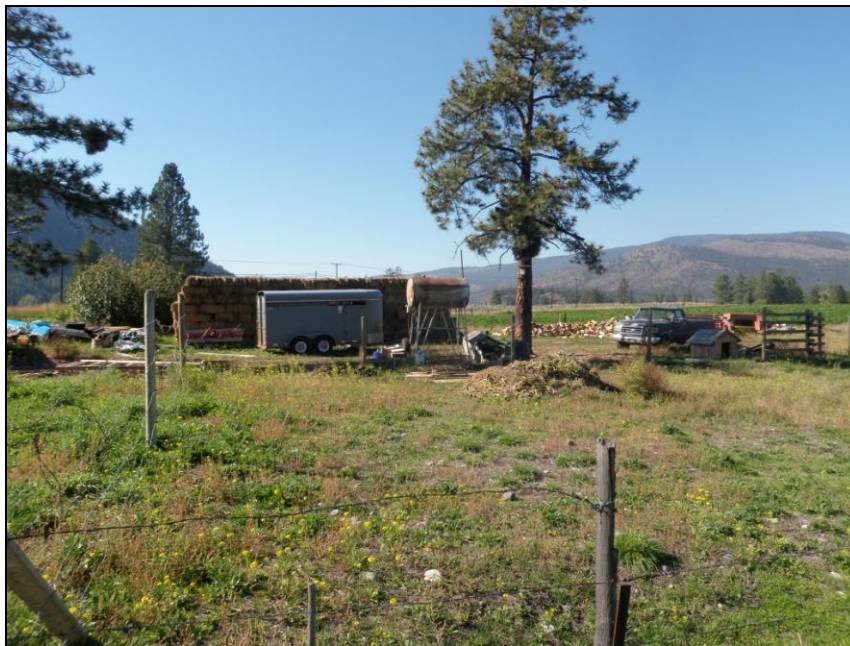
Photo 54. View of the Lot 197 AST located at 2196 Highway 8 facing west.
