**PHASE I
ENVIRONMENTAL SITE ASSESSMENT**

**Nicola Mameet IR # 1,
Lower Nicola Indian Band
Merritt, British Columbia**

Project No: 10-0374
April, 2011

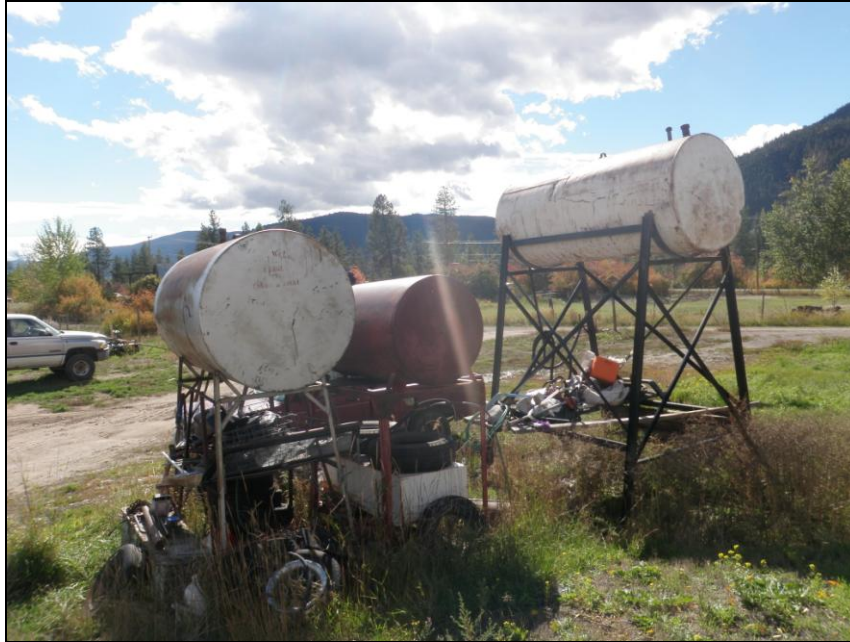
APEC 31 Lot 200 ASTs 651774E 5557470N	Three (3) privately owned ASTs (4500L unknown, 1200L gasoline, and 2300L diesel) are immediately adjacent to each other and appear in use. The tanks are in moderate condition with some rust and weeping occurring at the bungs and nozzles. The area has a hydrocarbon odor with spotty soil staining.	<ul style="list-style-type: none"> • PAH • PHC
APEC 32 Former Shulus School AST (ESSIMS 7000086497)	Fuel storage tank was removed from the school property in the 1980's. In 1999, the former location of the AST could not be confirmed during the FNESS UST/AST removal program, and soil conditions below the former AST remain unknown.	<ul style="list-style-type: none"> • PAH • PHC
APEC 33 Soil Contamination Charlotte Joe Residence (ESSIMS 7000086397)	Fuel storage tank was removed from Charlotte Joes residence during the FNESS UST/AST removal program. Contaminated soil was excavated from the property, however, the soil remains contaminated at 2.5m depth, as further excavation was prevented due to the proximity of the house foundation.	<ul style="list-style-type: none"> • PAH • PHC

Photo 57. View of the Lot 200 ASTs on Fyall Road facing southeast. Note the lack of secondary containment and the moderate tank condition.

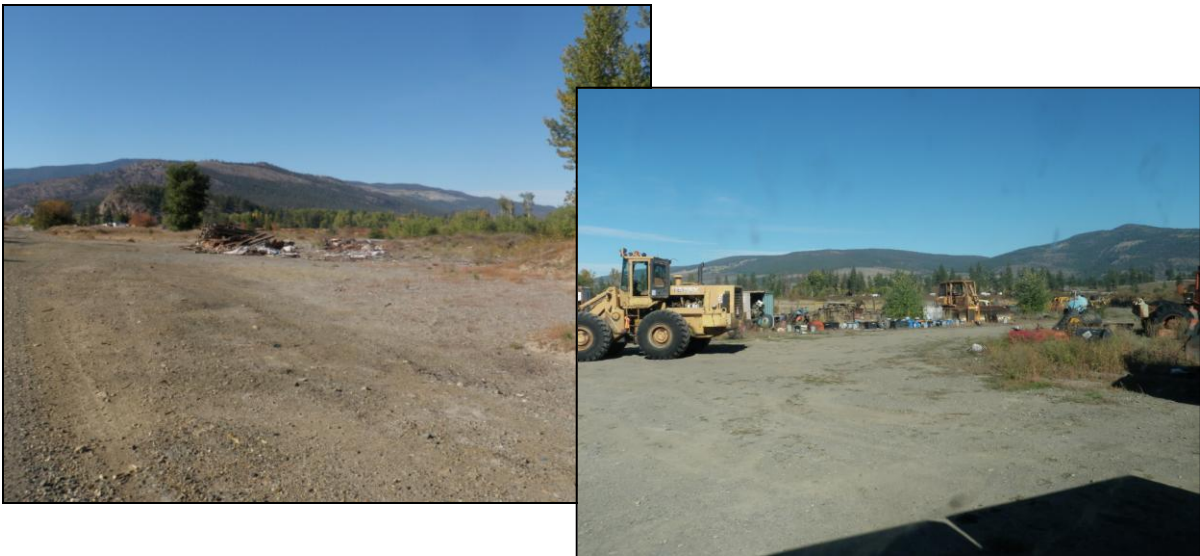
Photo 58. Overview of the former CP Ore Transfer Station (on right facing west) located west of the reserve showing the burn pile, surface debris, and sulphur staining. Overview of the Turtle Tracks Industrial facing northeast, showing heavy equipment storage and fuel and chemical handling and storage.
