**PHASE I  
ENVIRONMENTAL SITE ASSESSMENT**

**Zoht IR # 4,  
Lower Nicola Indian Band  
Merritt, British Columbia**

**Project No: 10-0374**  
April, 2011

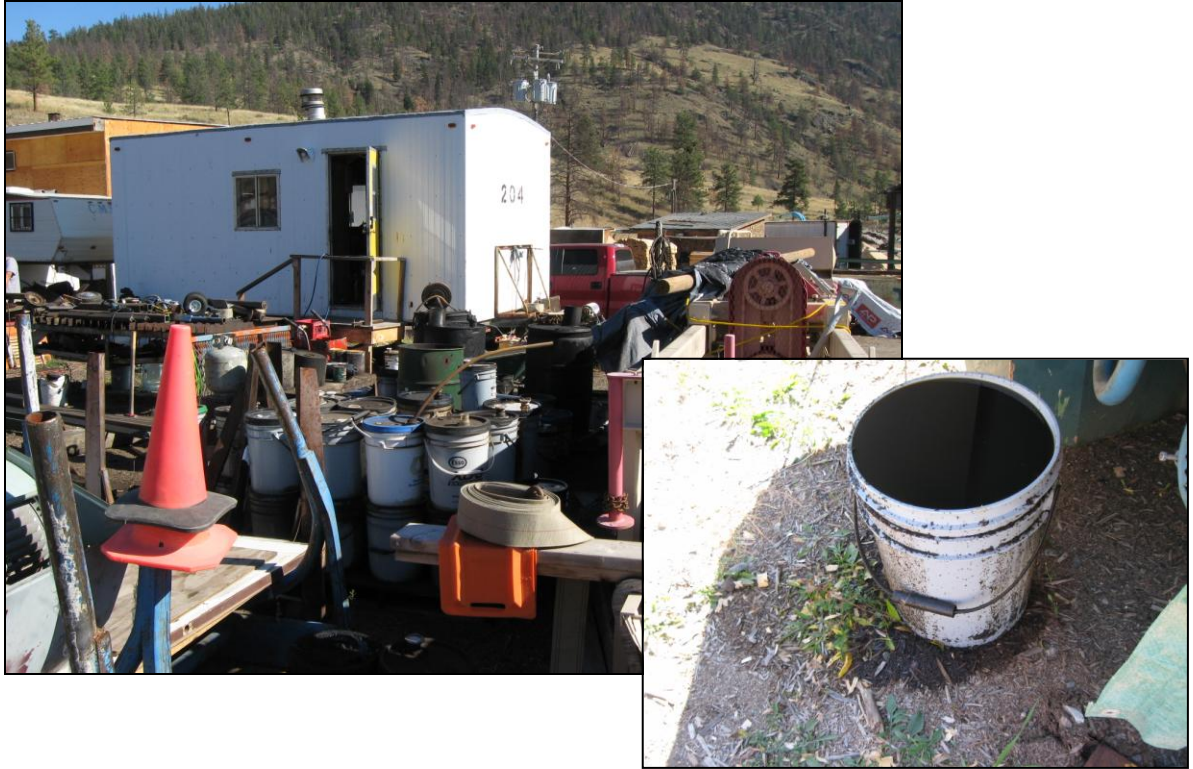
**Photo 3.** View of the hydrocarbon storage on the west side of the of the travel trailers in the northwest portion of the Site (Plan 59794 Post Mill) facing northeast. Note that many containers are open, overflowing, and the entire area contains spotty soil staining.

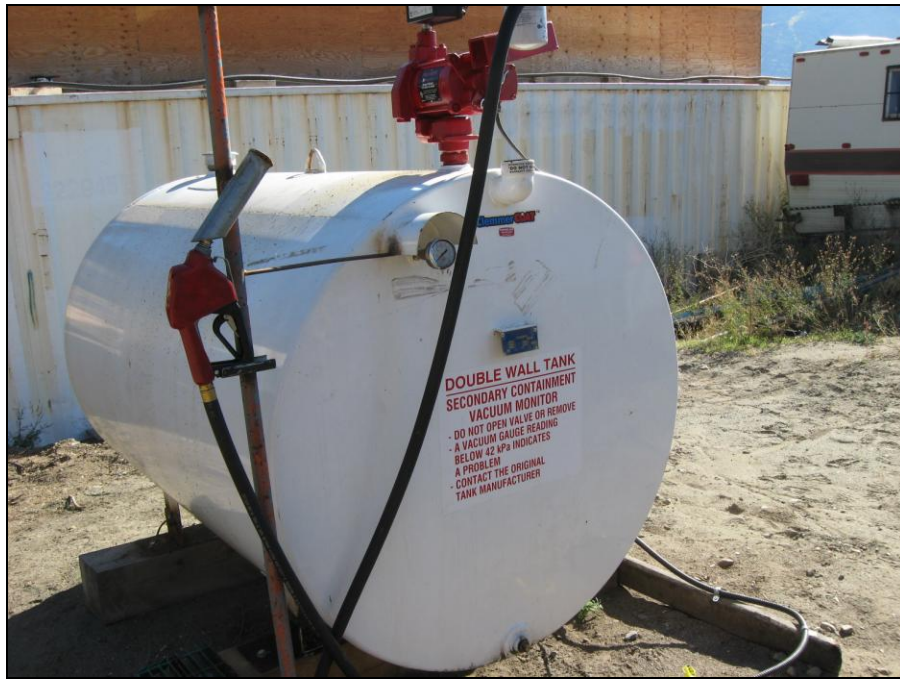
| AST # | Location (Site ID) | Capacity | Contents | Active | Condition |
|---|---|---|---|---|--|
| 1 | Plan 59794 Post Mill AST | 2200L | Unknown | Yes | New tank, double walled in excellent condition with no stains or odor. |

**Photo 4.** View of the new AST at the Plan 59794 Post Mill facing southeast. Note the travel trailer and oil storage area in the top right.

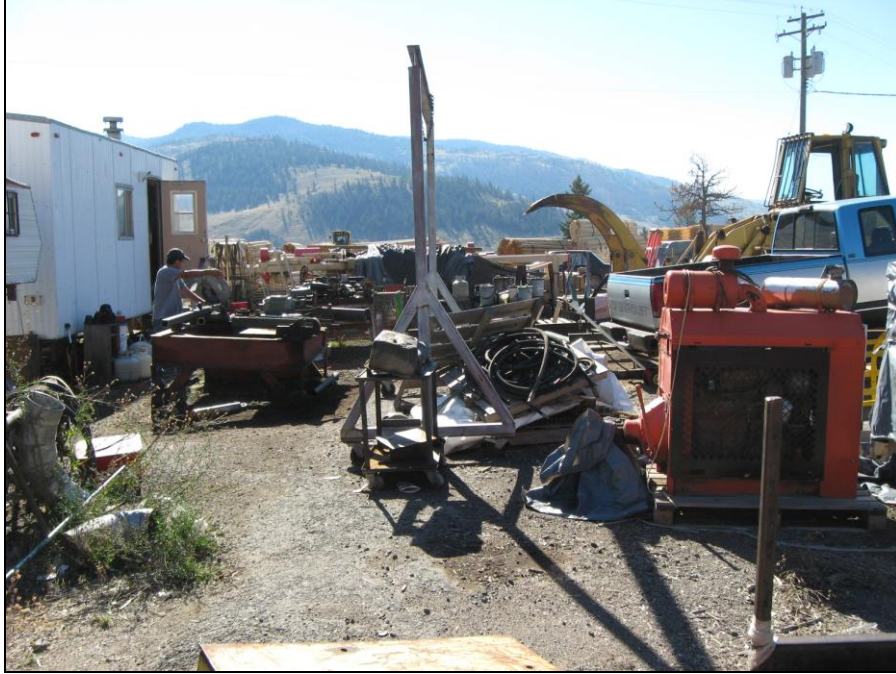
**Photo 5.** View of the metal and mechanical debris stored adjacent to the travel trailers at the Site (Plan 59794 Post Mill) facing south. Note the hydrocarbon storage area to the south.

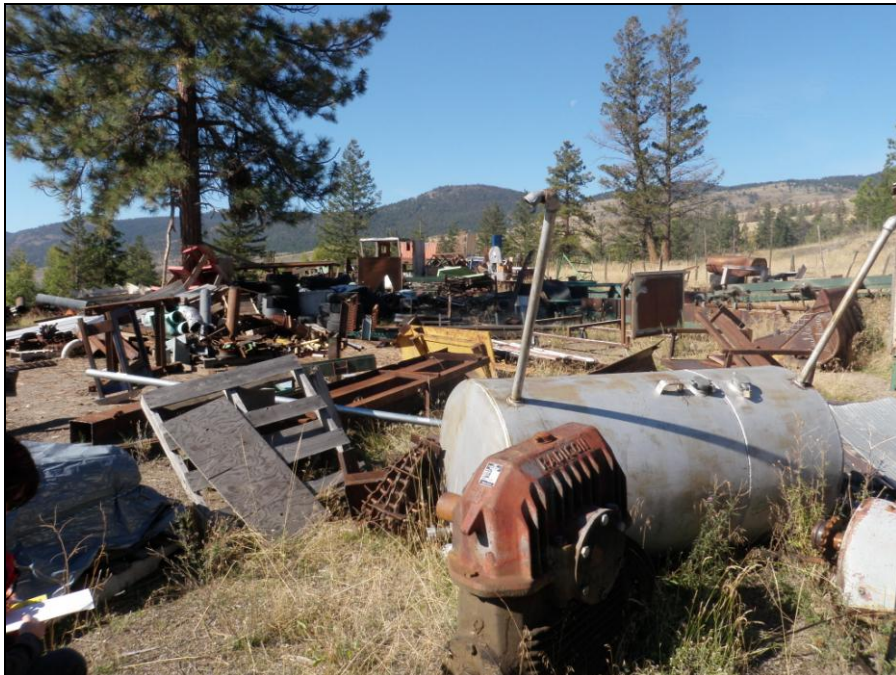
**Photo 6.** View of the scrap metals stored on the western portion of the Plan 59794 Post Mill facing southwest.

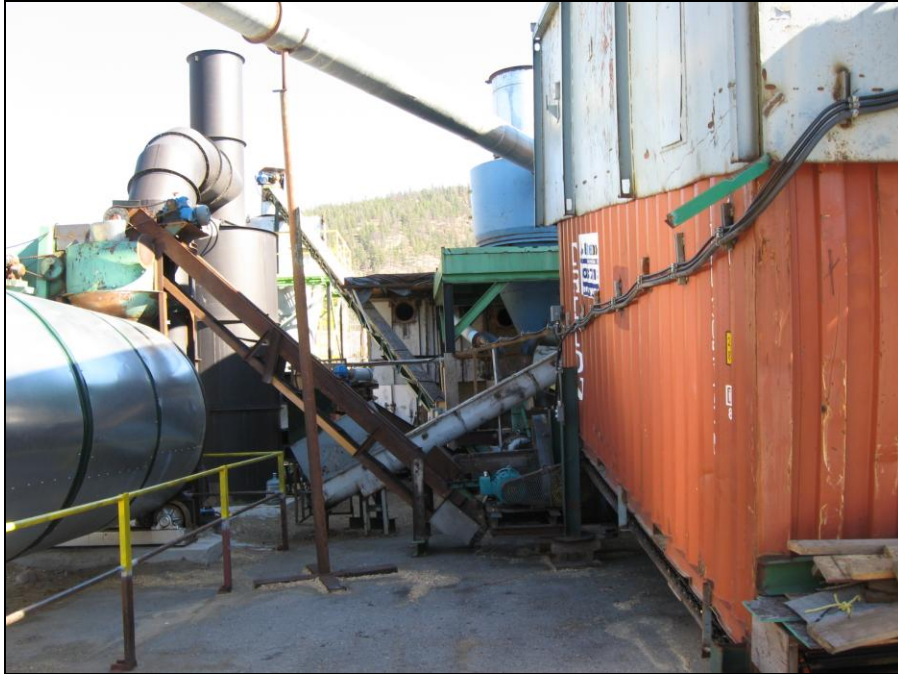
| Area ID | Structure Name | Description/Contents |
|--|--|---|
| | <p>Blower, Dryer and Biomass Burner<br/>(32.5m x 8.5m)</p> | <ul style="list-style-type: none"> <li>• Cylindrical steel biomass burner (pers. comm. Francis Shuter)</li> <li>• 2 Metal blowers/dryers</li> <li>• Converted steel storage containers hold sawdust</li> </ul> |

**Photo 7.** View of the biomass burner, dryer, and blower on the west side of the mill building at the Plan 59794 Post Mill facing northeast.

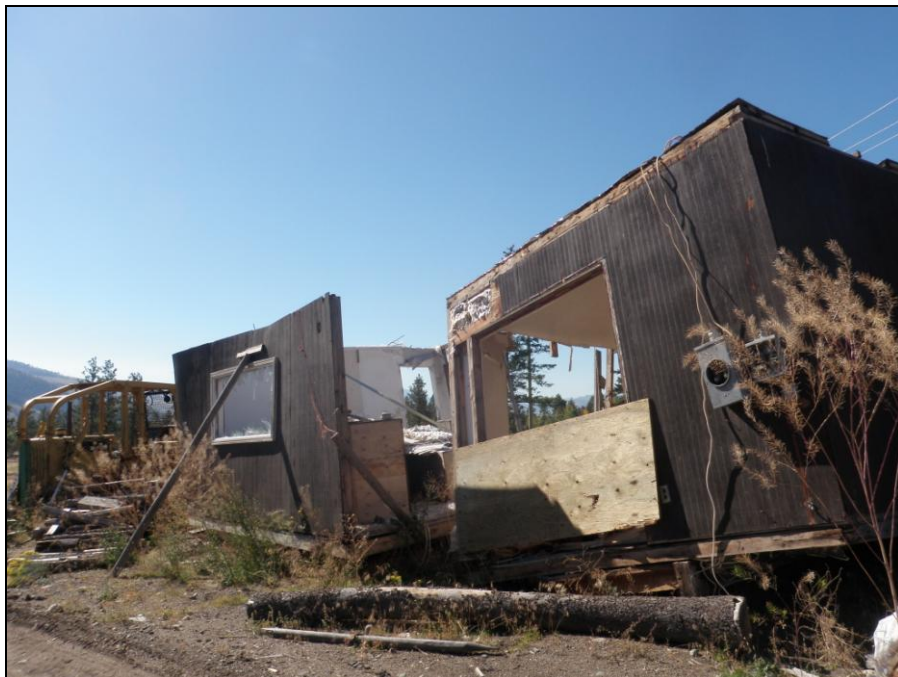
**Photo 8.** View of the collapsed office building and abandoned conveyor belts on the southwest portion of the Plan 59794 Post Mill facing south.

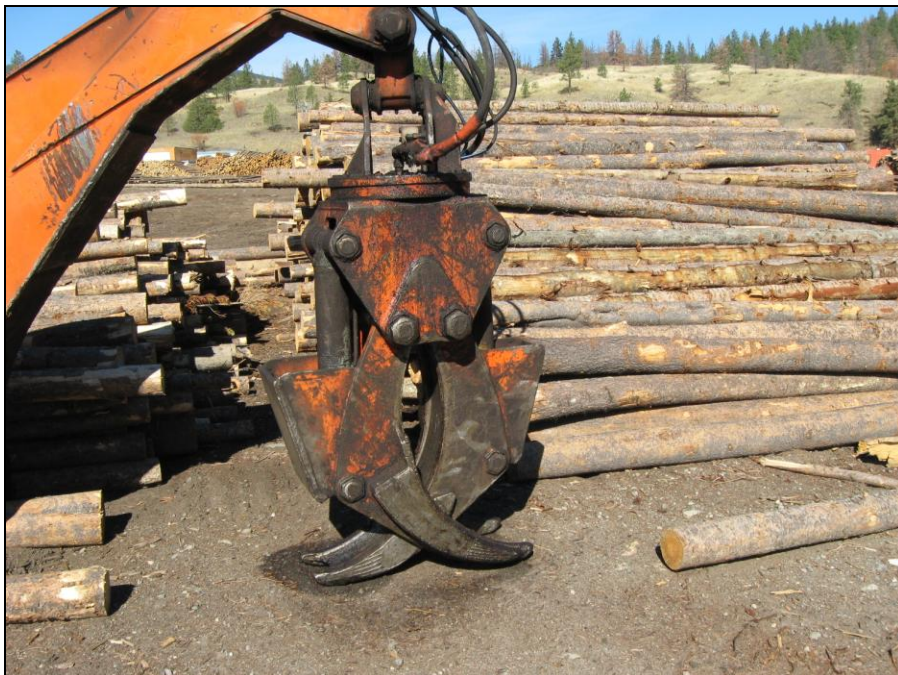
**Photo 10.** View of a buncher located on the southern portion of the Plan 59794 Post Mill facing northwest. Note the leaking hydraulic oil and soil staining.

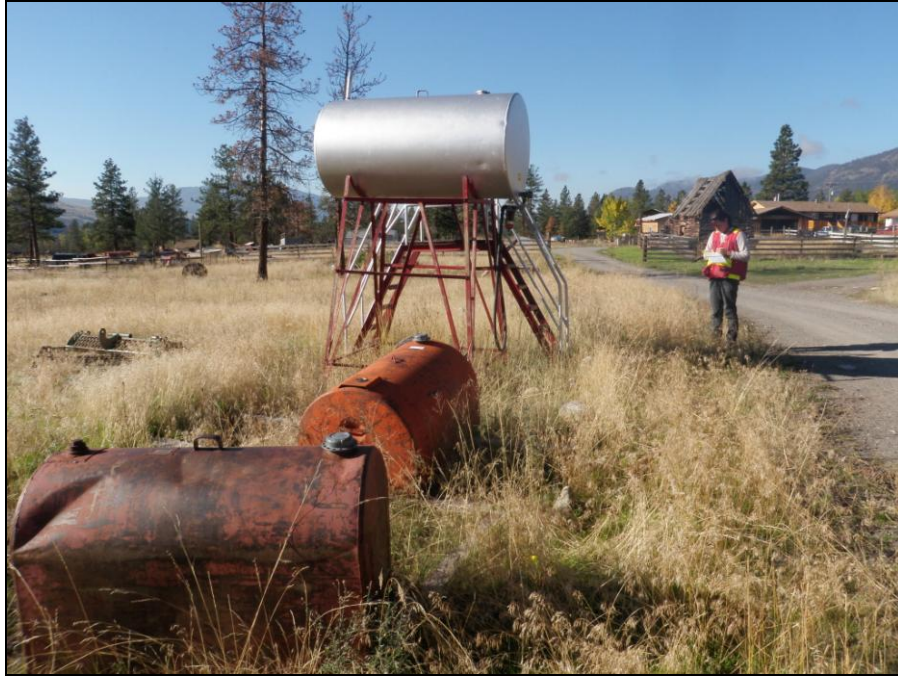
| AST # | Location (Site ID) | Capacity | Contents | Active | Condition |
|---|---|---|---|---|--|
| 2 | Plan 59794 AST<br>666559E<br>5560442N | 1300L | Diesel | Not since 2003 | Single walled. Some weeping at the hose joints, small stain below hose with a faint odor, vent and fill pipes in good condition, no secondary containment |

| APEC | Description of Contamination or Risk | COPC |
|--|---|---|
| <b>APEC 2</b><br>Plan 59794 AST | Single walled 13300L diesel AST is no longer in use, but is in original location. Some weeping at the hose joints, small stain below hose with a faint odor. No secondary containment. Two adjacent 300L tidy tanks are empty with no stains or odors. | <ul style="list-style-type: none"> <li>• PAH</li> <li>• PHC</li> <li>• VOC</li> </ul> |

**Photo 11.** View of the Plan 59794 AST located at the residence southwest of the Post Mill, facing south. Note the two empty tidy tanks adjacent to the AST.

A Phase 2 ESA is recommended to determine the presence or absence of contaminated media at the APECs identified by this assessment.

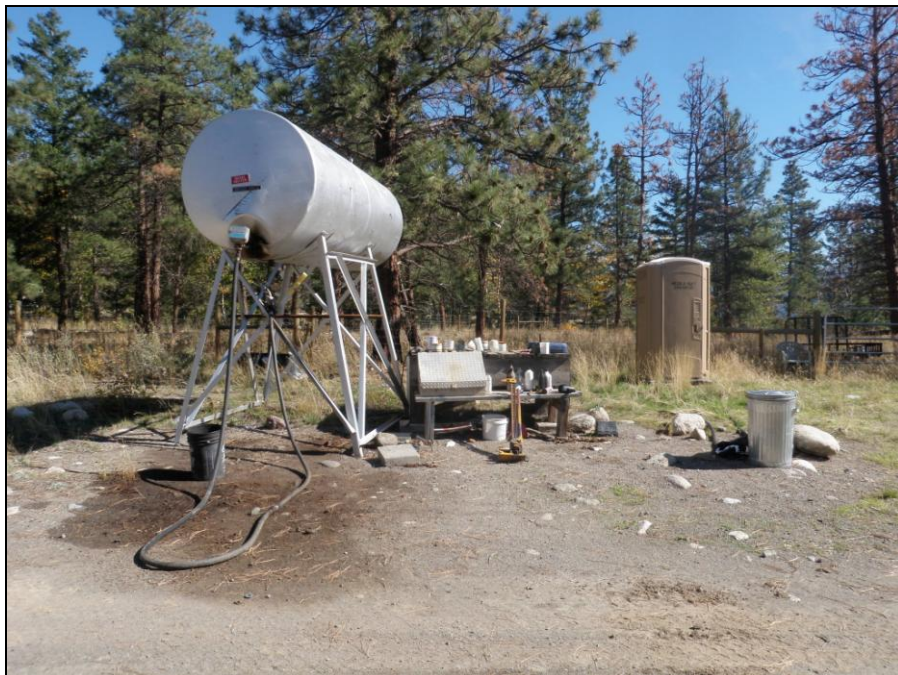
| AST # | Location (Site ID) | Capacity | Contents | Active | Condition |
|---|---|---|---|---|--|
| 3 | Lot 2 AST<br>666297E<br>5560265N | 4800L | Diesel | Yes | Tank is dented at hose inlet, hose is in good condition, weeping at joints, vent and fill pipe in good condition, tank partially full, fuel meter leaking, bucket placed below to catch product. |

Minor spills and stains associated with the diesel ASTs, drums, 20L oil pails, hydrocarbon storage, and machine maintenance are assumed. Spotty soil staining was observed within soils below the Zoht IR4 Lot 2 AST and was 0.8m in diameter, and appeared surficial. No stains or odors were observed at the Zoht IR4 Plan 59794 AST or tidy tanks. A 12m by 18m hydrocarbon storage area was noted in the maintenance area of the post mill. Spotty soil staining was observed throughout the storage area, and appeared to be surficial. No other spill or stain areas were noted at the Site, or in either of the off reserve dump sites.

| APEC | Description of Contamination or Risk | COPC |
|--|---|---|
| <b>APEC 3</b><br>Lot 2 AST | One 4800L diesel AST is partially full. Tank is dented at hose inlet, weeping at joints, fuel meter is leaking, and a bucket is placed below to catch product. 0.8m diameter soil staining was observed below, and appears surficial. | <ul style="list-style-type: none"> <li>• PAH</li> <li>• PHC</li> <li>• VOC</li> </ul> |

**Photo 12.** View of the Lot 2 AST (3221 Mill Creek Road) facing east. Note the soil staining below the tank, weeping valve, and adjacent hydrocarbon storage.

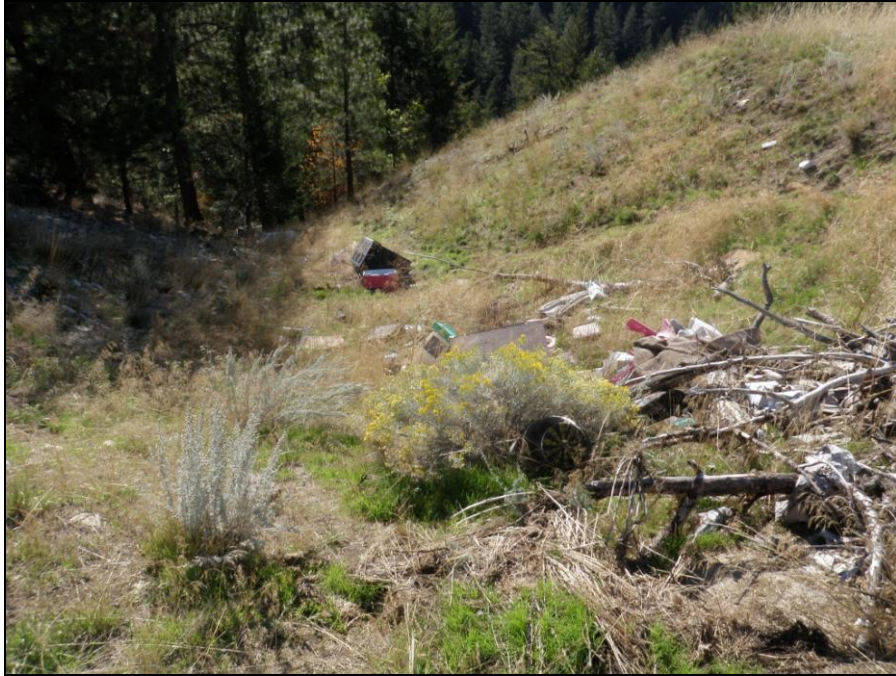
**Photo 13.** View of the occasional scattered domestic waste on the western portion of the Zoht IR4 Lot 11 Dump facing southeast.

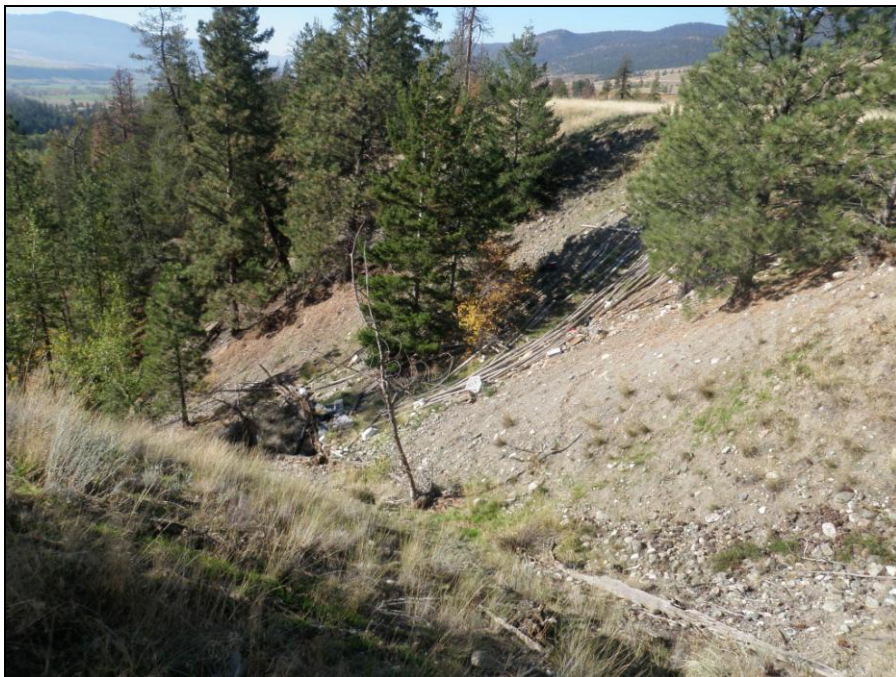
**Photo 14.** View of the scattered fence posts and domestic waste on the southern portion fo the Zoht IR4 Lot 11 Dump facing southwest.

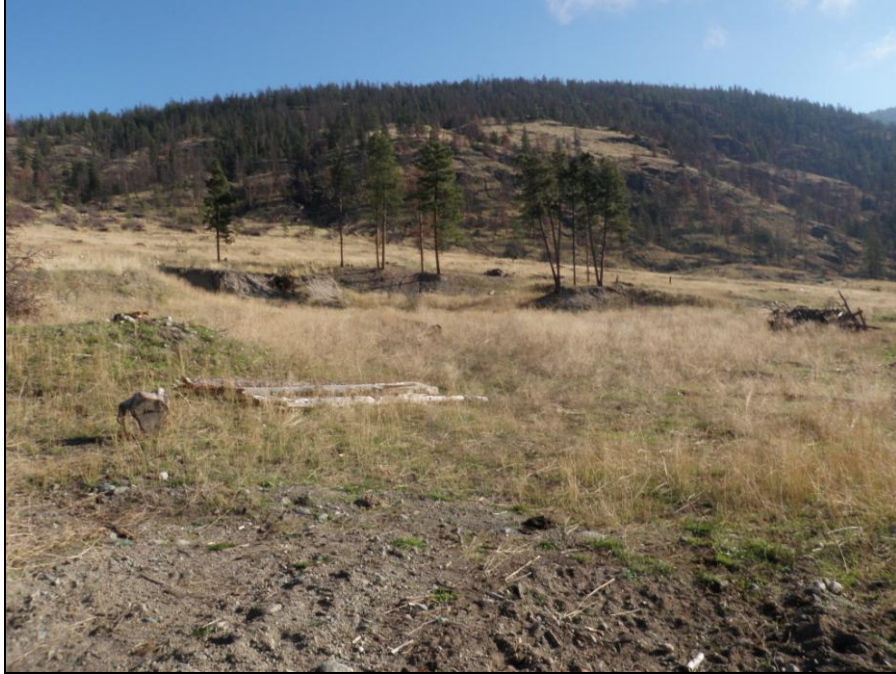
**Photo 15.** View of the Zoht IR4 Off Reserve Dump 1 facing northeast. Note the disturbed footprint of the reported buried dumpsite.

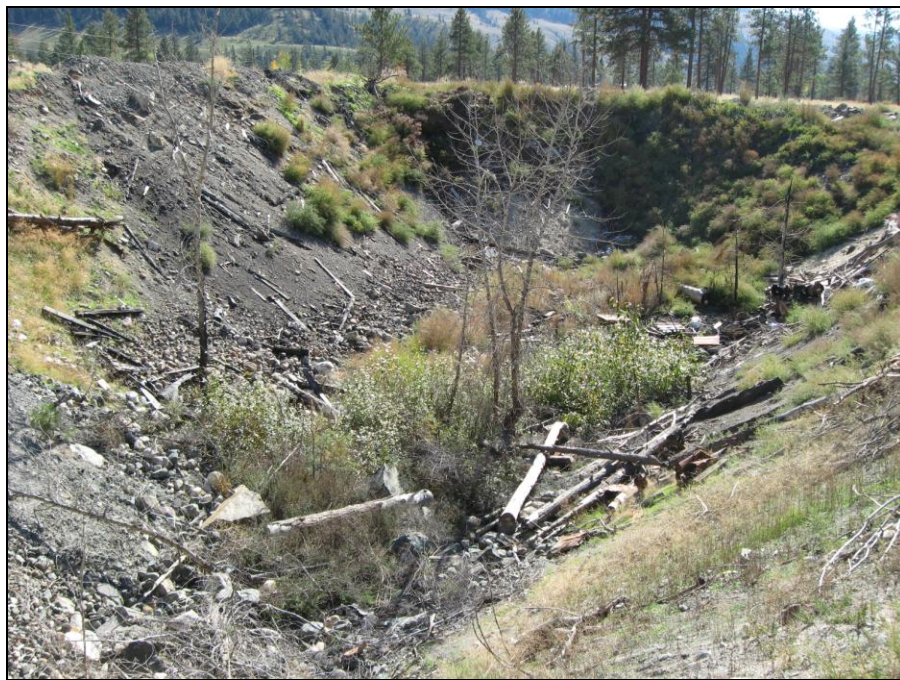
**Photo 18.** View of the Zoht IR4 Off Reserve Dump 2 Pit #2 facing south. Note the limited surface debris within the pit.

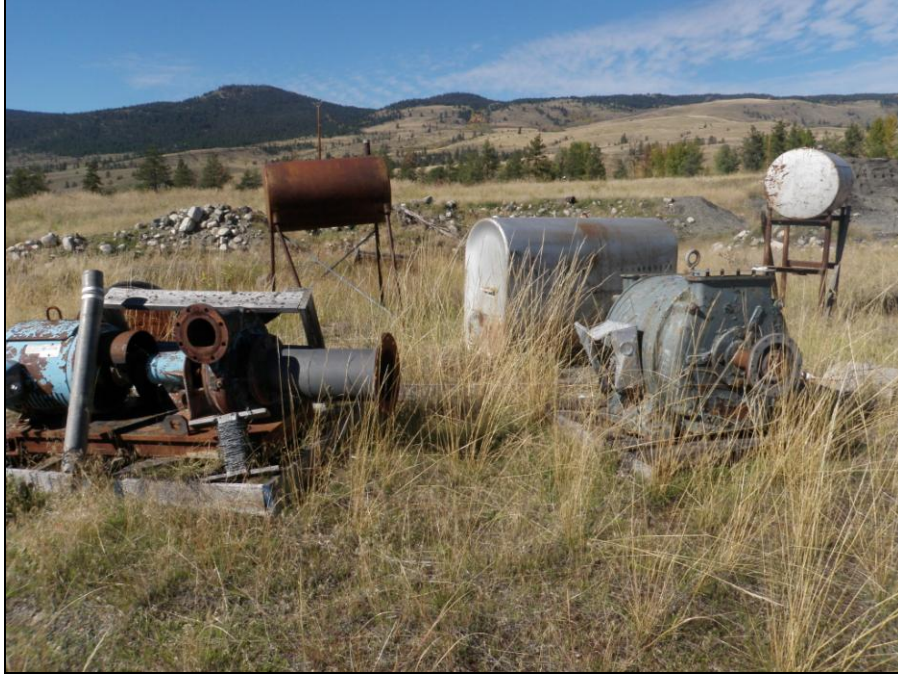
**Photo 19.** View of the abandoned ASTs and compressors on the southwestern portion of the Zoht IR4 Off Reserve Dump 2 facing west.

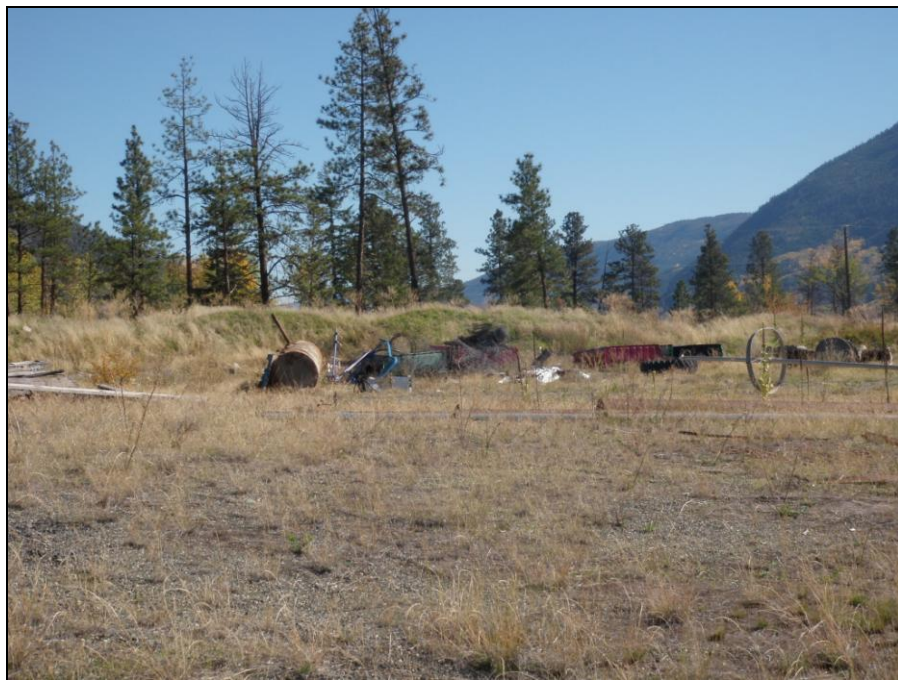
**Photo 20.** View of the abandoned truck boxes, AST, and UST in the central portion of the Zoht IR4 Off Reserve Dump 2 facing east.
