**LOWER NICOLA
INDIAN BAND**

SOLID WASTE MANAGEMENT: ILLEGAL DUMPING MITIGATION STRATEGY

Prepared by:
Land Forest People Consulting Ltd.
1076 Verdier Avenue
Brentwood Bay, BC V8M 1E6

UPDATED August 24th, 2020

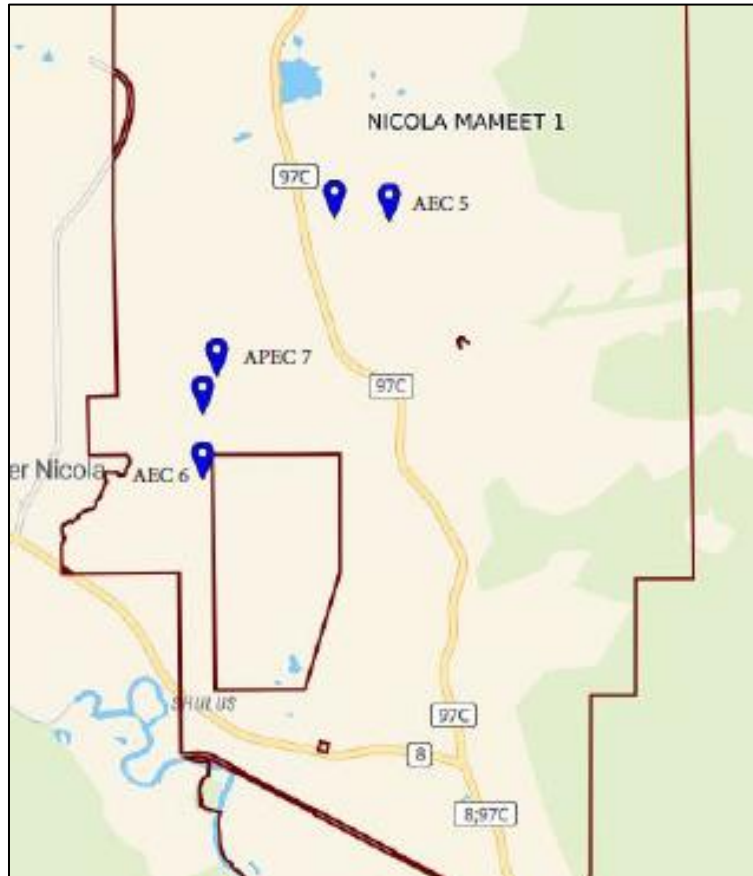
Figure 2 – Three dump sites visited on March 3: APEC 5, APEC 6, and APEC 7

On March 3, 2020 we visited the three sites listed below and referred to in Figure 2:

- APEC 5 Mamit Lake Road Four Mile Dump;
- APEC 6 Buried Dump 1 Mamit Lake Branch Road South; and
- APEC 7 Buried Dump 2 Mamit Lake Branch Road South

Note that both APEC 5 and APEC 7 comprise the two blue markers nearest the given site.

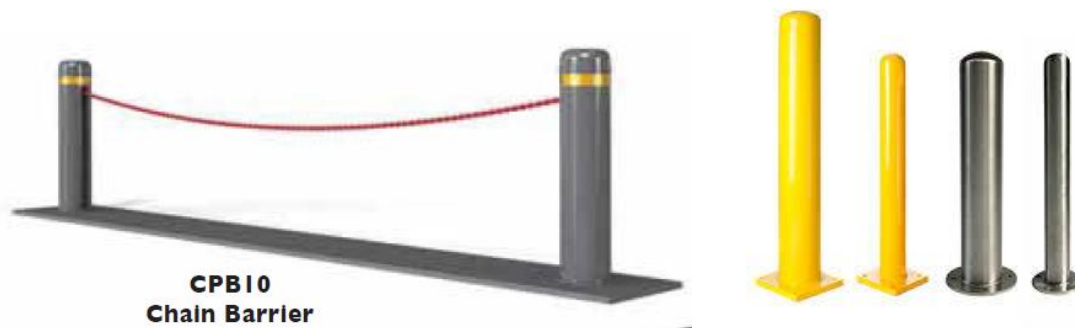
Figure 4 – Examples of Bollards

Other types of barriers may be used with greater effectiveness or lower cost than a swinging arm gate, depending on the site. Bollards are good choice for sites where it is desirable to maintain access by foot while blocking vehicle access. Bollards may be padlocked to be removable or hinged to allow vehicle access when necessary. Some examples of bollards are shown in Figure 4.

For both swinging arm gates and bollards, installation will require excavation and concrete footings and should be factored into the overall cost. As mentioned, LNIB have experienced issues in the past with tampering, and even unauthorized removal, of gates. It is recommended that LNIB consider more robust installation methods than have been used previously, such as deeper concrete footings. Despite such efforts however, tampering may never be fully prevented.

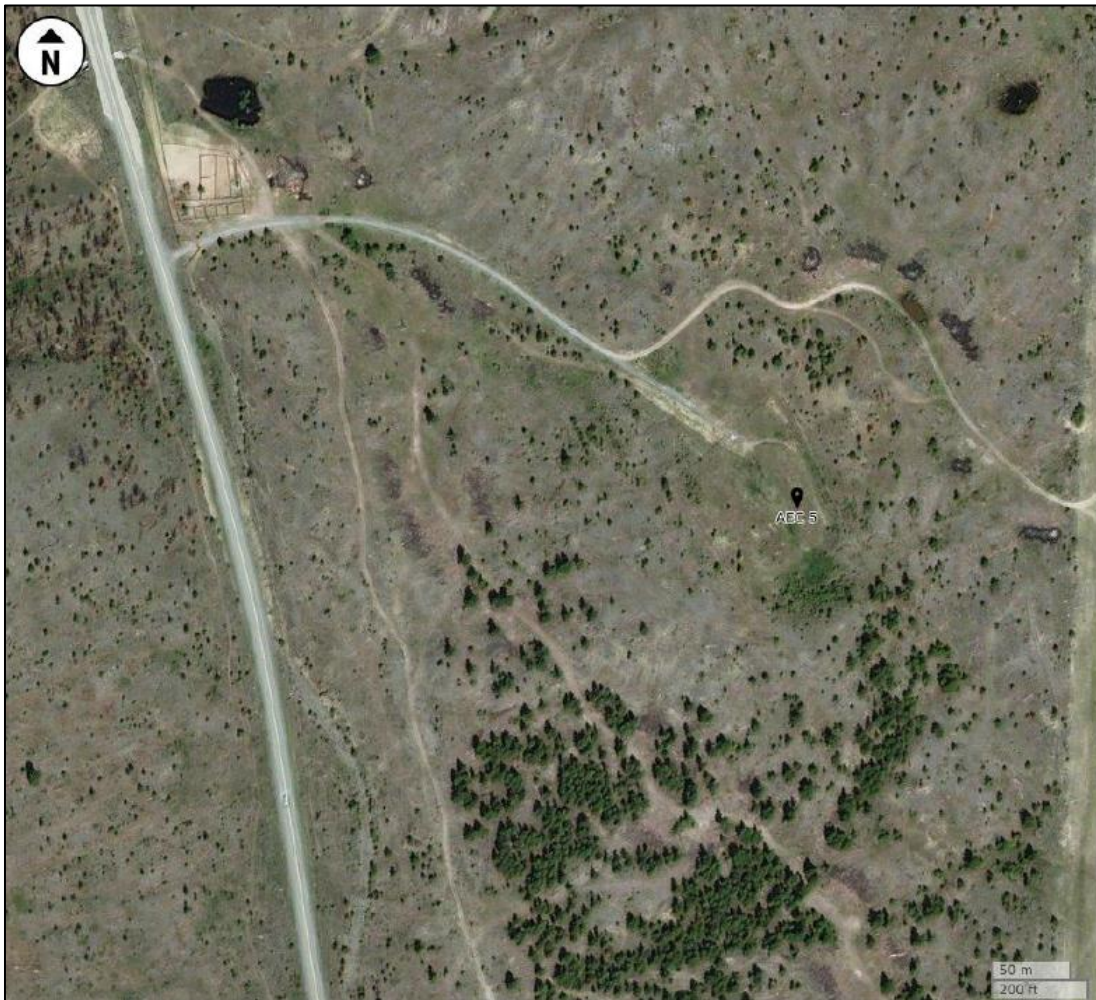
Figure 6 – Overhead view of APEC 5 Mamit Lake Road Four Mile Dump

Located on Nicola Mameet IR 1, APEC 5 is a short five-minute drive off the main road. A former dump that has since been decommissioned, this site was described in a 2011 Phase I Environmental Site Assessment by Columbia Environmental as follows:

A buried dump (80m x 15m) was observed within a fenced and gated compound east of Mamit Lake Road. The gate has been removed and some recent dumping has occurred at the gate. Contents and environmental impact of the buried materials is unknown. Two monitoring wells are installed adjacent to the buried debris. Dump has been decommissioned and covered.

- *Three (3) monitoring wells surround the buried dump*
- *Covered mound measures 80m x 15m x 1.2m*
- *Fence surrounds property, but gate has been removed & small pile of domestic waste is observed at entrance (3m diameter)*
- *Former dump site has been covered with soil.*
- *Dumped materials reportedly buried at the site include domestic waste, vehicle parts, building materials, appliances, metals, and various other wastes.*
- *Dumping was unsupervised and there is the potential for various types of waste within the buried dump.*
- *A recent pile of debris is located at the north gated entrance and includes mostly domestic waste.*

Because the wooden gate has recently been upgraded, we recommend that LNIB consider using the existing gate in conjunction with a new, sturdy lock and a trail camera. If this doesn't prove to be an effective strategy, we recommend that LNIB incur the cost of installing a swinging-arm gate.

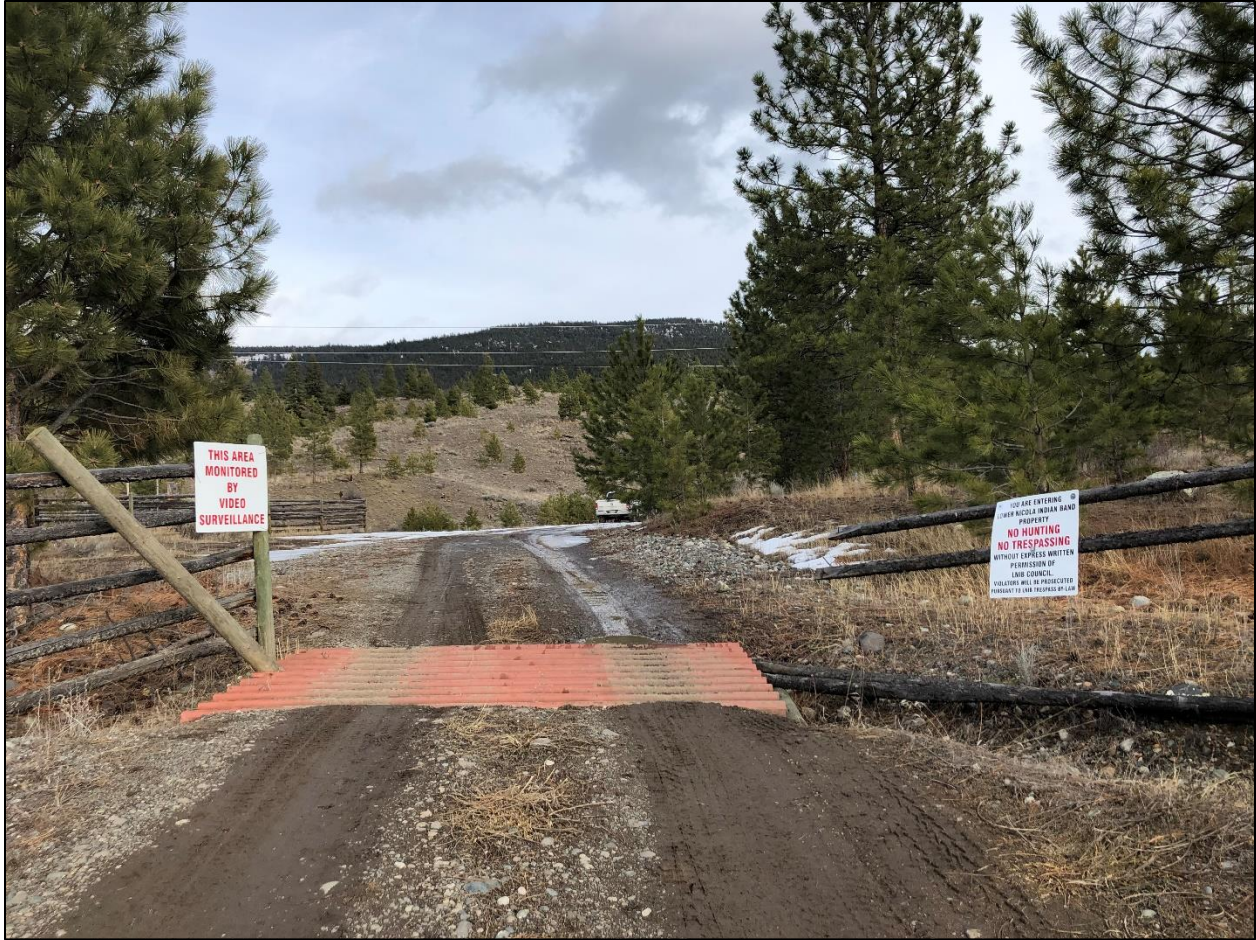
Figure 7 –Potential gate location leading to APEC 5 Mamit Lake Road Four Mile Dump

Ground level view of potential gate location leading to APEC 5 Mamit Lake Road Four Mile Dump, taken March 3, 2020

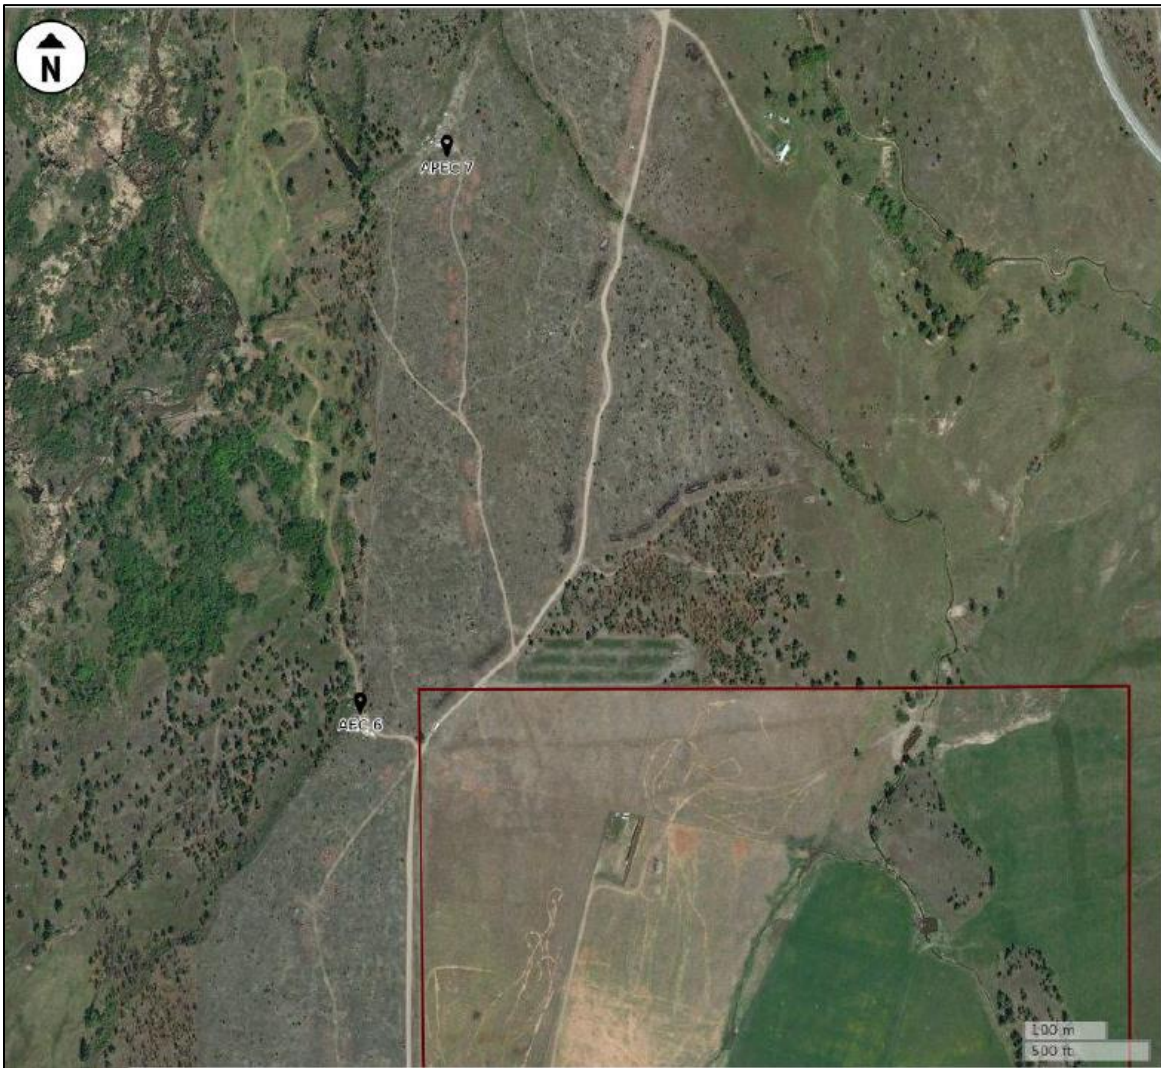
Figure 8 – Overhead view of APEC 6 and APEC 7 Buried Dumps

APEC 6 is a buried dump on Mamit Lake Branch Road South and APEC 7 is a buried dump on Mamit Lake Branch Road North.

APEC 6 and APEC 7 are located just off of Mamit Lake Branch Road on Nicola Mameet IR 1. Both are former dumps that are now buried. Several small, undesignated dump sites are located in proximity to APEC 6 and APEC 7, an example of which is shown in figure 9.

We recommend that LNIB direct a significant portion of their resources toward APEC 6 and APEC 7. These two sites, as well as the general area around them, are the most active illegal dump sites on LNIB land owing to their close proximity to the community and extensive tree cover.

We recommend the use of gates and cameras in this area. It is not possible to completely block access to both sites, nor to all of the smaller undesignated sites in the vicinity, with a single gate or even series of gates. The aim would be to use both gates and cameras strategically in order to reduce activity in this area as much as possible.

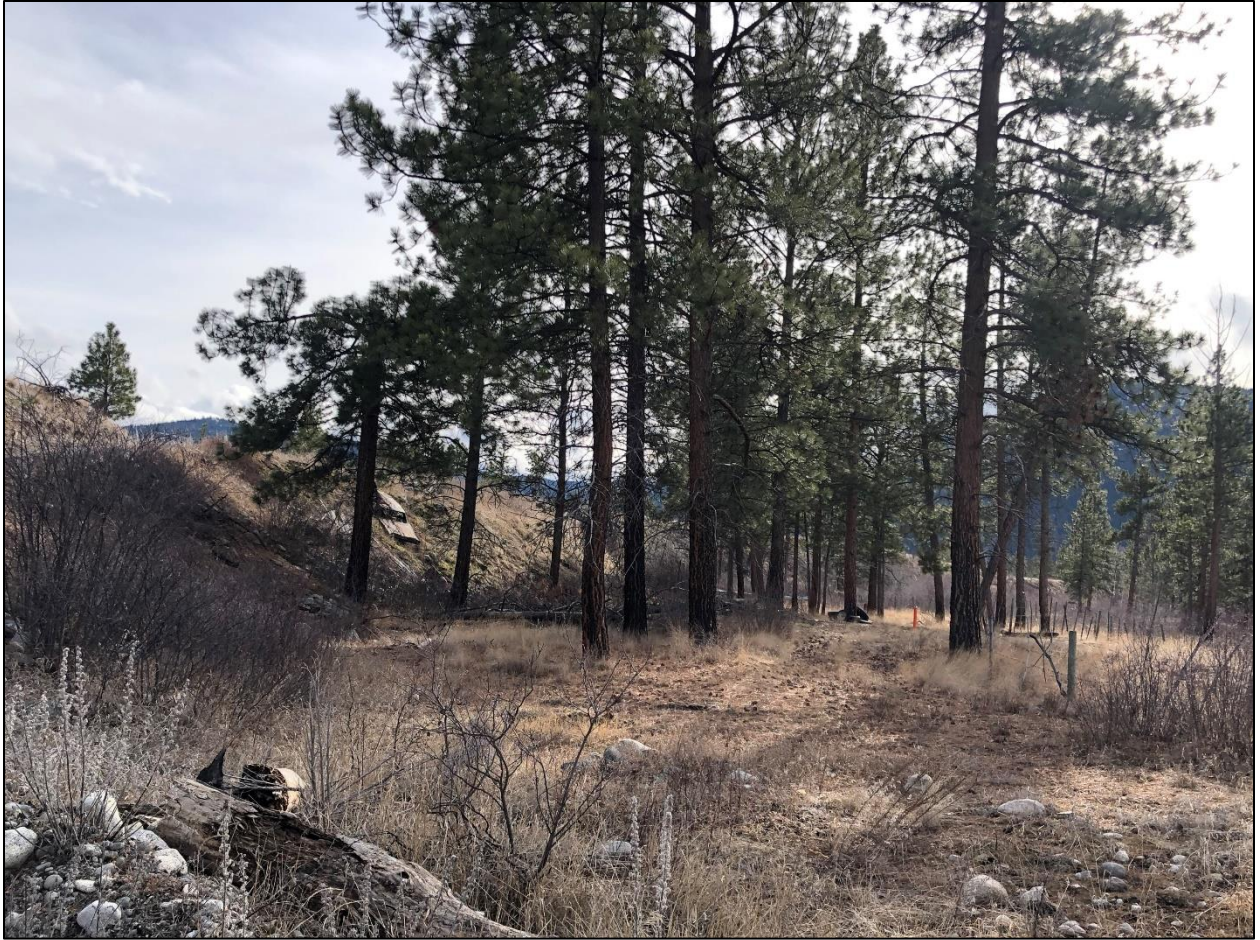
Figure 10 – Ground level view of APEC 6 Buried Dump 1 Mamit Lake Branch Road South

APEC 6 is on a small spur road that terminates at a creek where irrigation intake infrastructure is located. The area is subject to seasonal flooding. APEC 6 is described in a 2019 Phase II Environmental Site Assessment report by Gandalf Consulting as follows:

Surface debris includes electronics, appliances, building materials, furniture, paint cans, scrap metals, rubber tires, and domestic waste.

Recommended gate locations for APEC 6 are shown below in figure 12, near the entrance to the access road. Restricting access here rather than closer to the site will help to mitigate dumping at undesignated sites along the route, as well as making use of the fencing here. There are two entrances, so both must be blocked. This may be accomplished with one gate at each entrance, or by completing the fencing of the entrance seen on the right, and installing a gate at the entrance on the left. More research should be done to determine which of the two options (two gates, or one gate plus fencing), is a better or more cost-effective option. Either of these options to restrict access to APEC 6 would provide an additional benefit of restricting access to the irrigation intake infrastructure and flooding area, which are concerns for LNIB. As far as we are aware, there is no need to give access to the APEC 6 site, and in fact access here should be broadly restricted for safety reasons.

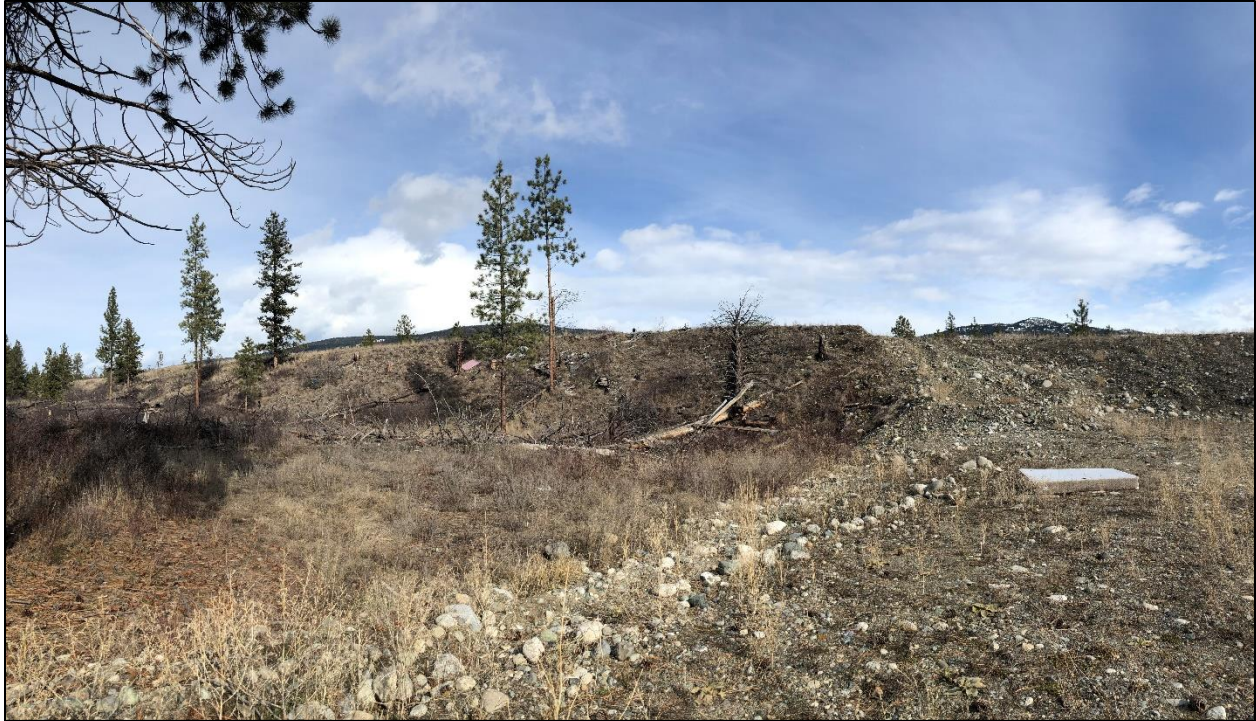
Figure 11 – Ground level view of APEC 7 Buried Dump 2 Mamit Lake Branch Road North

APEC 7 is described in the same report as follows:

Surface debris includes electronics, appliances, building materials, furniture, paint cans, scrap metals, rubber tires, and domestic waste.

It is slightly more difficult to restrict access entirely to APEC 7. The entire area is flat and drivable, making a gate easily circumvented. We recommend using two gates, located at some distance from the actual site itself, as a means of controlling access to APEC 7. The first gate would be located north of the entrance to APEC 7 on Mamit Lake Branch Road at close to the driveway of the one residential trailer here. A second gate would be located at the intersection of Mamit Lake Branch Road and Highway 97C. Access for the trailer resident is maintained from the south, or from the north by obtaining the access code for the lock. In winter the road to the north is not plowed, and often not accessible. An additional benefit of restricting access at the trailer site is that access to the irrigation ditch will also be restricted, which is of interest to LNIB.

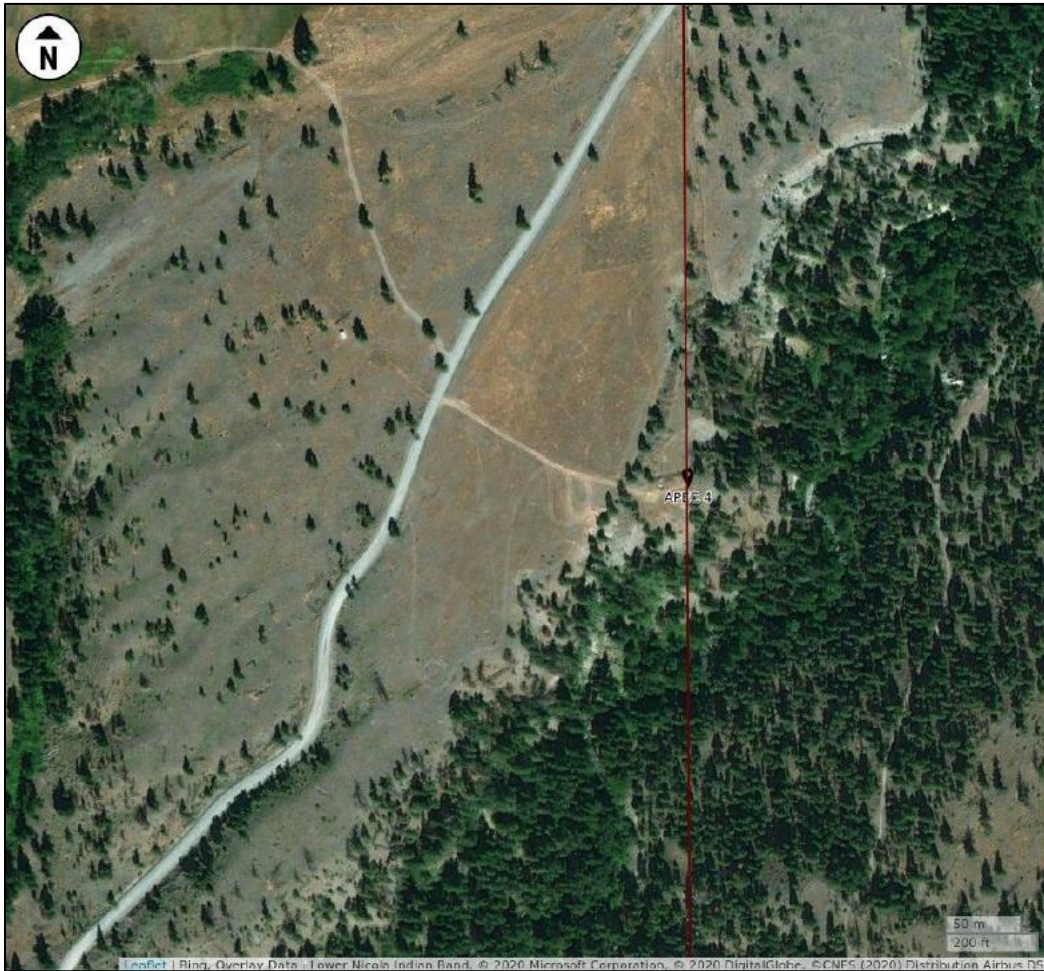
Figure 13 – Overhead view of APEC 4 Zoht Lot 11 Dump Site

APEC 4 Zoht Lot 11 Dump Site is described in the 2019 Gandalf report as follows:

Dump contains two areas of debris scattered down a steep ravine and embankment. Debris includes domestic waste, one appliance, occasional 20L pails, furniture, and dimensional wood waste. Recent debris was noted in the 2014 site reconnaissance.

Mill Creek Road, the main road by which APEC 4 is accessed, is heavily travelled by members and the wider community and the secondary road is generally unfenced, making a gate impractical here. APEC 4 is suited to the use of a camera.

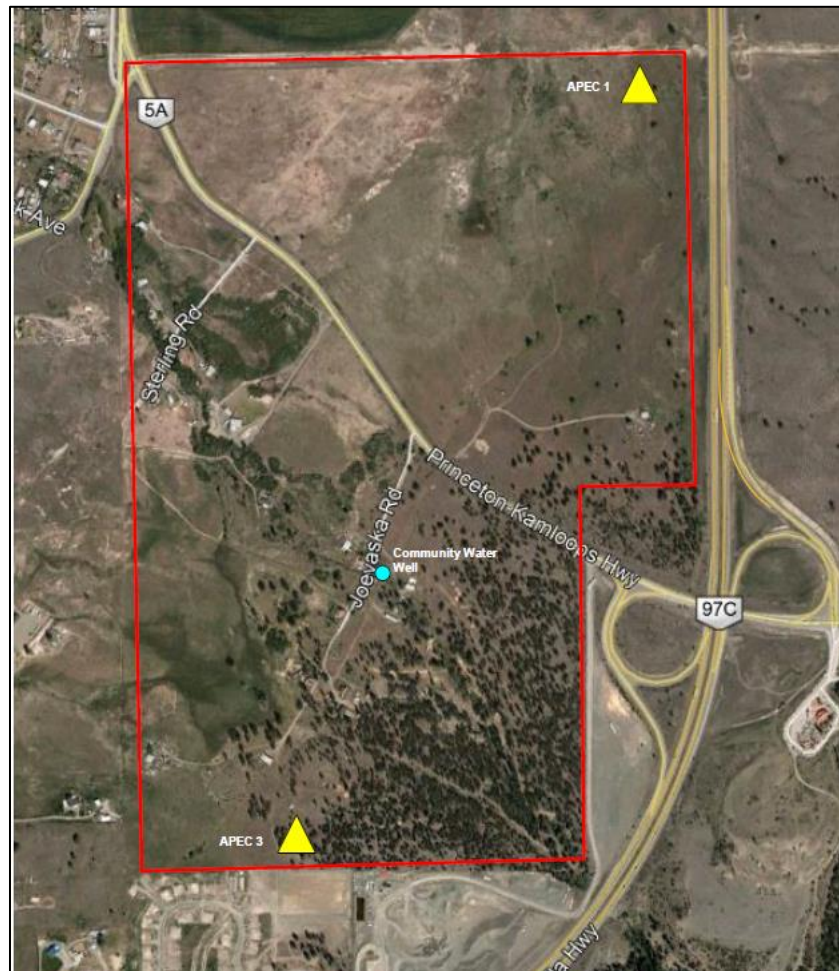
Figure 14 – Overhead view of APEC 1 Lot 9 Residential Dump and APEC 3 Lot 6 Residential Dump

APEC 1 and APEC 3 are located on Joeyaska IR 2 near the junction of Highway 97C and Highway 5A. The *2015 Phase I Environmental Site Assessment Update* report by Columbia Environmental describes the sites as follows:

LNIB will be undertaking a project in 2020-2021 to implement the recommendations found in this report. Further development of a strategy to combat illegal dumping on IR 2 will be done as part of that project.

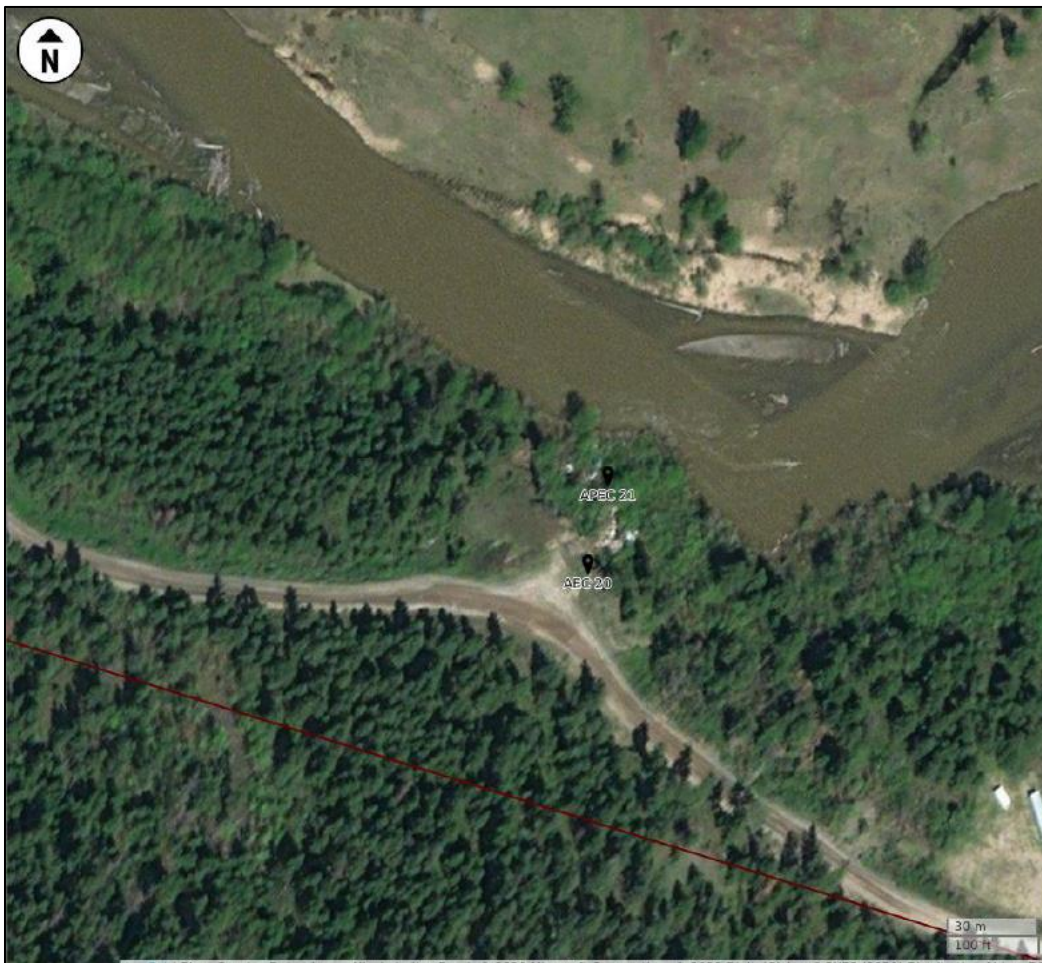
Figure 15 – Overhead view of APEC 21 Nicola River Dump

This site is located on the south side of the Nicola River, close to the boundary of Nicola Mameet IR 1. Access to this site is across IR 1.

Site is down a bedrock slope between Lindley Creek Road and the Nicola River. The area is densely vegetated riparian area at the toe of slope and is within the floodplain of the Nicola River. Debris includes numerous abandoned vehicles, appliances, domestic waste, scrap metals, furniture, building materials, and rubber tires. Debris and abandoned vehicles were observed within the wetted portion of the river.
