**PHASE I
ENVIRONMENTAL SITE ASSESSMENT**

**Nicola Mameet IR # 1,
Lower Nicola Indian Band
Merritt, British Columbia**

Project No: 10-0374
April, 2011

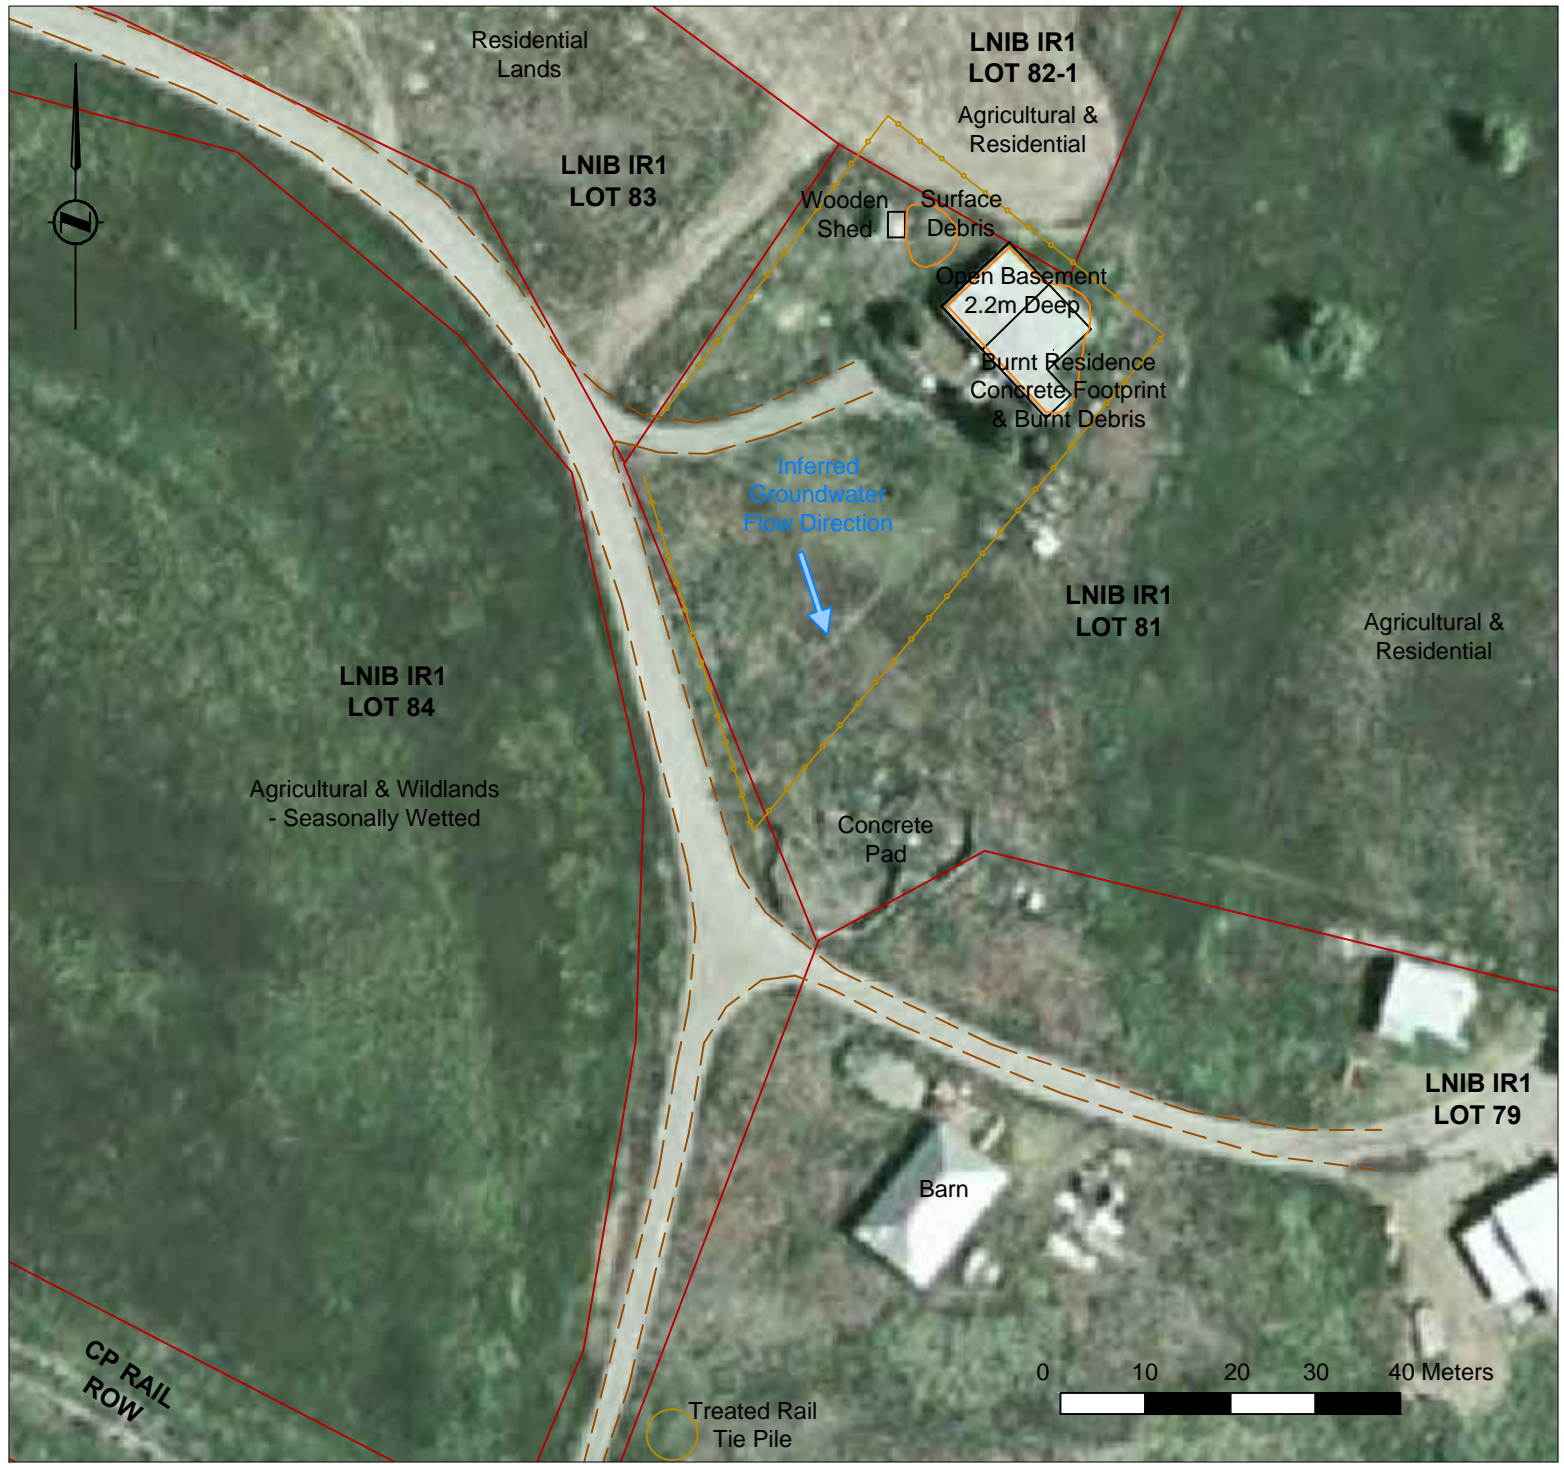
Figure 21
Nicola Mameet IR #1
Lot 81 Burnt House

APEC 23 Lot 81 Burnt House 653278E 5556032N	Foundation and surrounding area is littered with scattered burnt debris. Basement portion is open to 2.2m below surface grade, and contains standing water. Area is overgrown and the open basement presents a safety hazard. Adjacent shed contains debris.	<ul style="list-style-type: none"> • Metals • PAH • PHC
APEC 24 Lot 17 & 18 Residential Dump 653223E 5555894N	Buried residential dump (20m x 8m) contains metals and domestic waste, and potential unknown substances. Buried debris is on bank above seasonally wetted area within a residential development.	<ul style="list-style-type: none"> • Metals • PAH • PHC • VOC
APEC 25 Lot 86 Residential Dump 652973E 5556056N	Buried residential dump contains metals and domestic waste, and potential unknown substances. Buried debris is on bank and within seasonally wetted area and within a residential development.	<ul style="list-style-type: none"> • Metals • PAH • PHC • VOC

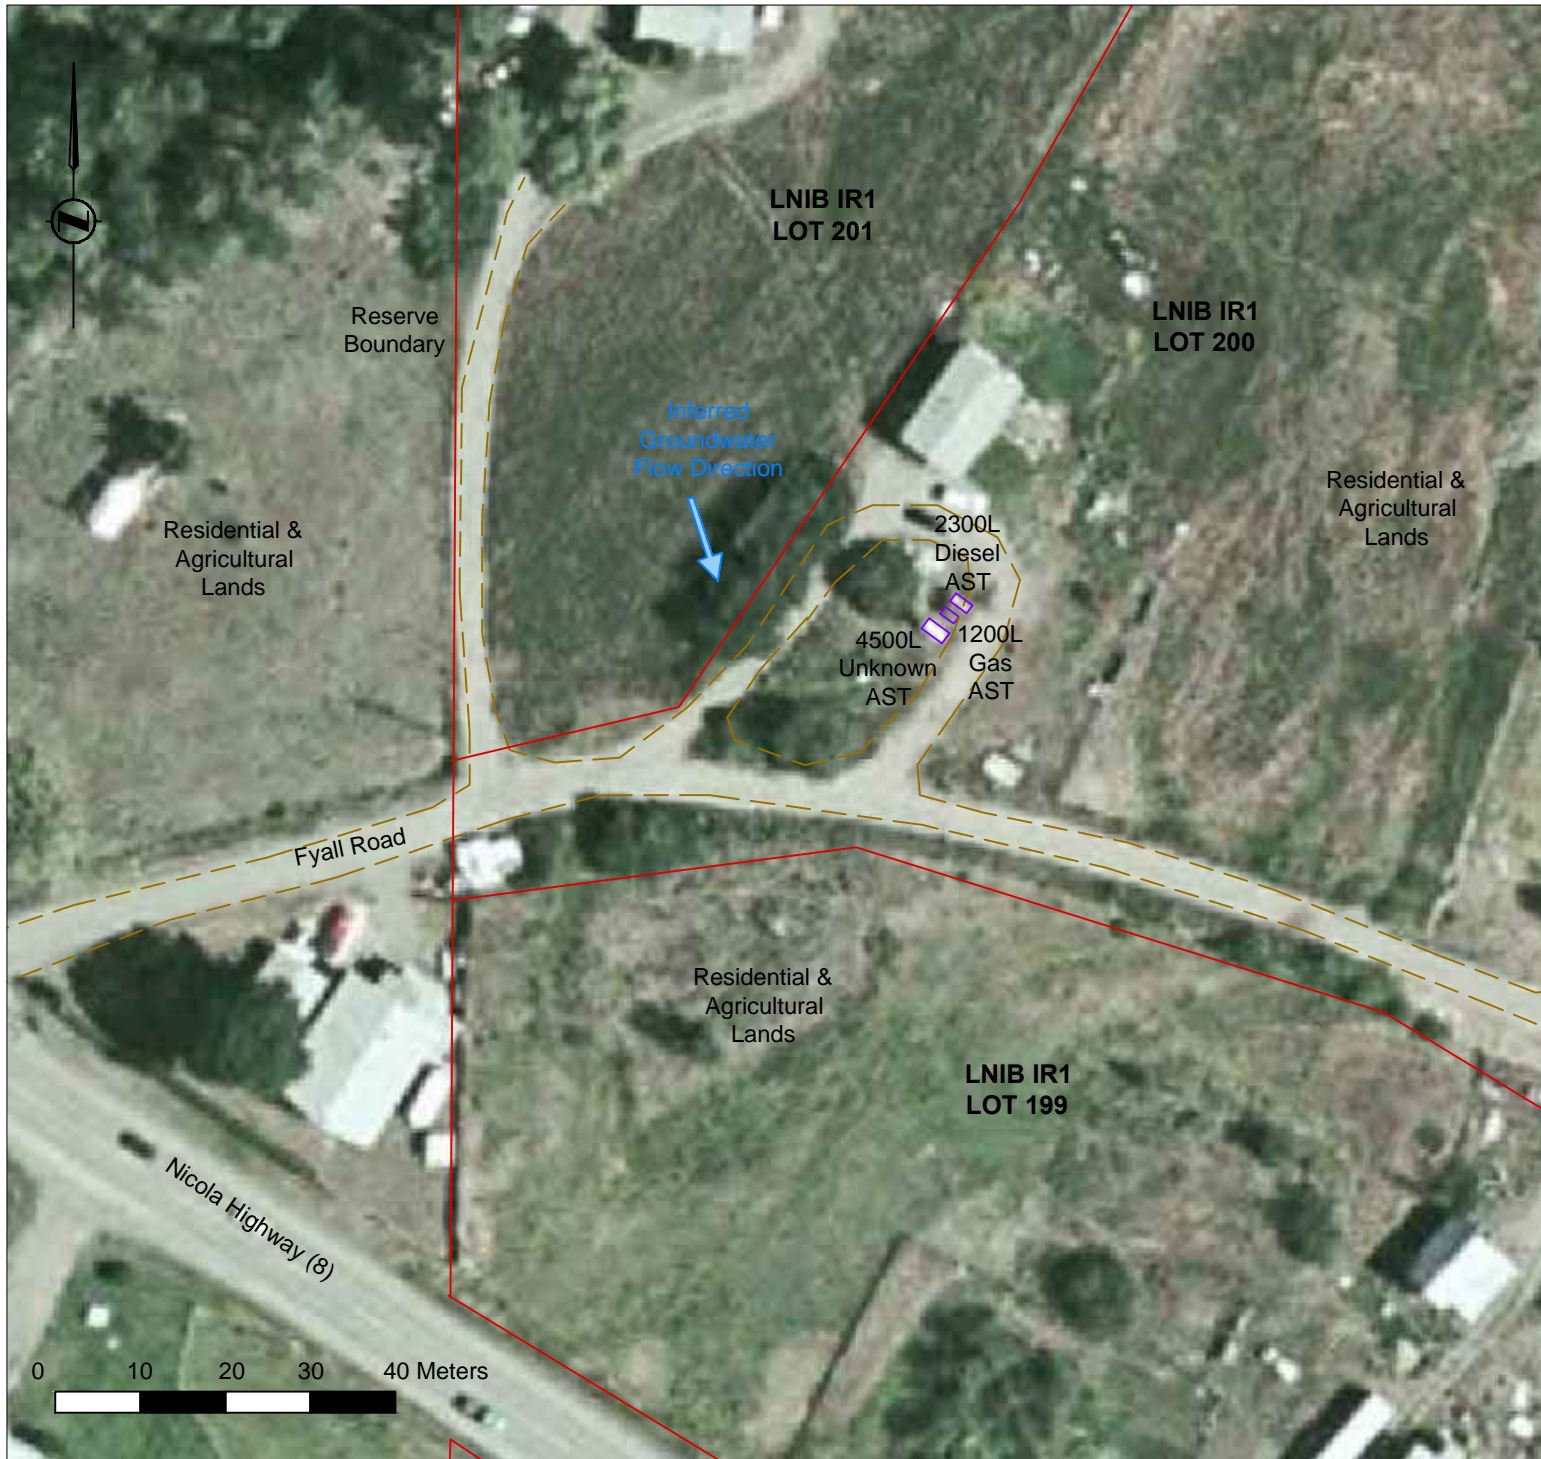
Figure 29
Nicola Mameet IR #1
Lot 200 ASTs

APEC 31 Lot 200 ASTs 651774E 5557470N	Three (3) privately owned ASTs (4500L unknown, 1200L gasoline, and 2300L diesel) are immediately adjacent to each other and appear in use. The tanks are in moderate condition with some rust and weeping occurring at the bungs and nozzles. The area has a hydrocarbon odor with spotty soil staining.	<ul style="list-style-type: none"> • PAH • PHC
APEC 32 Former Shulus School AST (ESSIMS 7000086497)	Fuel storage tank was removed from the school property in the 1980's. In 1999, the former location of the AST could not be confirmed during the FNESS UST/AST removal program, and soil conditions below the former AST remain unknown.	<ul style="list-style-type: none"> • PAH • PHC
APEC 33 Soil Contamination Charlotte Joe Residence (ESSIMS 7000086397)	Fuel storage tank was removed from Charlotte Joes residence during the FNESS UST/AST removal program. Contaminated soil was excavated from the property, however, the soil remains contaminated at 2.5m depth, as further excavation was prevented due to the proximity of the house foundation.	<ul style="list-style-type: none"> • PAH • PHC

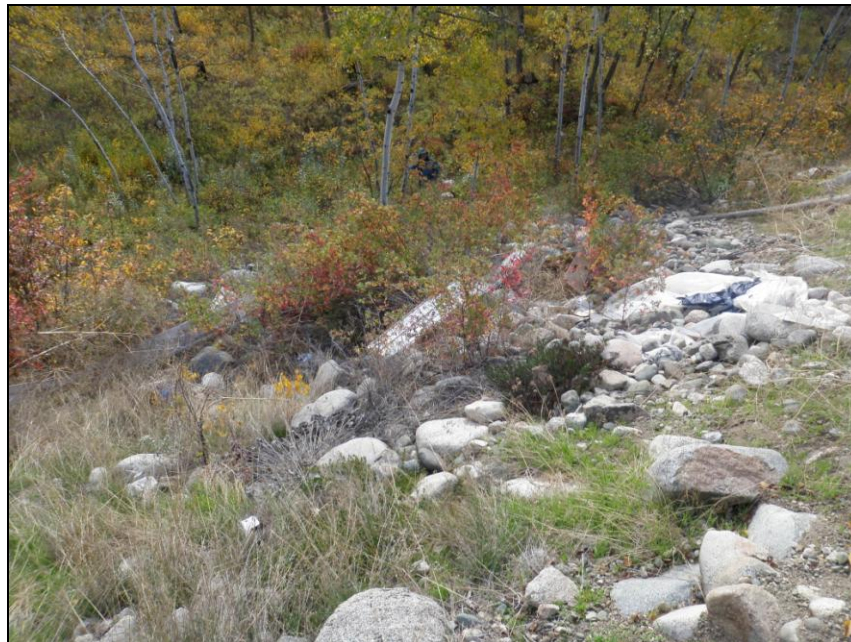
Photo 4. View Rocky Pines residential dump facing east. Note the limited waste materials.

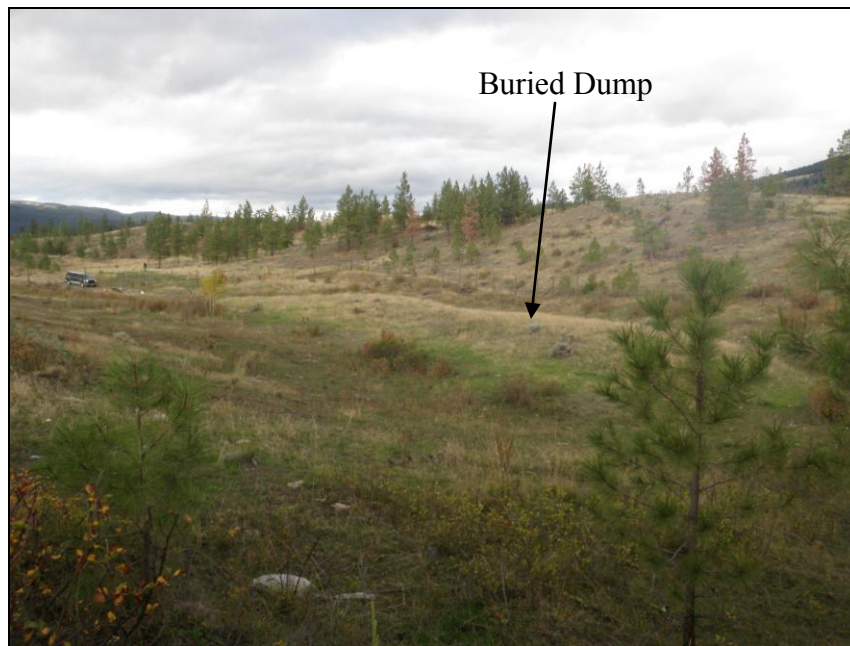
Photo 8. View of the buried Four Mile Dump debris facing northwest. Note the elongated feature in the center of the photo is the buried dump extent.

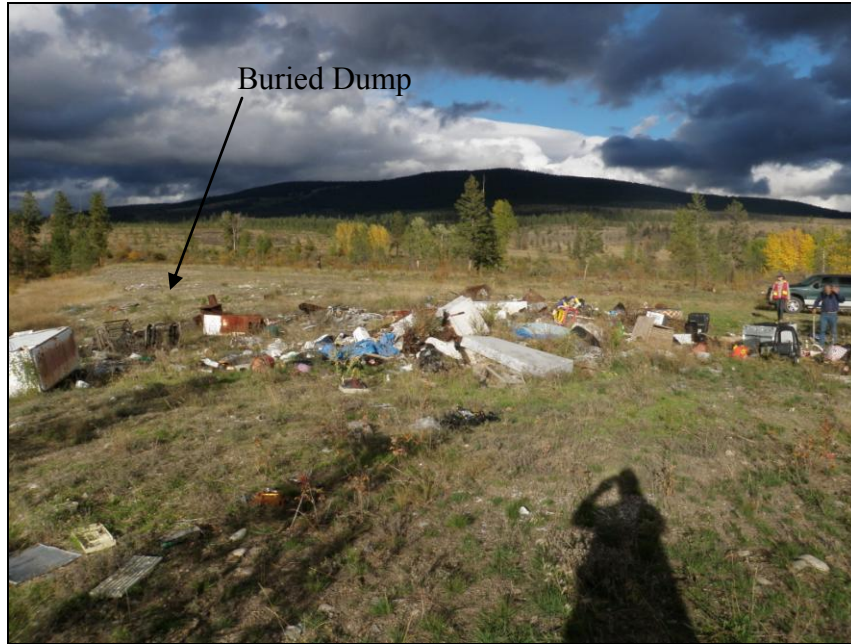
Photo 11. View of Buried Dump #2 Mamit Lake Ranch Road North facing north. Note the recent dumping of domestic waste. The disturbed area is the reported extent of buried materials.

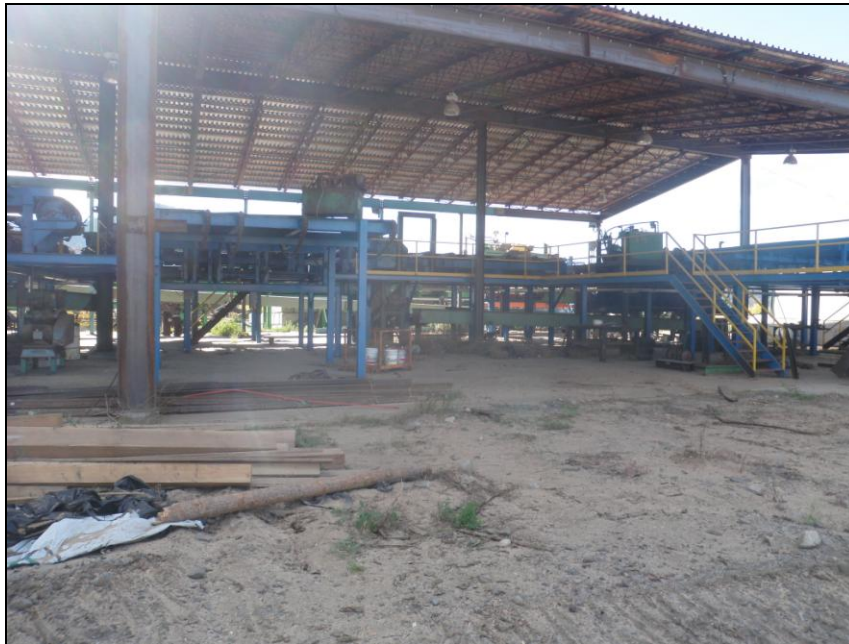
Photo 22. View of the inoperable sawmill, and limited petroleum product storage within the covered building. Note the concrete pad below.

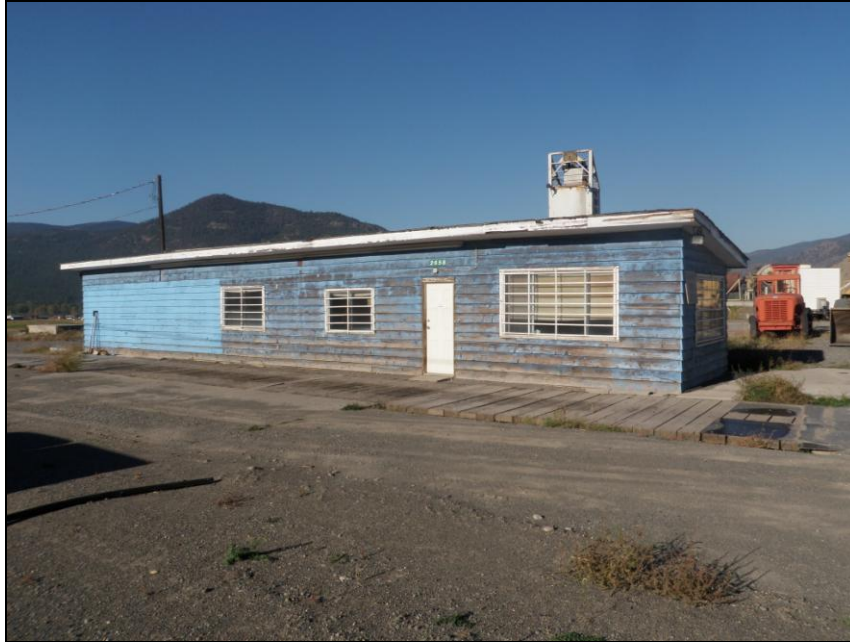
Photo 23. Overview of the abandoned Mojos Gas Station Building on Lot 265 facing southwest. Note the sump below the treated wood at the front of the building, and remaining concrete pad.

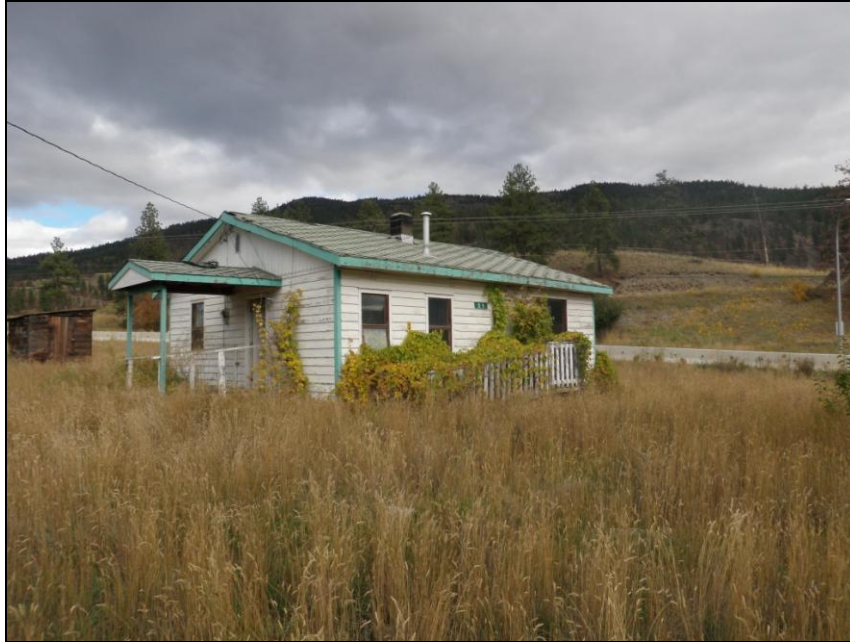
Photo 29. View of the Abandoned House on Lot 105 facing northeast.

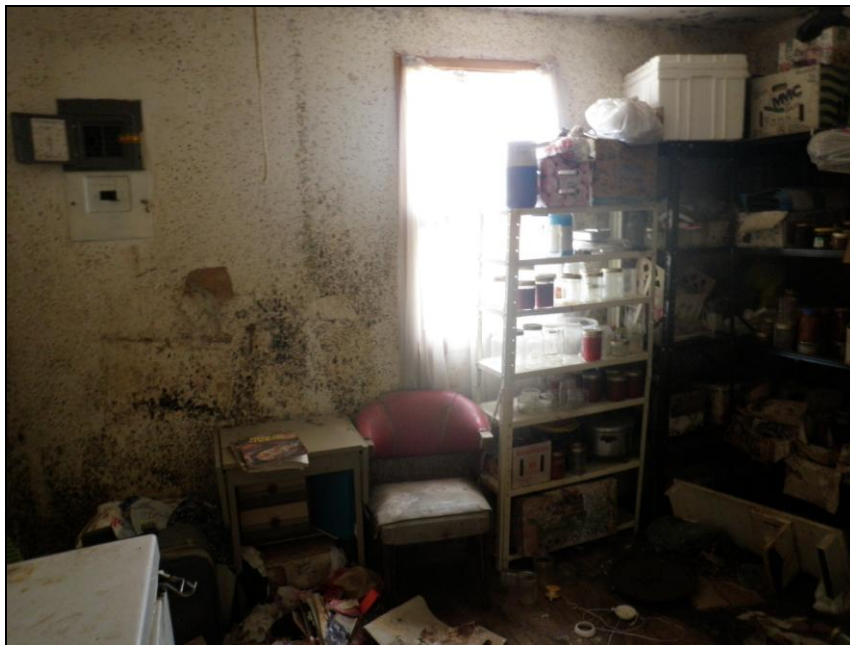
Photo 30. View of the interior of the Lot 105 Abandoned House showing mold on walls, and remaining household materials inside.

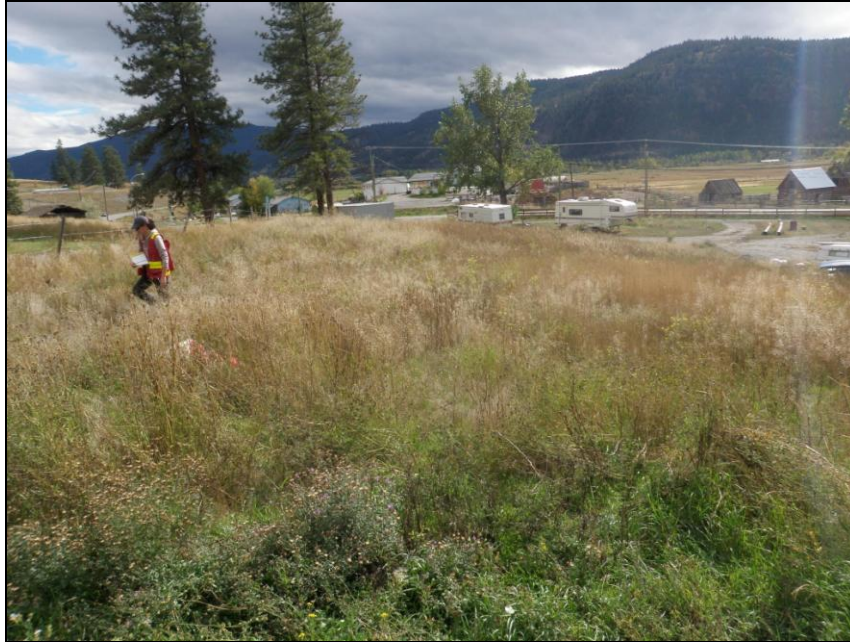
Photo 31. View of the Lot 87-4 debris area. Note the lack of debris at the Site.

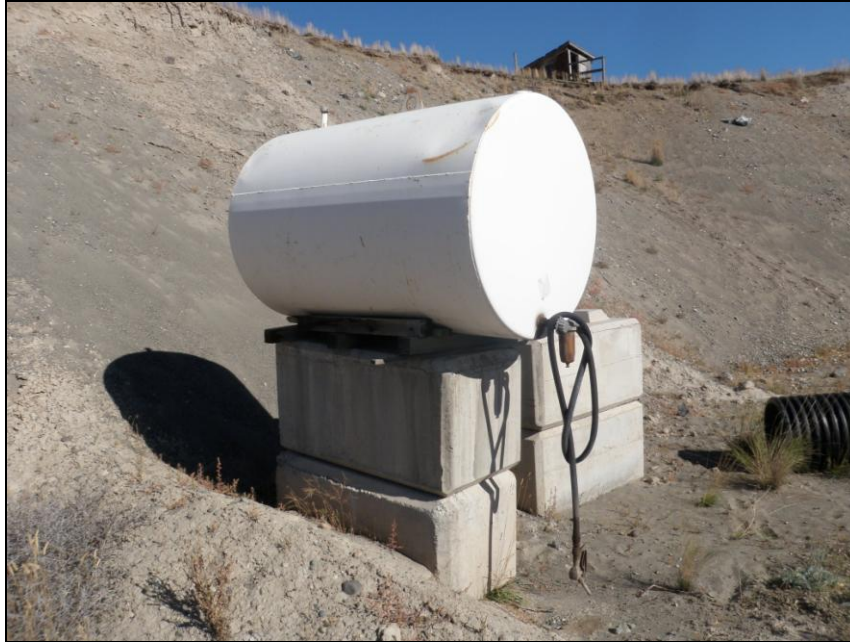
APEC 16 Lot 208 AST (213E) 654749E 5555735N	Privately owned 2300L diesel AST is empty and in good condition. Some weeping at the nozzle and cracks in the hose were noted. Tank is to be moved to a more permanent location and will be in use.	<ul style="list-style-type: none"> • PAH • PHC
APEC 17 Lot 208 AST (225E) 654867E 5555589N	APEC 17A – Two privately owned ASTs (1000L diesel and 1350L gasoline) are in moderate condition and do not appear in recent use. No soil staining or odor was noted below. Some petroleum hydrocarbon storage is occurring in the vicinity.	<ul style="list-style-type: none"> • PAH • PHC
	APEC 17B – One privately owned AST (2300L unknown contents) appears in good condition and does not appear in use. No soil staining or odors were noted. 2 tidy tanks were noted adjacent.	<ul style="list-style-type: none"> • PAH • PHC
APEC 18 Lot 58 AST (260E) 654855E 5555240N	Privately owned 900L diesel AST is empty and appears in moderate condition. The tank is on a treated wooden support that is rusting and has some weeping at the nozzle. A second adjacent 900L tank is empty and on its side. No staining or odors were observed below the tanks.	<ul style="list-style-type: none"> • PAH • PHC

Photo 35. View of Lot 208 AST (213E) on Highway 8 facing northeast. Note that tank is likely to be moved to a more permanent location near the residence to the east.

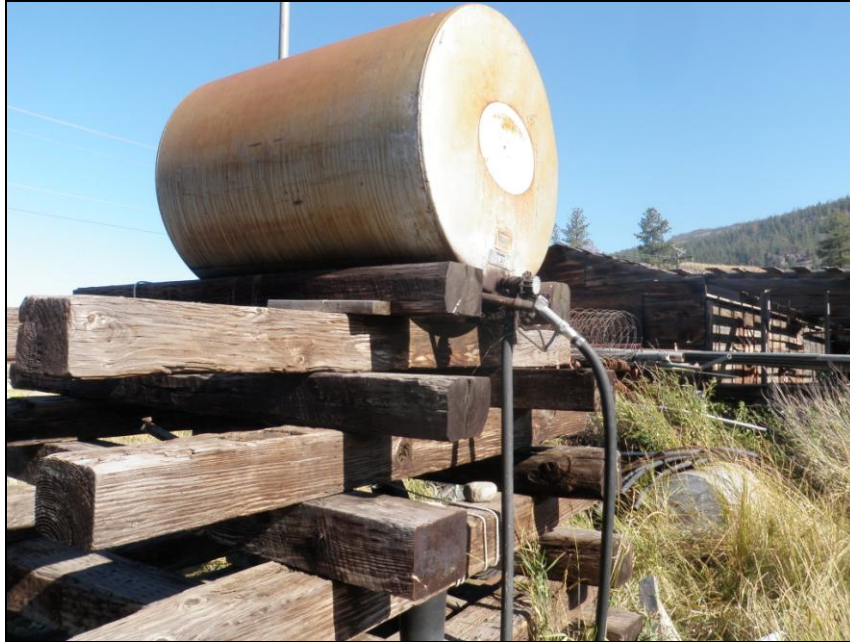
Photo 37. View of the Lot 58 AST (260E) on Highway 8 facing north. Note the treated wood supports, and second empty tank abandoned in the grass to the right.

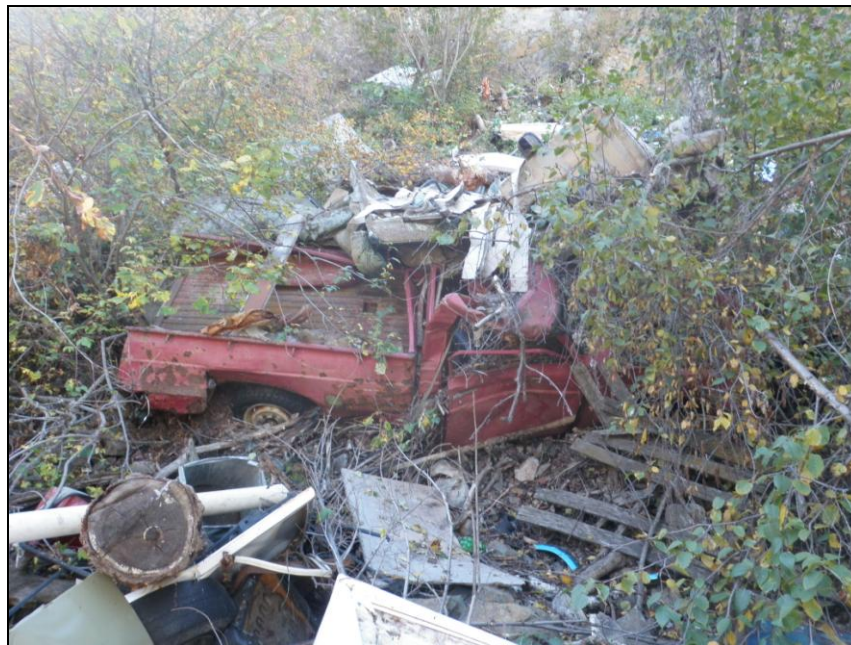
Photo 40. View of typical debris within the BC Plan 215 Nicola River Dump. Note the building materials, metals, wood waste, domestic waste, furniture and white goods and dense vegetation throughout the area.

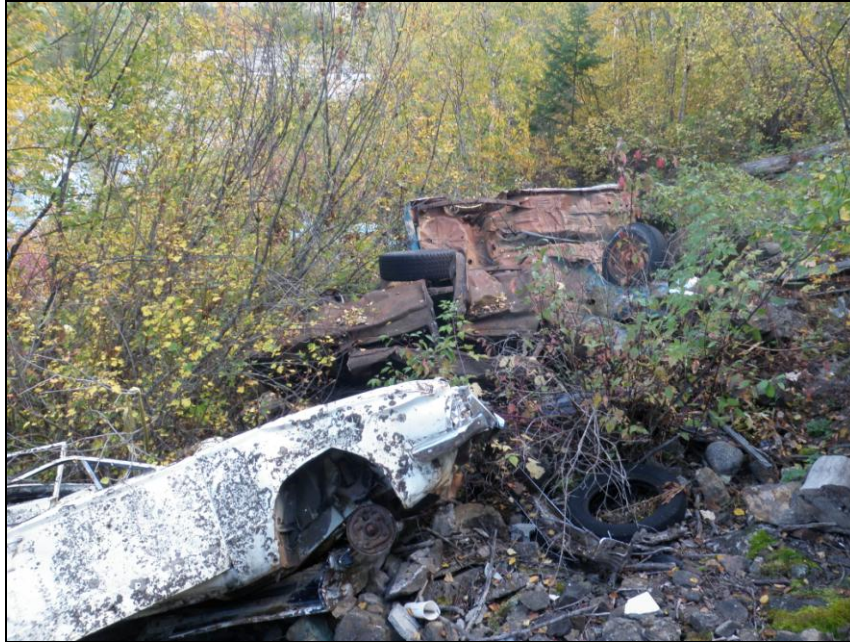
Photo 41. View of two automobiles within Nicola River Dump facing northeast. Note the proximity to the river and debris scattered within the talus slope.

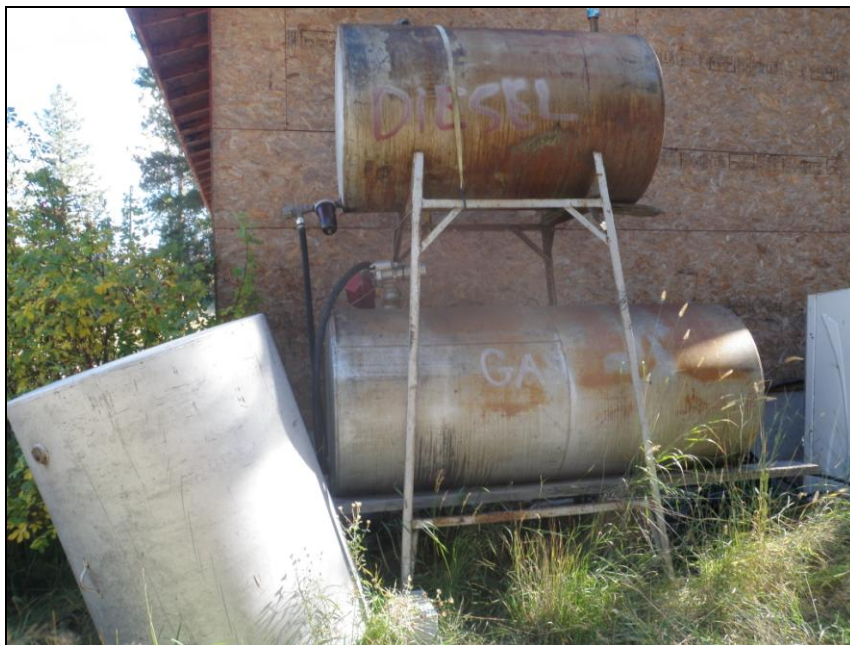
Photo 42. View of the BC Plan 215 Shulus Road ASTs facing east.

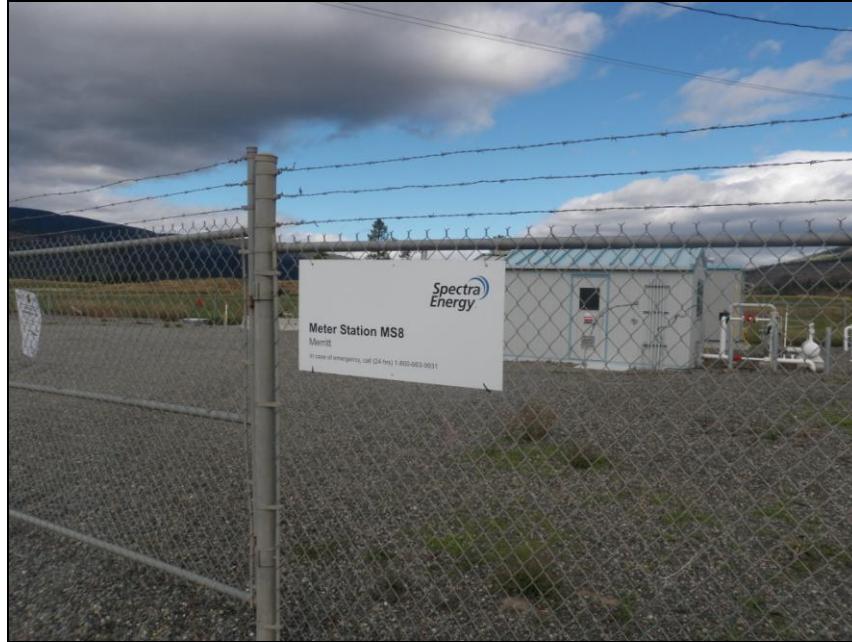
Photo 43. View of the Lot 96 Spectra Energy Power Station located off reserve facing northwest. Note the three meter station buildings, and pesticide use notice on the fence at left.

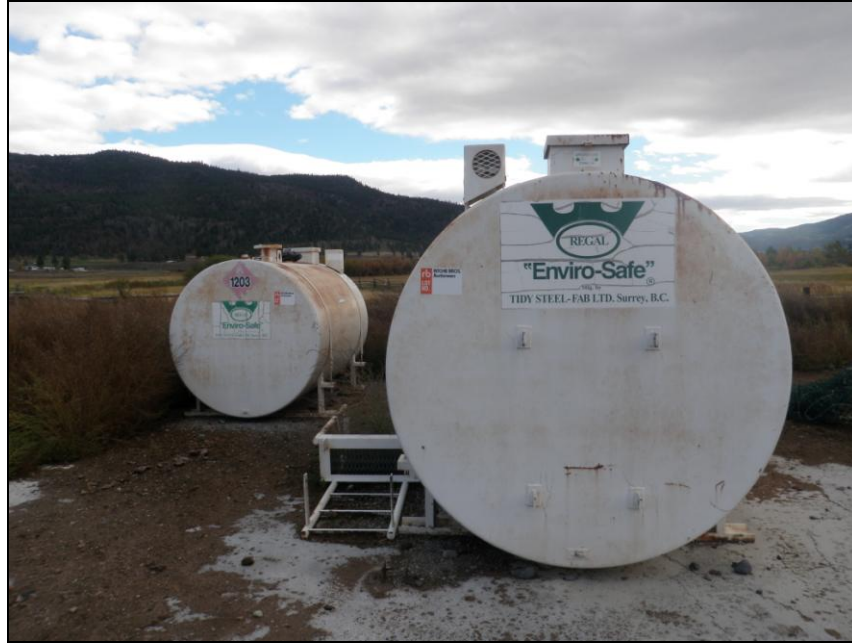
Photo 47. View of the Lot 183 Abandoned Gas Station ASTs facing east. Note the ASTs are empty and abandoned on a concrete pad south of the “Johnny’s on the Rez” Gas Station.

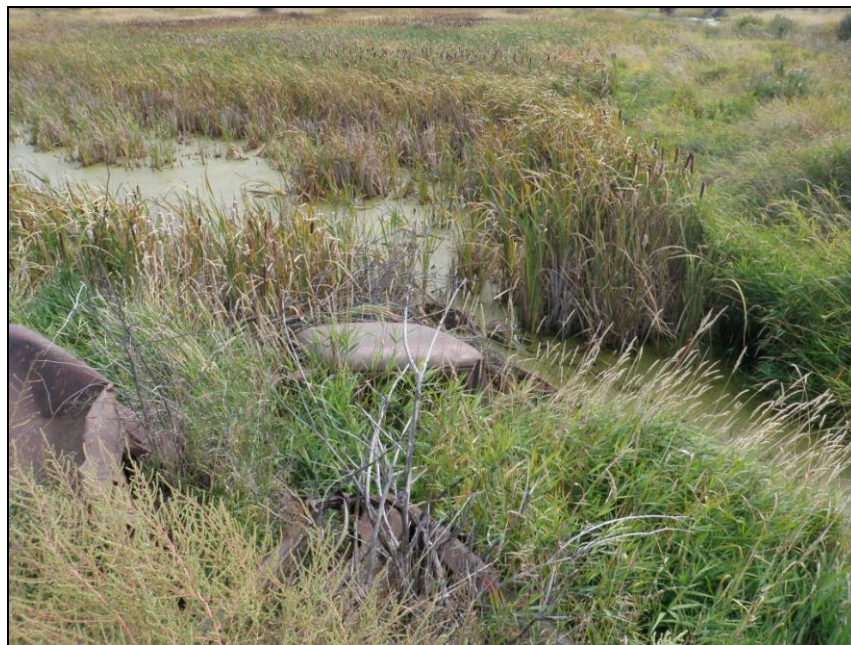
Photo 50. View of Lot 86 Residential Dump facing west. Note the buried car within the wetland and surface metals along the bank. Wetland is connected to the Nicola River.

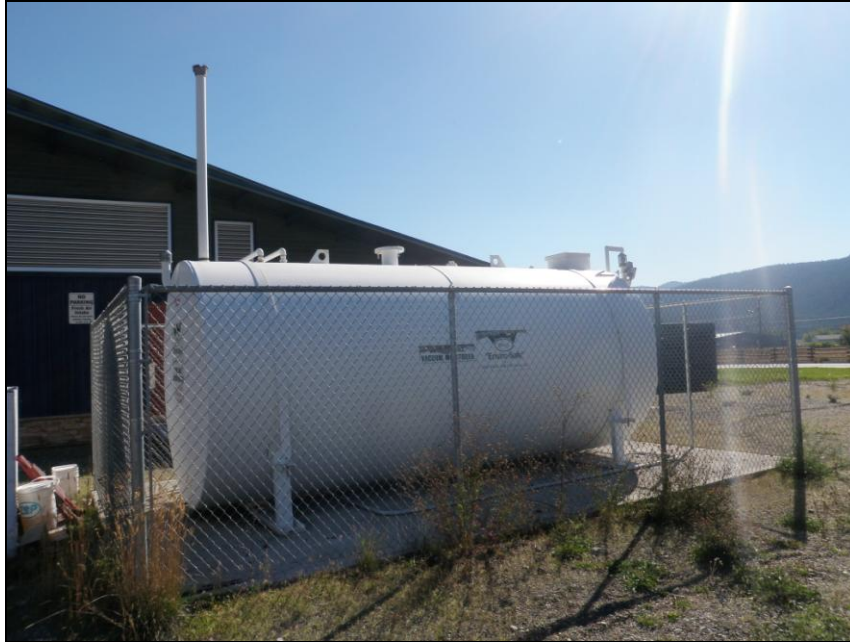
Photo 55. View of the LNIB School AST facing southeast. Note the concrete pad with the fenced compound.

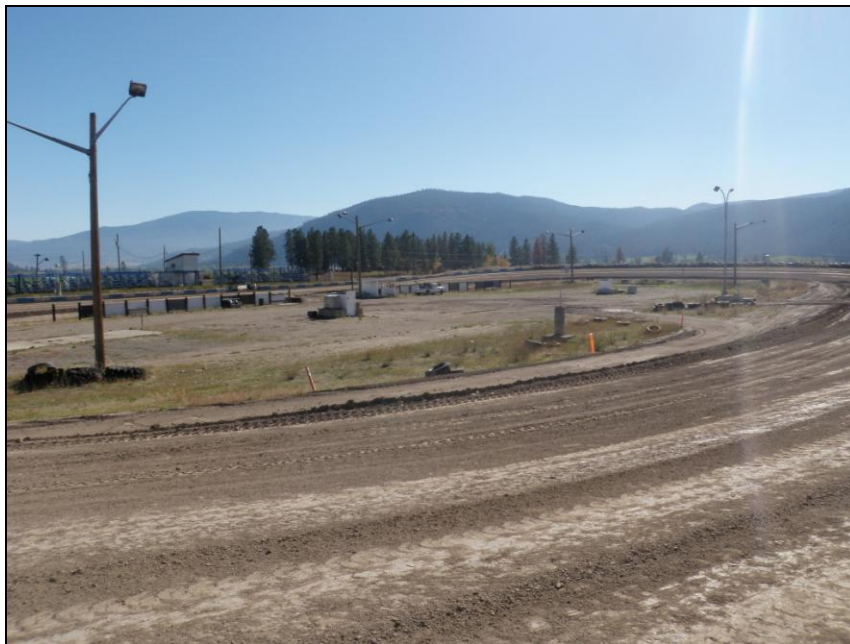
Photo 56. View of the Lot 198 Merritt Speedway facing southeast.
