**PHASE I  
ENVIRONMENTAL SITE ASSESSMENT**

**Zoht IR # 4,  
Lower Nicola Indian Band  
Merritt, British Columbia**

**Project No: 10-0374**  
April, 2011

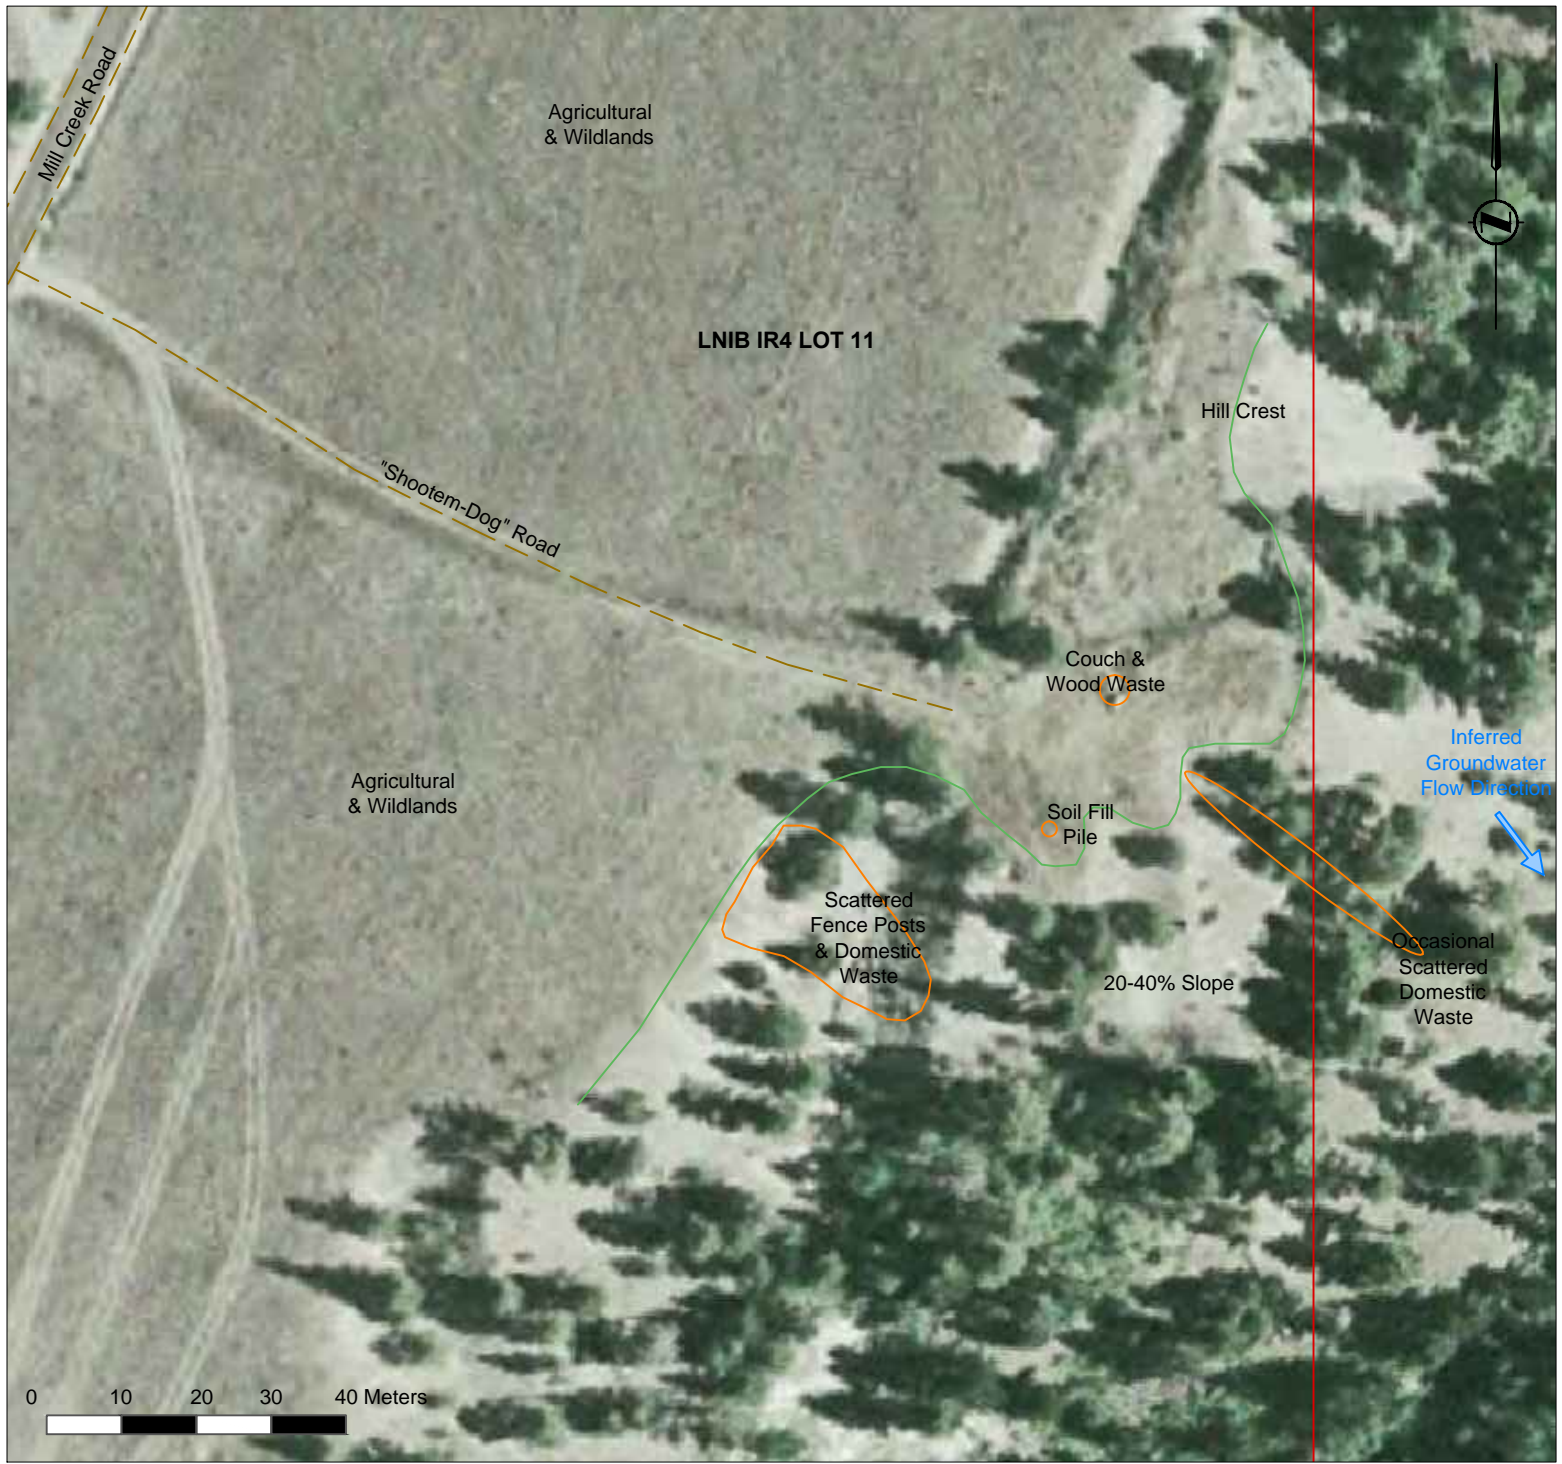
**Figure 5**  
Zoht IR#4  
Lot 11 Dump

Some accumulation of metals debris was observed on-site. Figures 2 and 5 show major stockpiles of metal equipment and debris at the Post Mill and Lot 11 Dump respectively. Since the Post Mill is an active industrial site with continuing operations and moving storage components, currently observed debris may have been moved from different locations many times prior to the 2010 site reconnaissance. Since the observed metal debris piles and domestic wastes are surficial in nature and composed largely of scrap metal and old

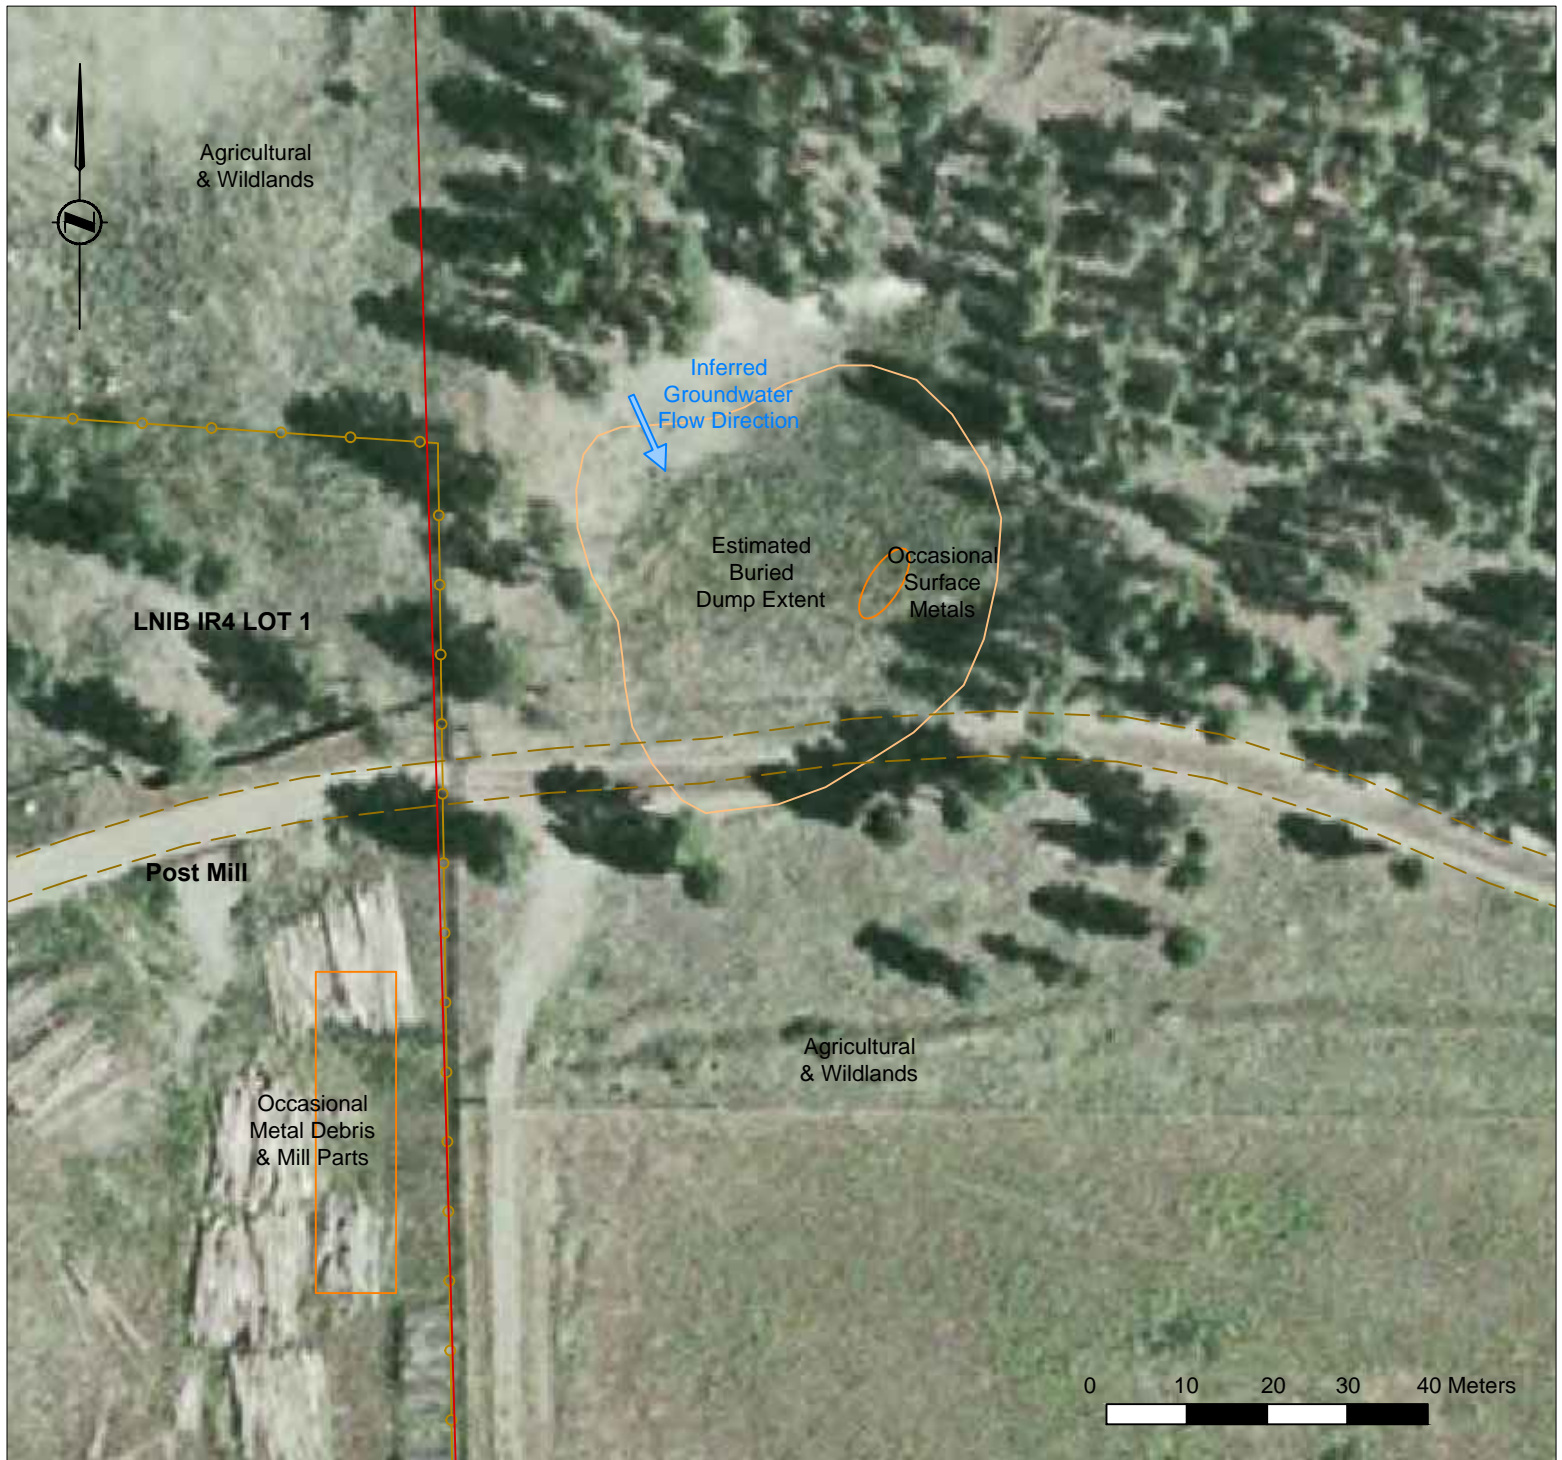
**Figure 6**  
Zoht IR#4  
Off Reserve Dump#1

at this location is sloped to the southeast, away from the Reserve. . It is reported to contain mostly domestic waste from the Lakeside Estates on Nicola Lake. Dump #1 is retained as an APEC with low potential for impacting the Site and is shown on Figure 6. Dump #2 is located immediately adjacent to the southern border of the Reserve. Limited surficial debris was noted at the Site and it is down-gradient from the reserve. As such, Dump #2 is not retained as an APEC. The oil pipeline right of way is an off-site APEC.

A Phase 2 ESA is recommended to determine the presence or absence of contaminated media at the APECs identified by this assessment.

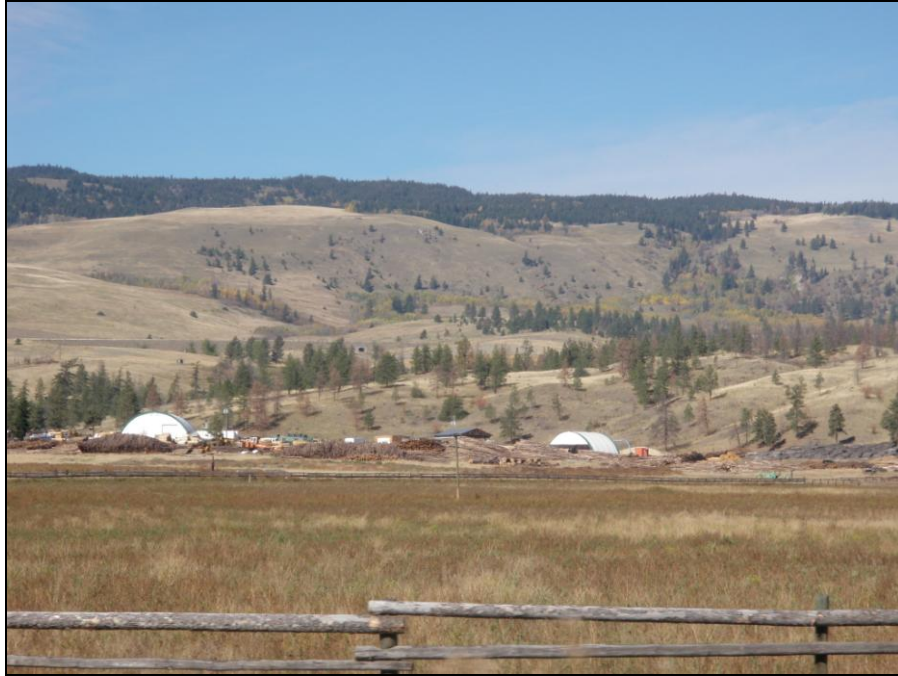
**Photo 1.** Overview of the Zoht IR4 Plan 59794 Post Mill looking west from Monck Park Road.

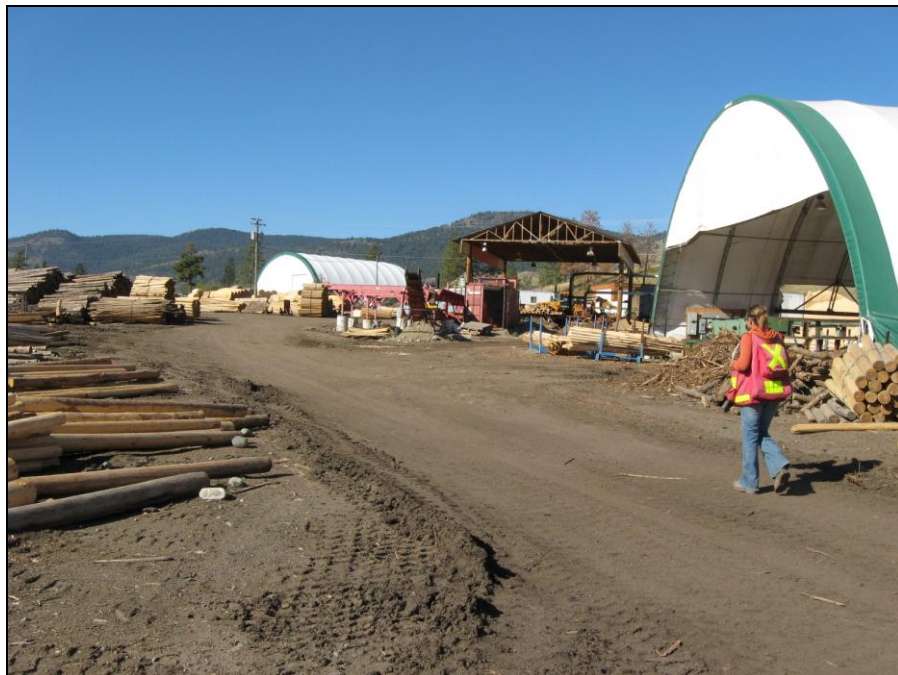
**Photo 2.** Overview of the post processing area (de-barkers, post point areas) on the northern portion of the Site (Plan 59794 Post Mill) facing west. Note the canvas covered buildings hold machinery for cutting, shaping, and trimming posts.

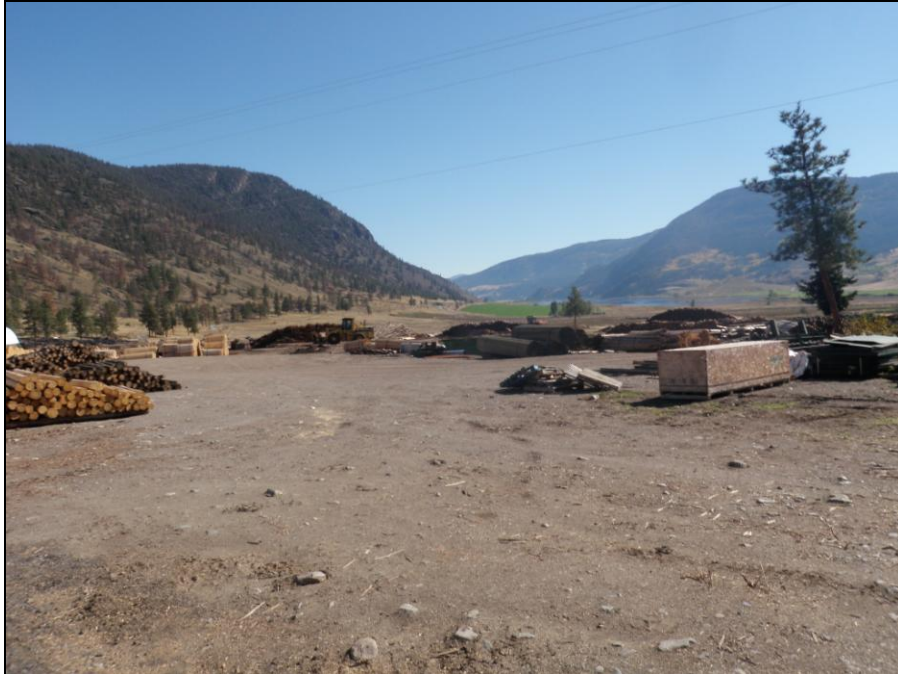
**Photo 9.** View of the southern portion of the Plan 59794 Post Mill wood stacking area facing east.

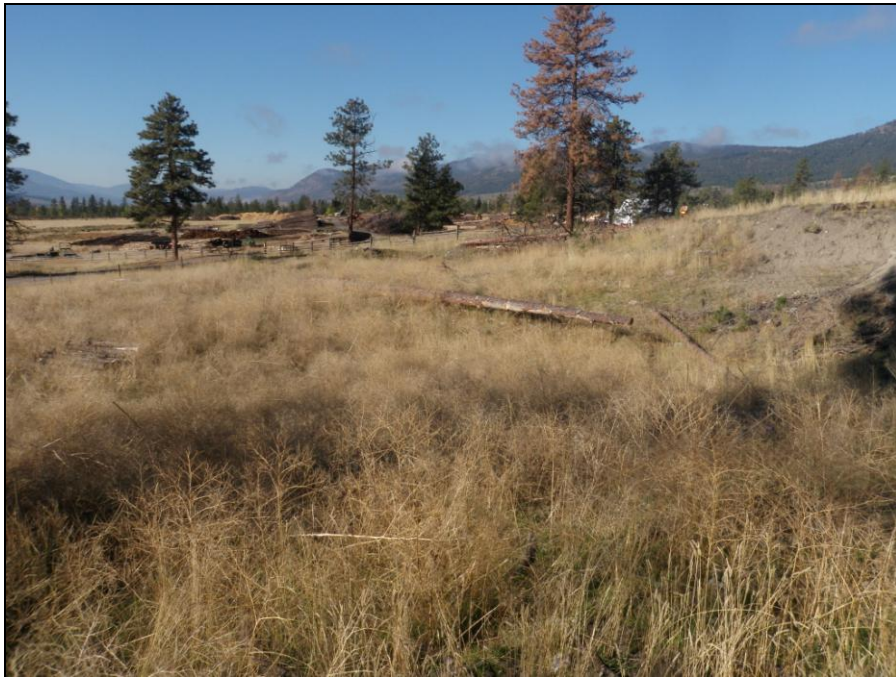
**Photo 16.** View of the Zoht IR4 Off Reserve Dump 1 facing southwest. Note the reserve boundary to the east marked by a wooden post and rail fence.

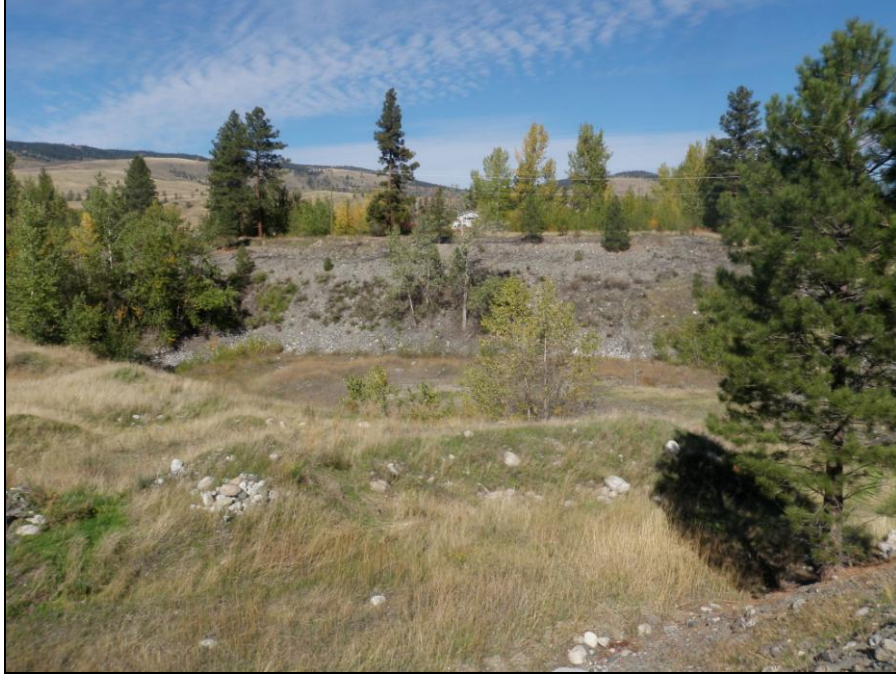
**Photo 17.** View of the Zoht IR4 Off Reserve Dump 2 Pit #1 facing north. Note the reserve boundary to the north on the top of the northern pit wall.
